Deputy Clerk's Report

the **play inspection** company

Annual Inspection

Marden Playing Field

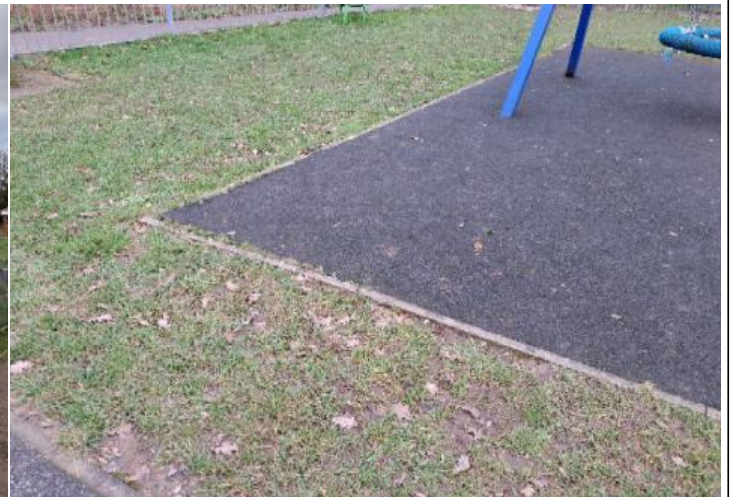
Finding: There are trip hazards at the edges of the surface

Action: Remove trip hazard

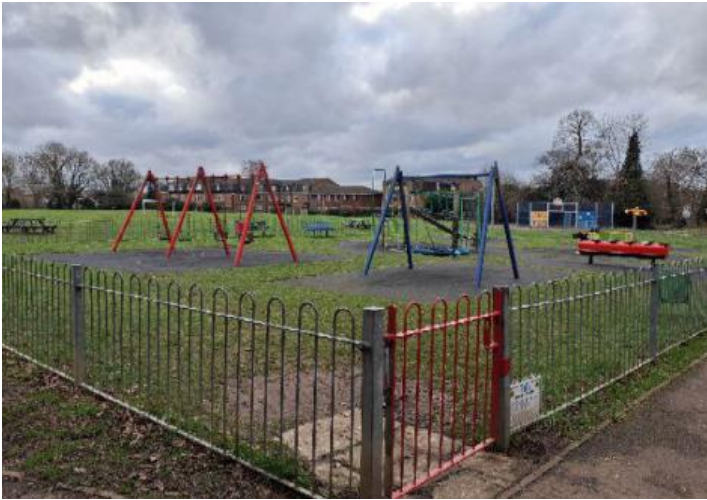
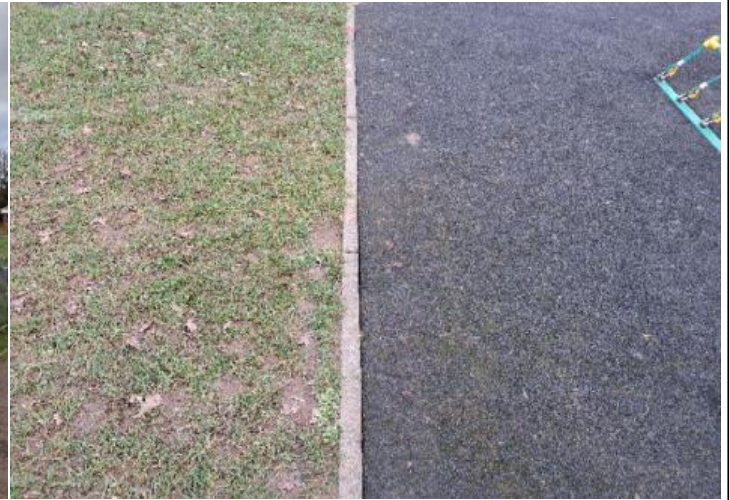
Finding: There are gaps opening between the surfacing and the edging surround or between the joints in the surfacing
Action: Monitor for any further deterioration and repair as required

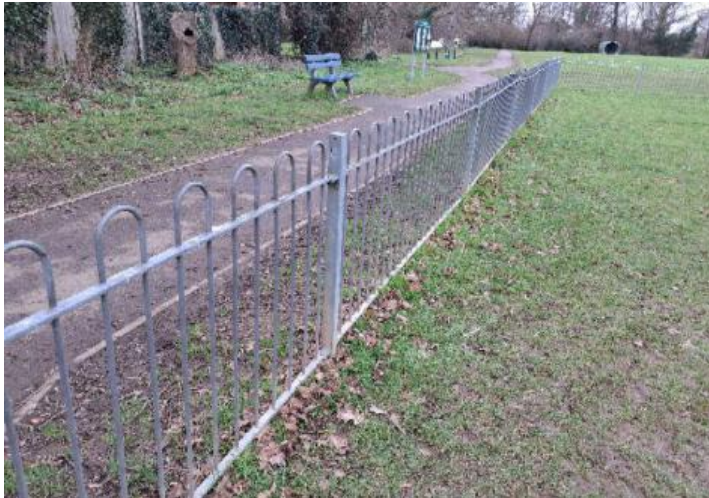
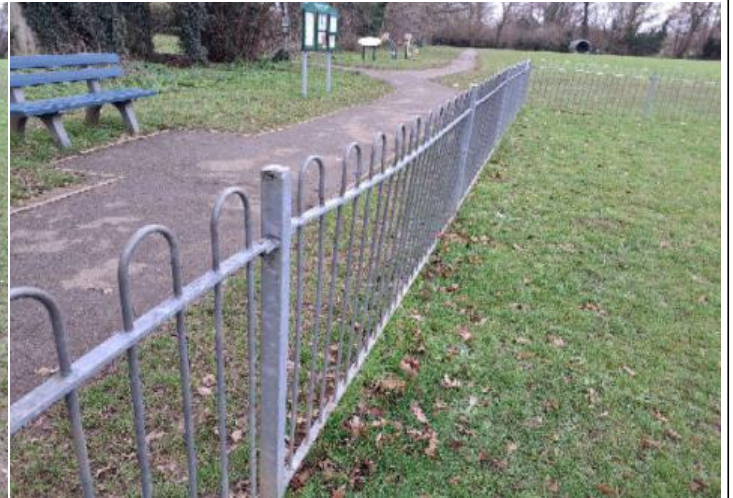
Finding: There is some damage to the fence sections

Action: Monitor for any further deterioration and repair as required

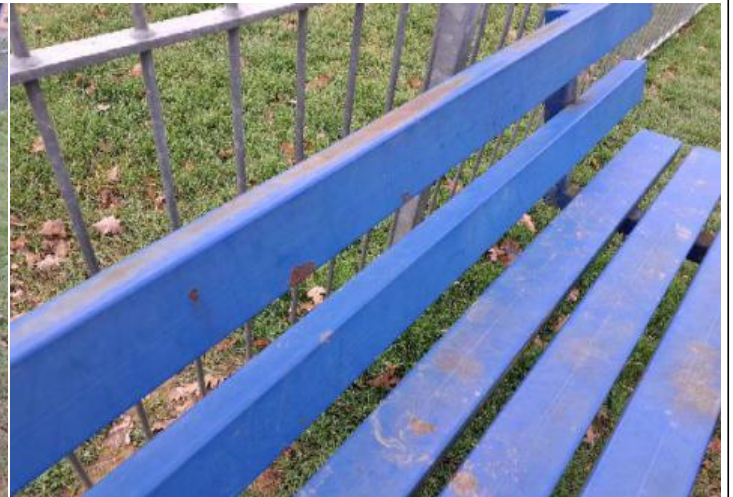
Finding: The paintwork on this item has been damaged or worn exposing the metal underneath which is rusting / corroding

Action: Treat affected areas and repaint

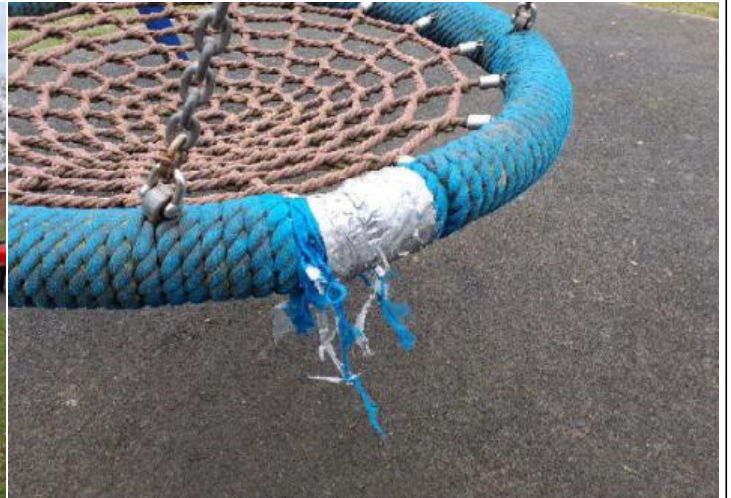
Finding: The seat is severely damaged and requires replacing

Action: Replace damaged seat

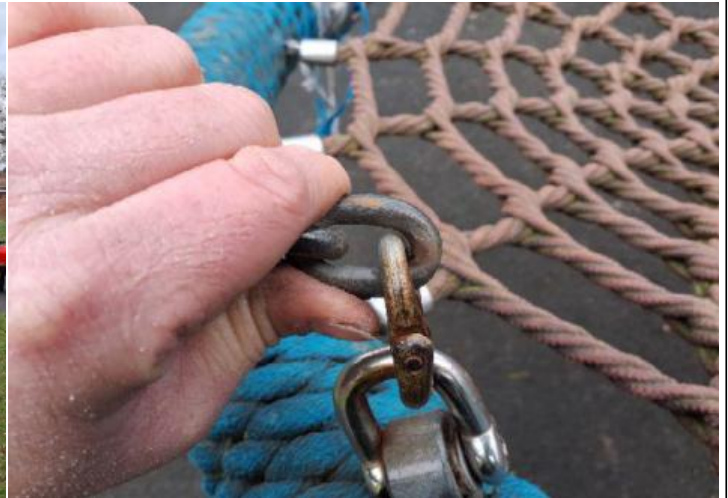
Finding: There is some notable evidence of chain wear

Action: Monitor for any further deterioration and replace when 40% worn

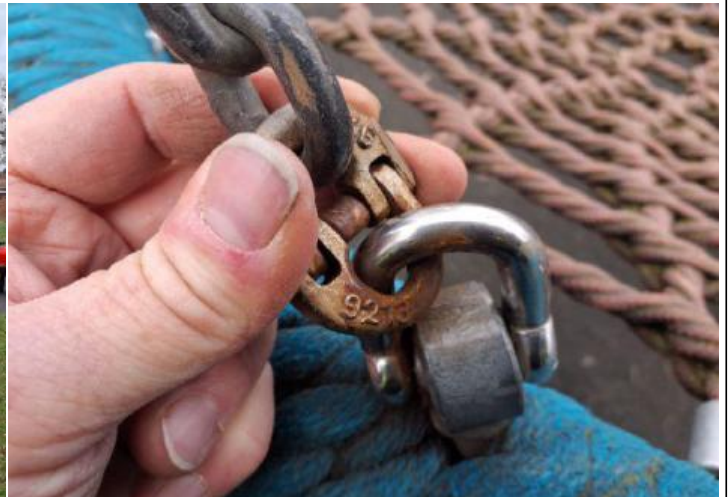
Finding: There is some wear to the shackles.

Action: Monitor for any further deterioration and replace when 40% worn

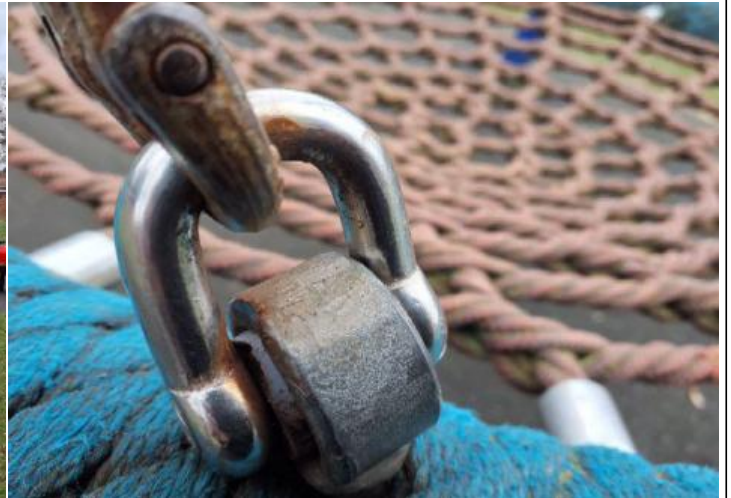
Finding: The swing seat connectors have some wear present

Action: Monitor for further deterioration and replace when 40% worn

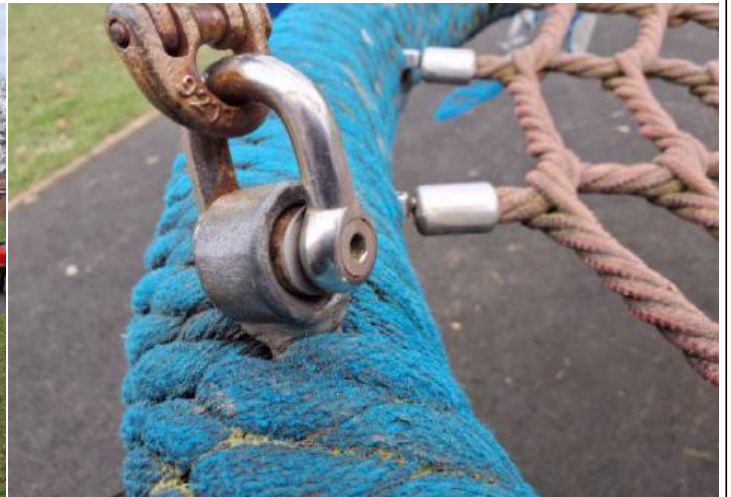
Finding: The bush / bushes is / are showing signs of wear

Action: Monitor for any further deterioration and replace as required

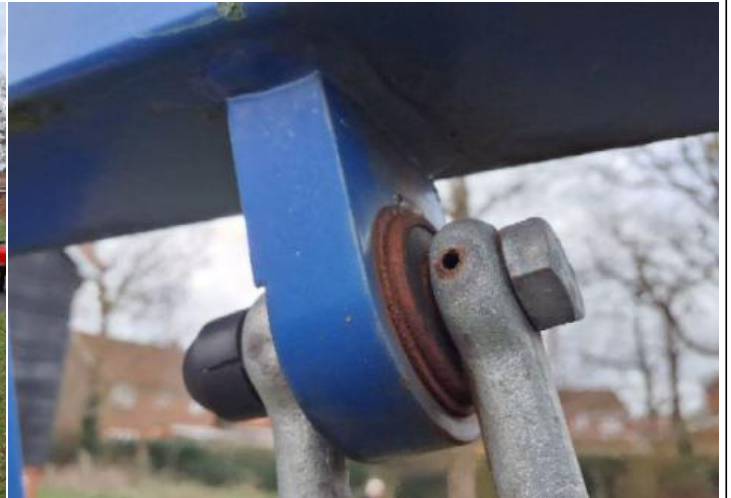
Finding: The split pins are missing from the shackles

Action: Insert split pins to secure the shackles

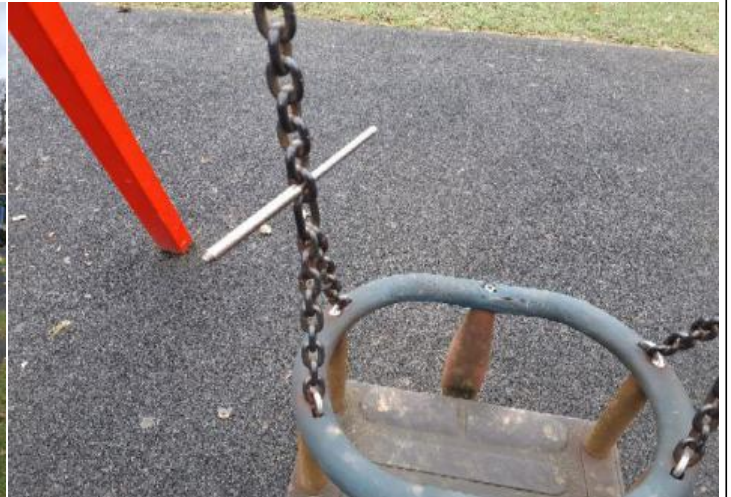
Finding: The chain openings are in excess of the 8.6mm as recommended by BS EN 1176

Action: Monitor - No action given the risk assessment

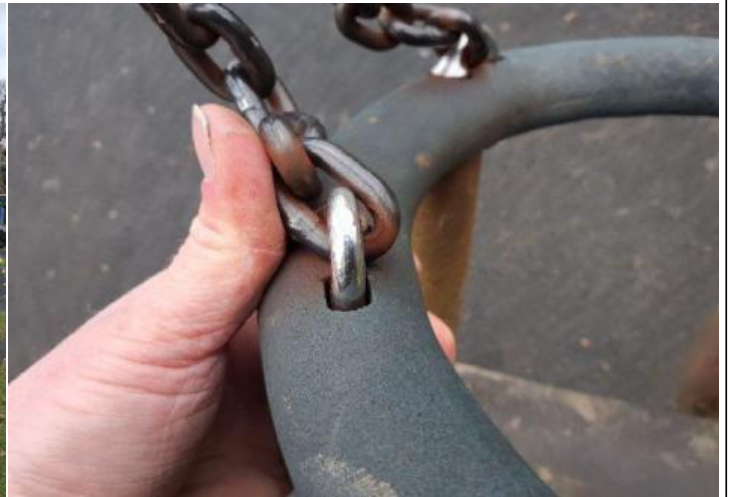
Finding: There is some notable evidence of chain wear

Action: Monitor for any further deterioration and replace when 40% worn

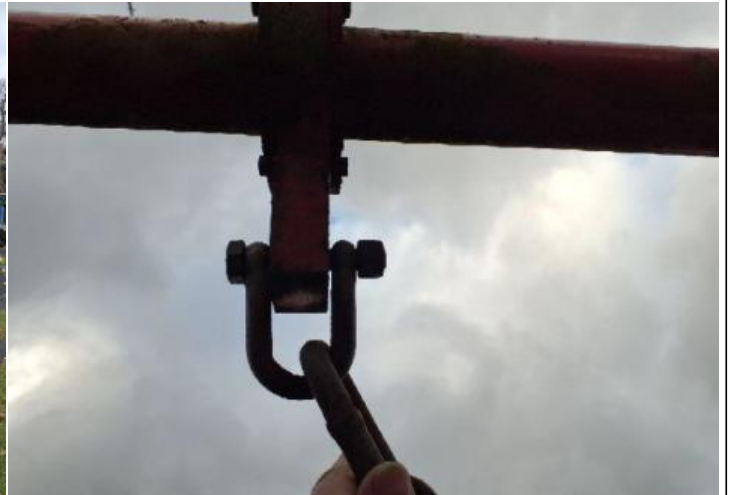
Finding: There is some wear to the shackles.

Action: Monitor for any further deterioration and replace when 40% worn

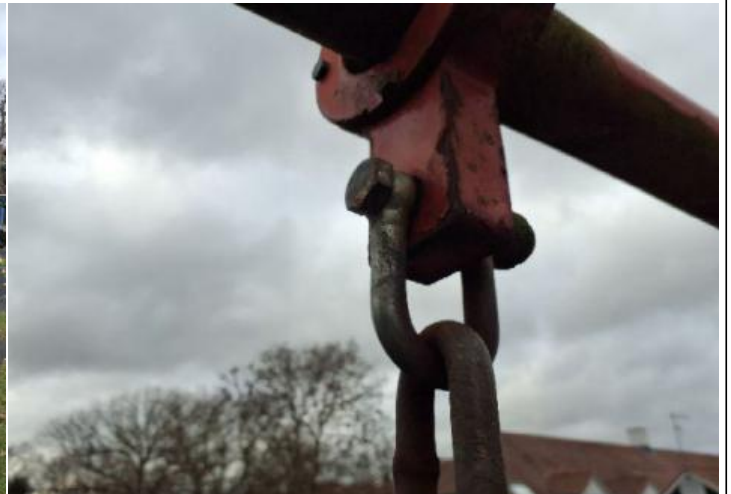
Finding: The bush / bushes is / are showing signs of wear

Action: Monitor for any further deterioration and replace as required

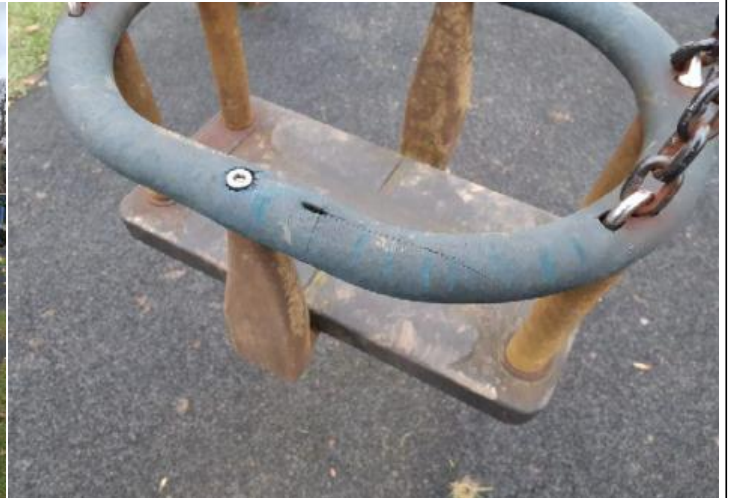
Finding: The seat has minor damage or wear

Action: Monitor for any further deterioration and replace as required

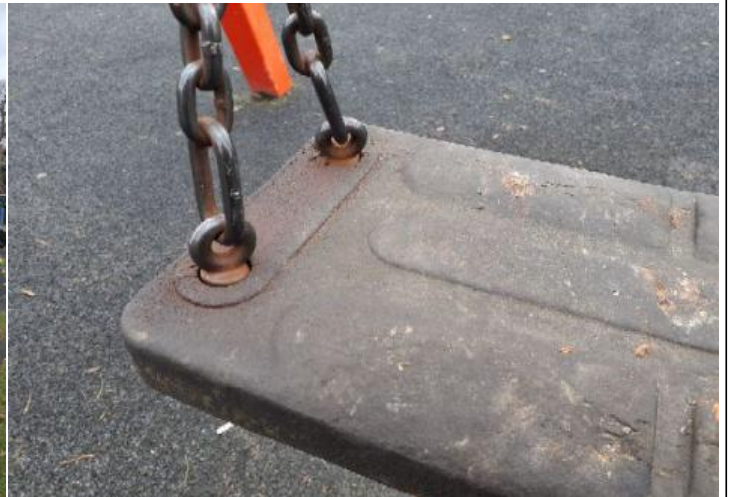
Finding: The swing seat connectors are loose

Action: Tighten to secure

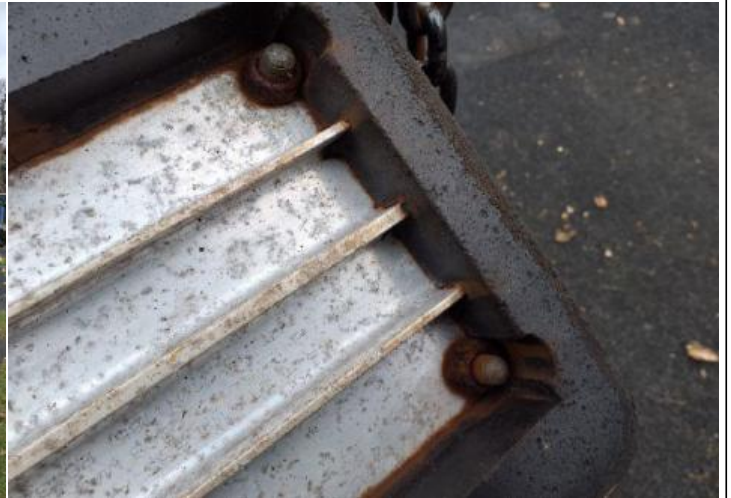
Finding: The fixings have corroded excessively

Action: Replace all corroded fixings

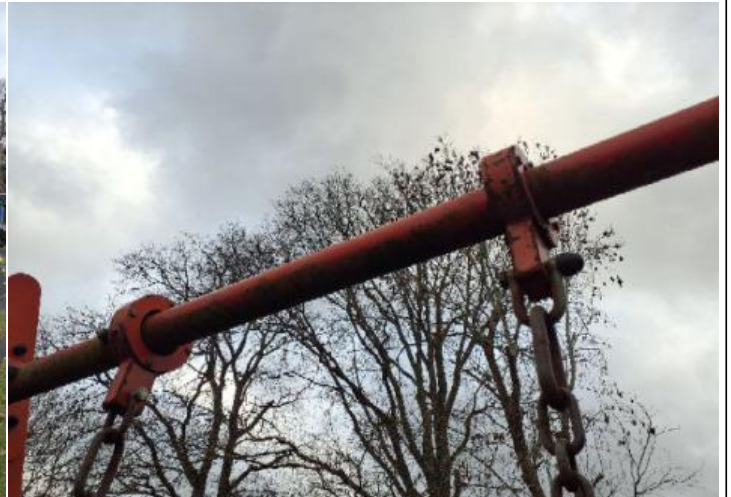
Finding: The paintwork on this item has been damaged or worn exposing the metal underneath which is rusting / corroding

Action: Treat affected areas and repaint

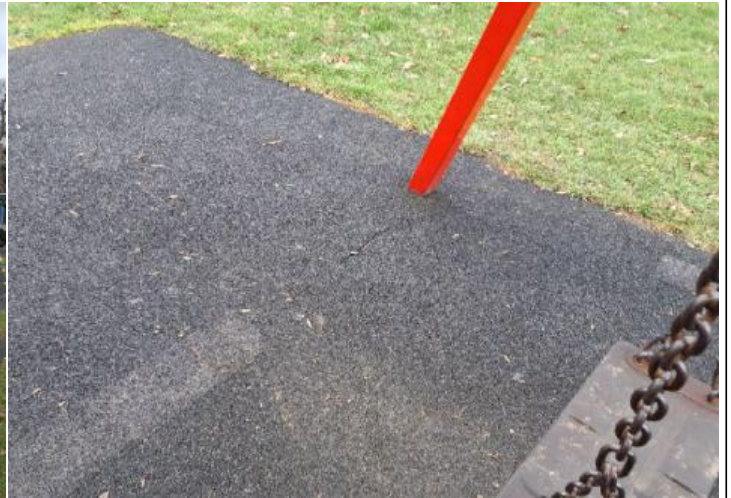
Finding: There is some minor damage to the surface

Action: Monitor for any further deterioration and repair as required

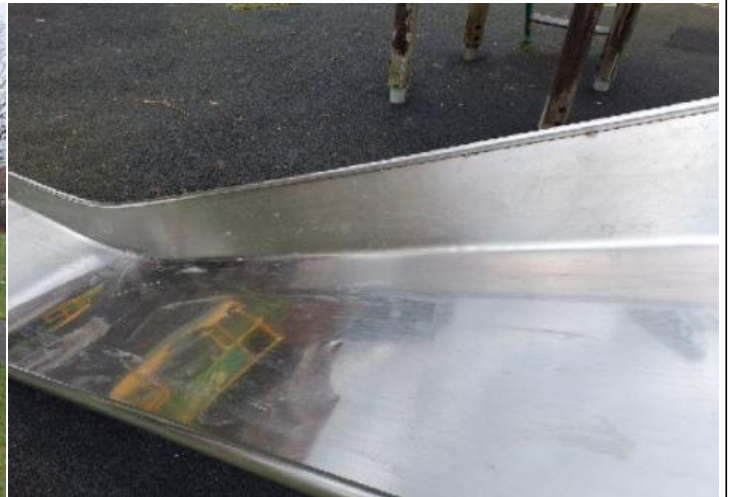
Finding: There are a number of dents in the slide surface

Action: Monitor for any further deterioration and repair as required

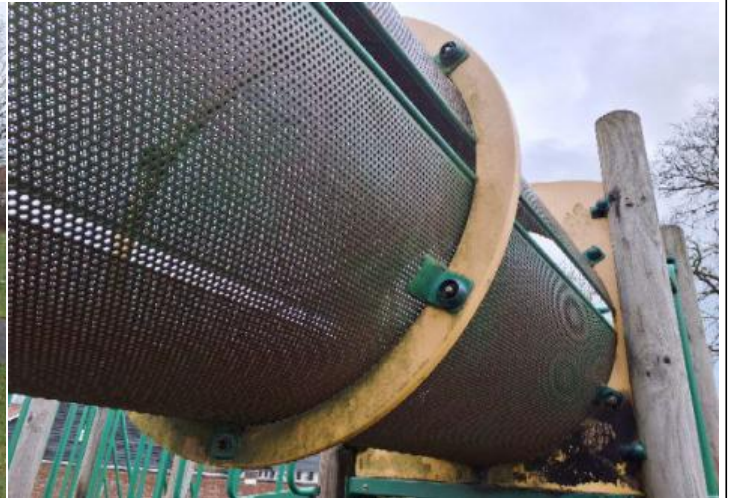
Finding: There is/are bolt cap covers missing or damaged on the item

Action: Replace missing or damaged bolt cap covers

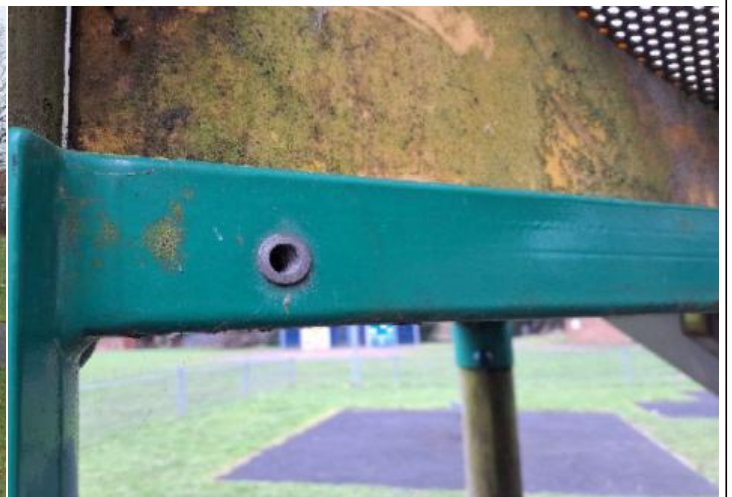
Finding: There is/are inserts missing

Action: Replace missing inserts

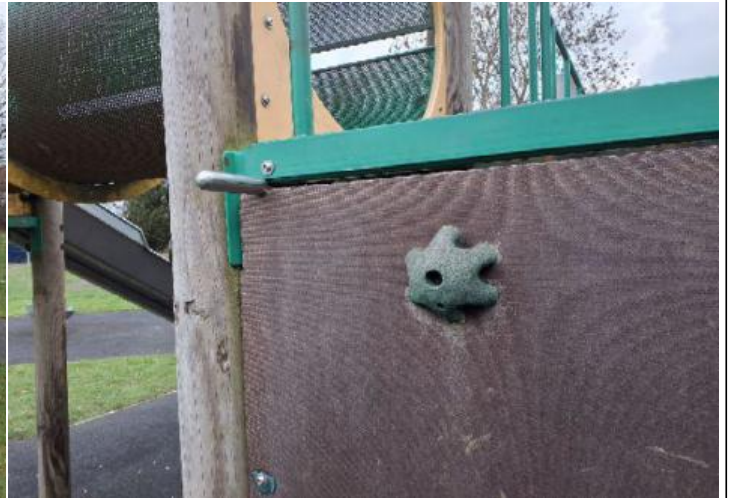
Finding: There is/are finger entrapment/s in the top of the climbing wall and the item fails to meet the requirements of BS EN 1176 Part 1 4.2.7.6 Entrapment of fingers

Action: Adjust to remove the entrapment

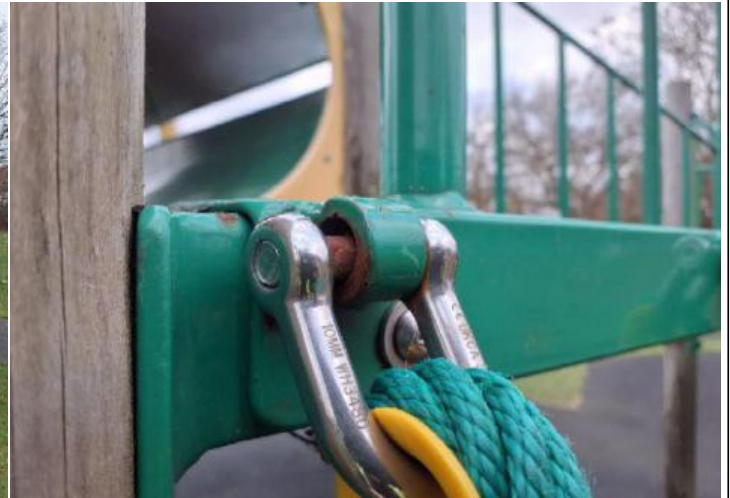
Finding: The bushes are worn or missing causing the fixing lugs to wear
Action: Replace worn or missing bushes

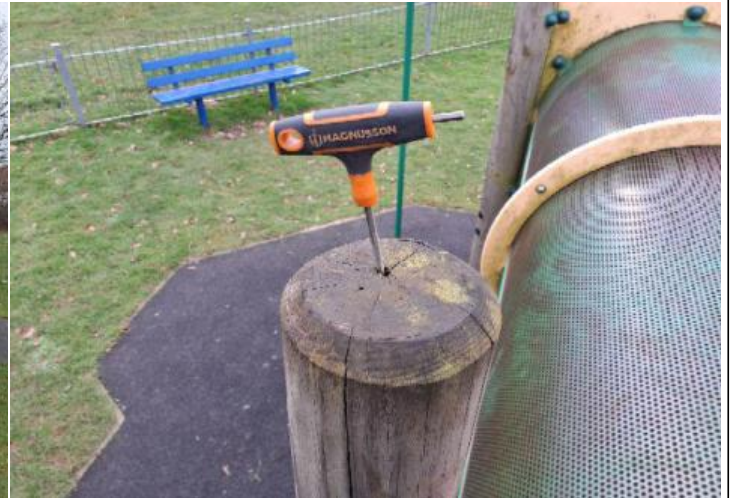
Finding: There is some evidence of rot in the timber

Action: Monitor for any further deterioration and replace as required

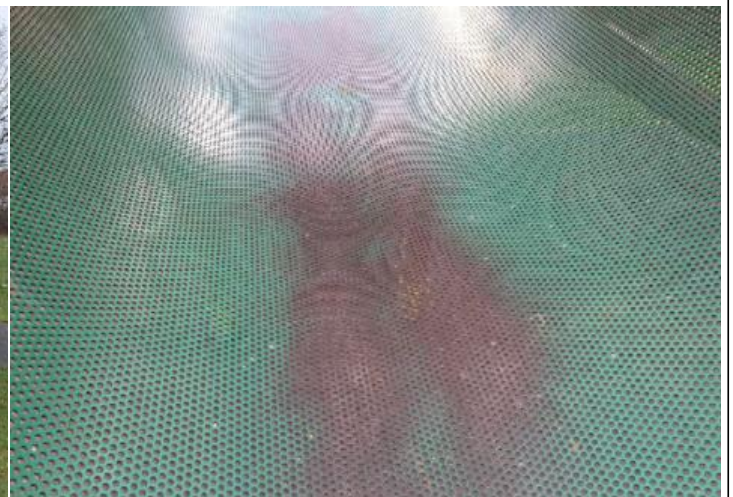
Finding: The paintwork on this item has been damaged or worn exposing the metal underneath which is rusting / corroding

Action: Treat affected areas and repaint

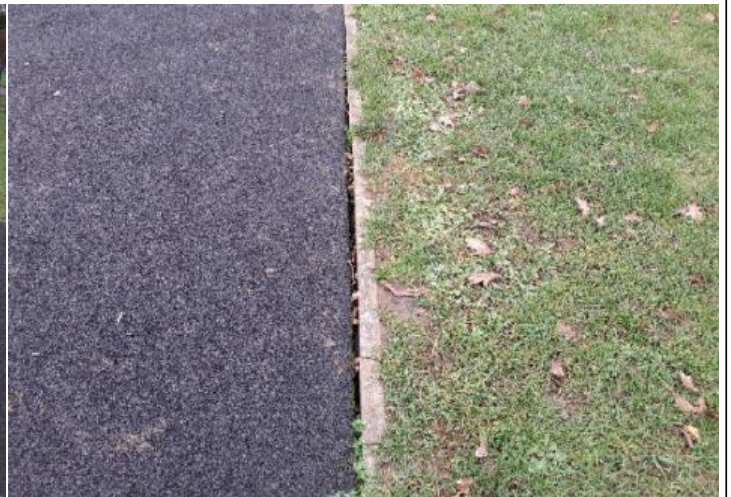
Finding: There are gaps opening between the surfacing and the edging surround or between the joints in the surfacing

Action: Monitor for any further deterioration and repair as required

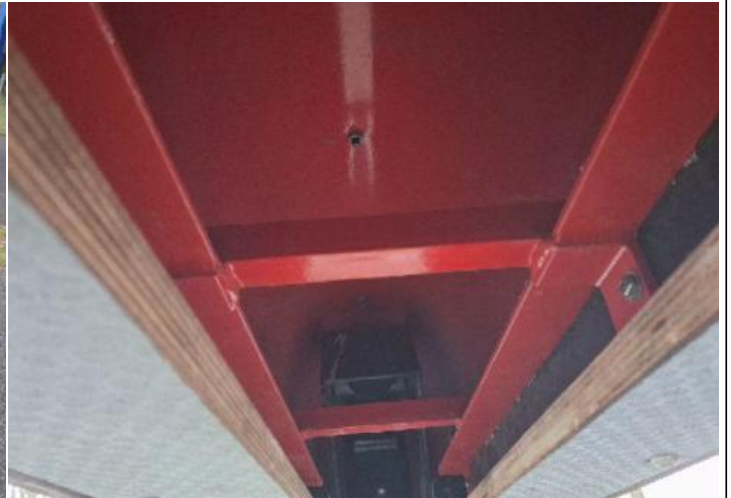
Finding: There is no gaiter protection for accessible moving parts (possible shear trap) as recommended in BS EN 1176 Part 1; 4.2.6 Moving Parts

Action: Monitor - No action given the risk assessment

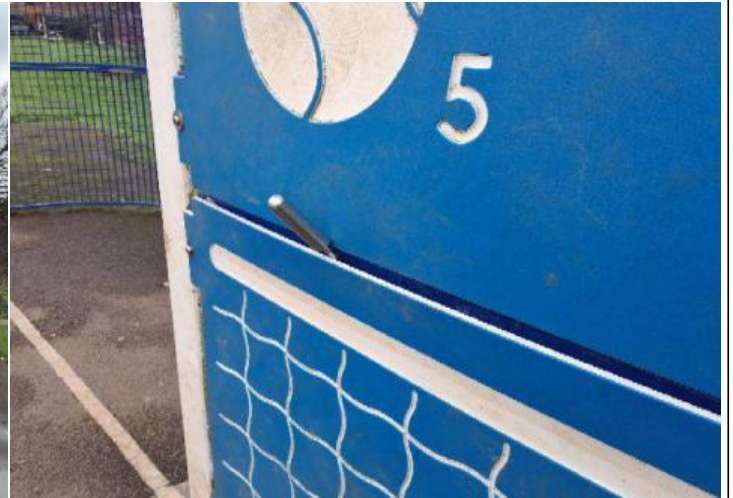
Finding: There is/are finger entrapments in the framework and the item fails to meet the requirements of BS EN 15312 Clause 4.4.2.2 Entrapment of fingers

Action: Monitor - No action given the risk assessment

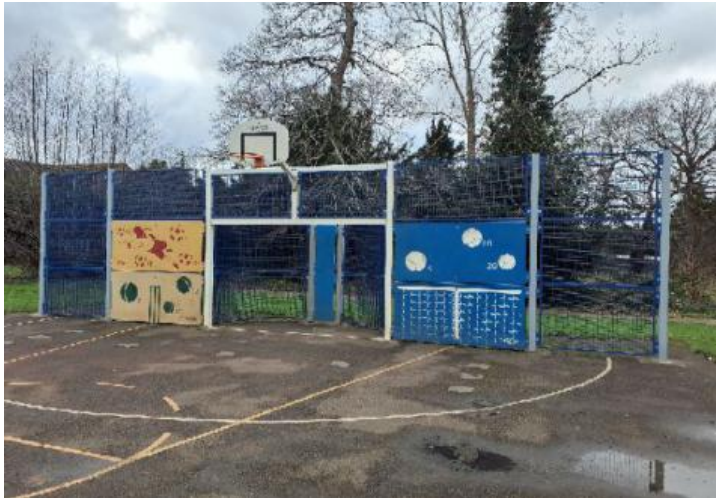
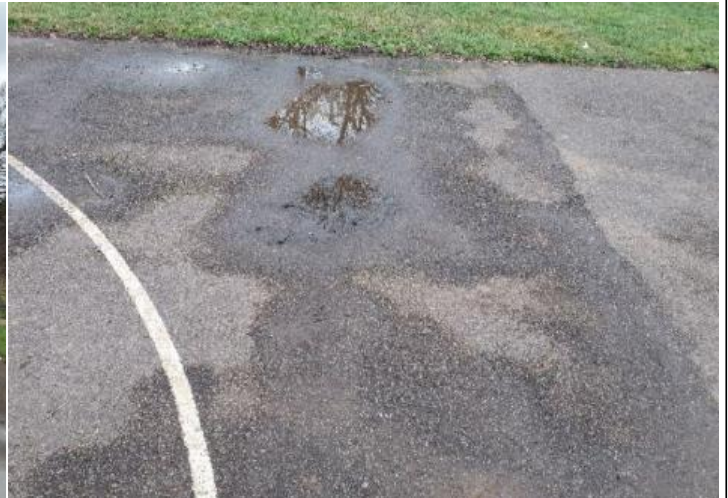
Finding: There is algae, silt or moss growth on the surface resulting in slippery conditions

Action: Clean and treat appropriately

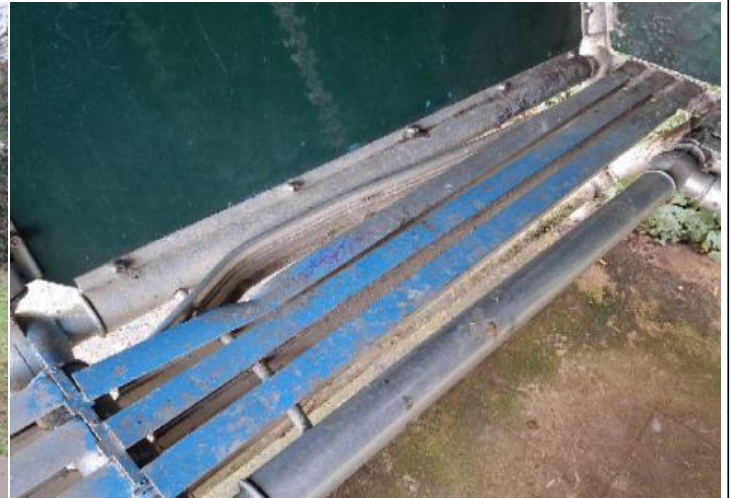
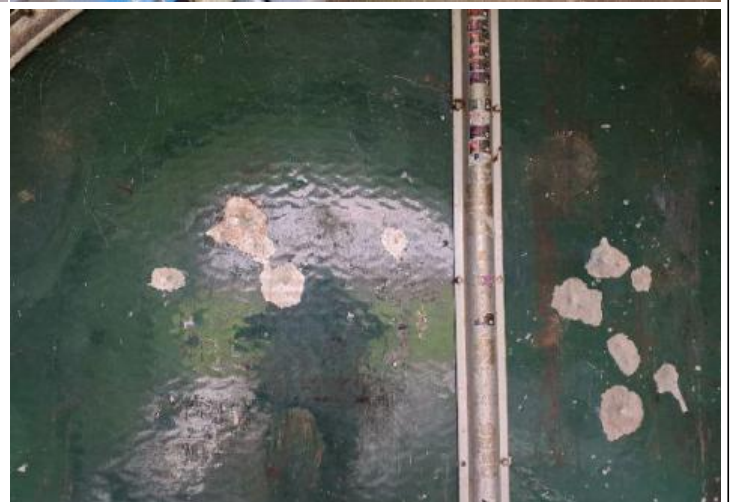
Finding: The item has been damaged

Action: Monitor for any further deterioration and replace as required

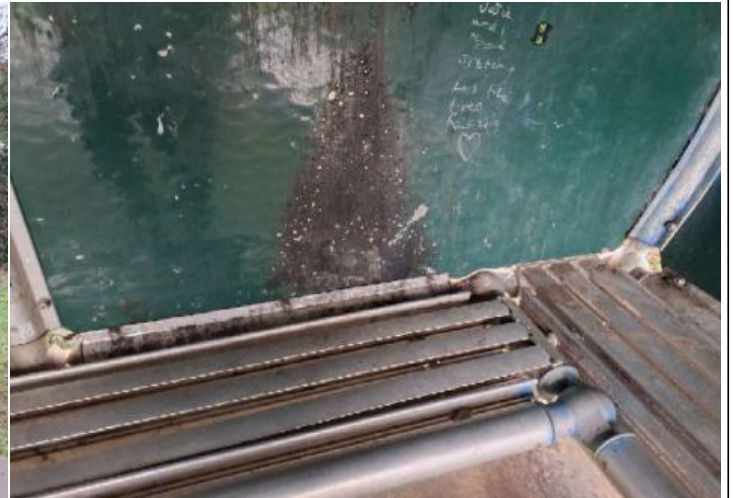
Finding: There is some evidence of fire damage to the item **Action:** Monitor for any further deterioration and repair as required

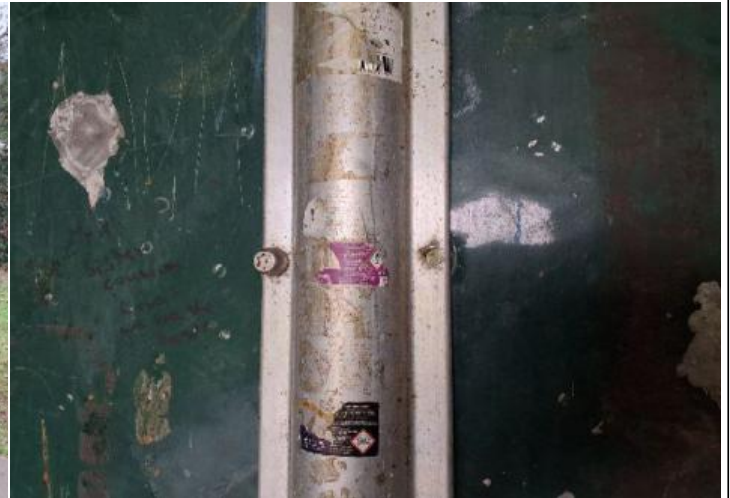
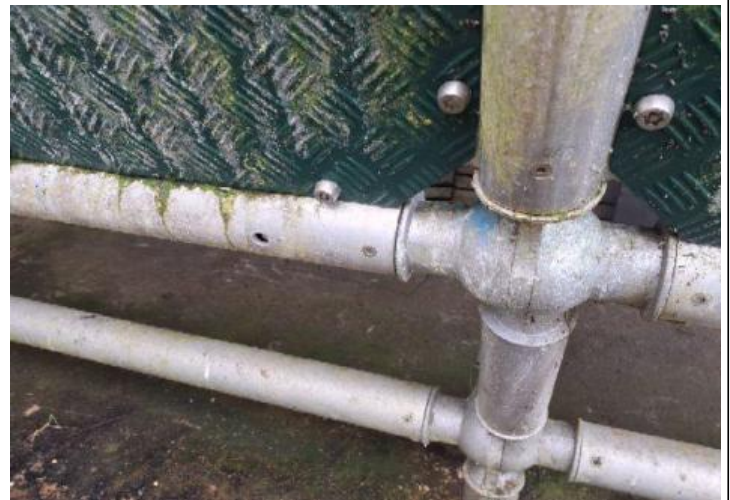
Finding: There is or are fixings missing on the item

Action: Replace all missing fixings

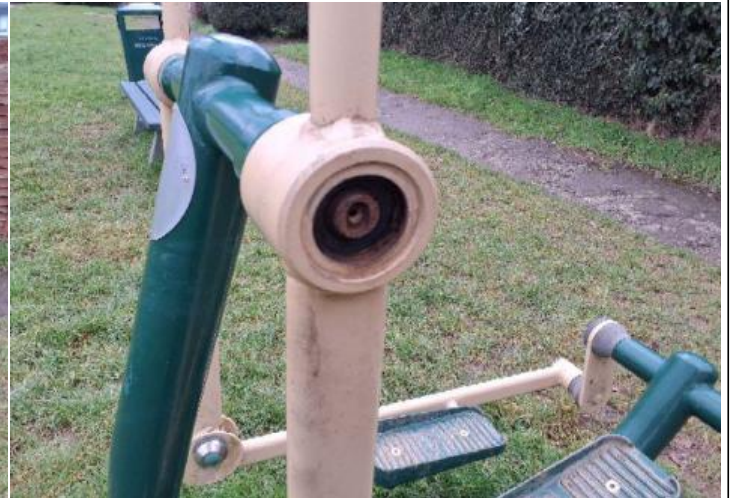
Finding: There is or are fixings missing on the item

Action: Replace all missing fixings

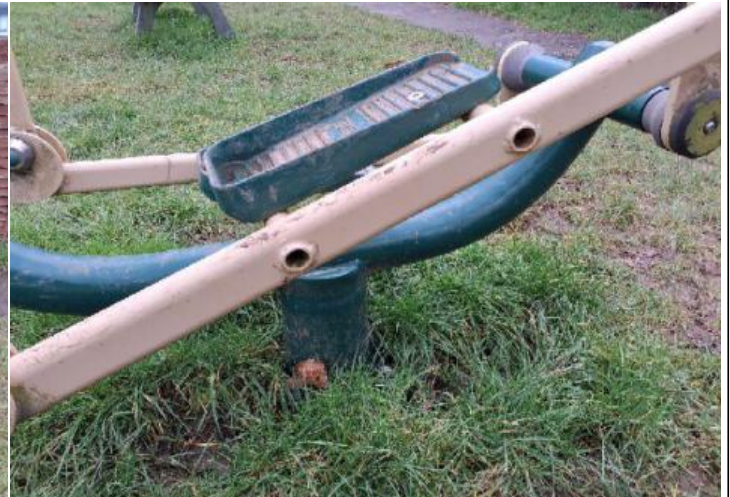
Finding: There is/are inserts missing

Action: Replace missing inserts

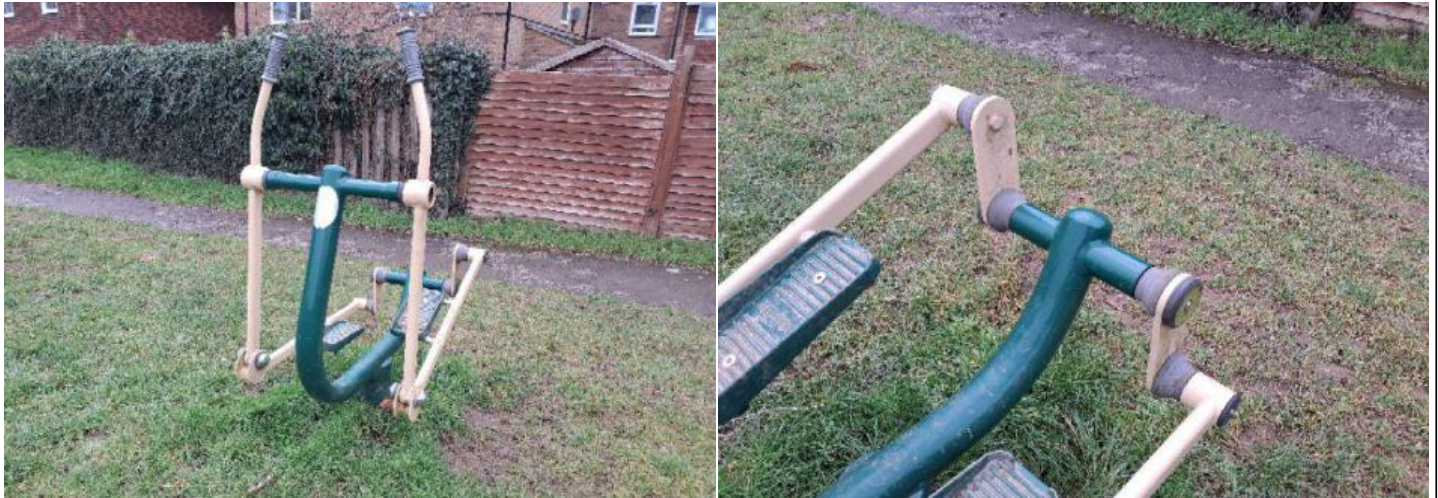
Finding: The bearing is showing signs of wear **Action:** Monitor for any further deterioration and replace as required

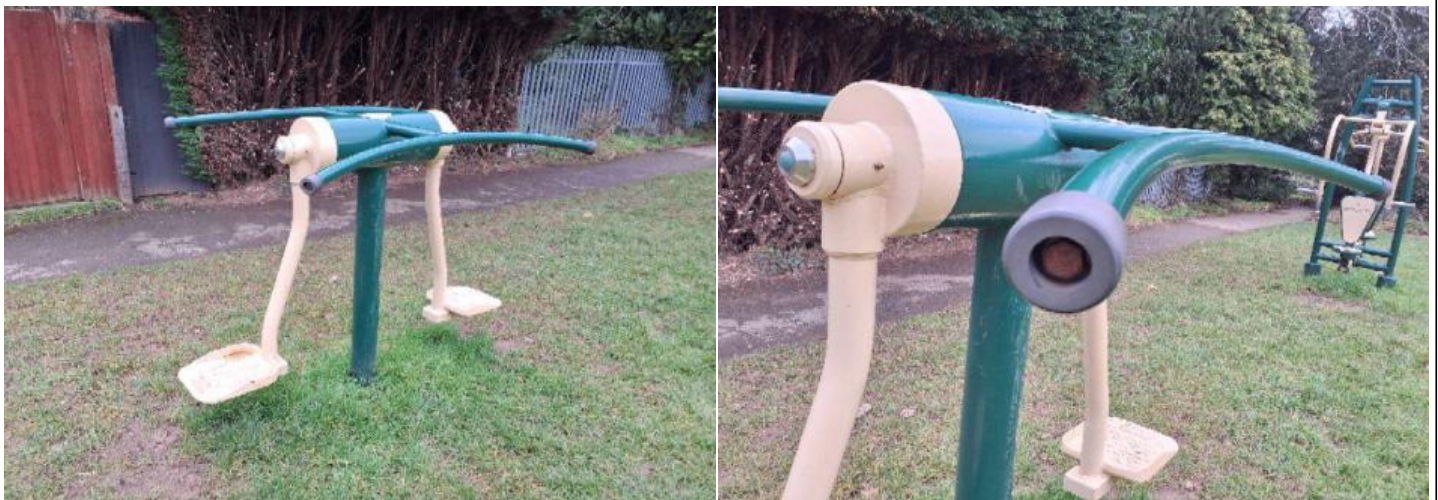
Finding: There is/are bolt cap covers missing or damaged on the item **Action:** Replace missing or damaged bolt cap covers

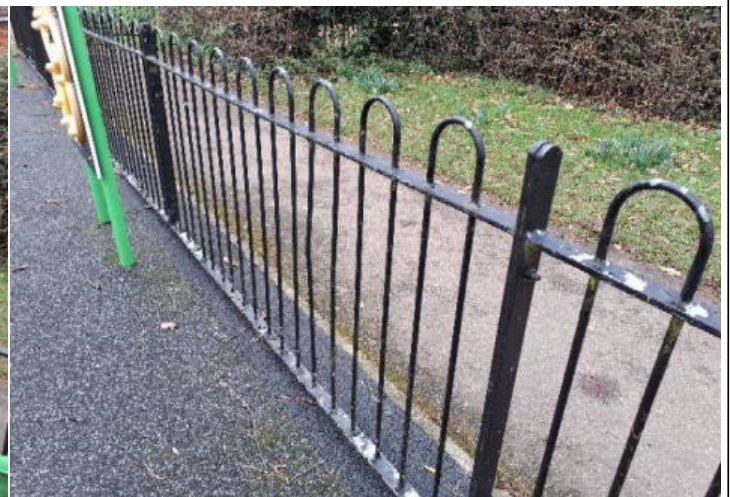
Finding: There is some damage to the fence sections

Action: Monitor for any further deterioration and repair as required

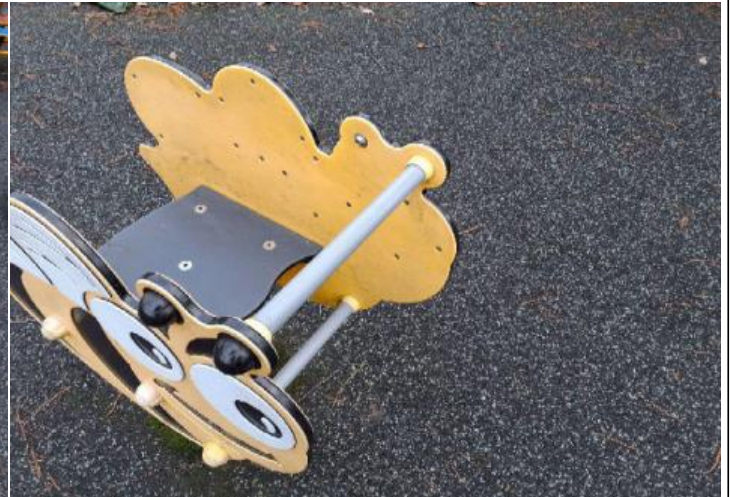
Finding: The Handgrips/Footrests rotate and may cause an unexpected movement for the user

Action: Secure Handgrips/Footrests to prevent rotation.

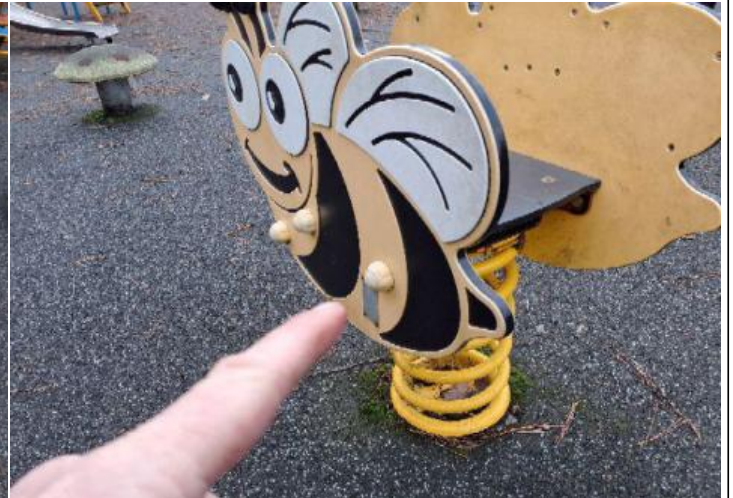
Finding: A number of fixing(s) have worked loose

Action: Secure all loose fixings

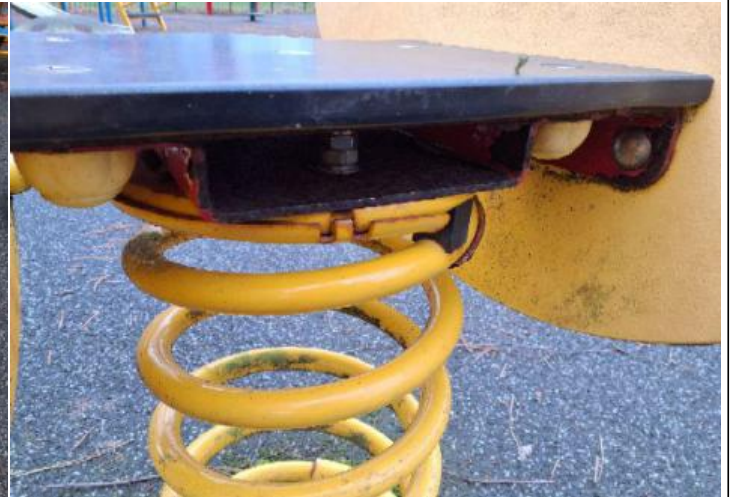
Finding: The paintwork on this item has been damaged or worn exposing the metal underneath which is rusting / corroding

Action: Treat affected areas and repaint

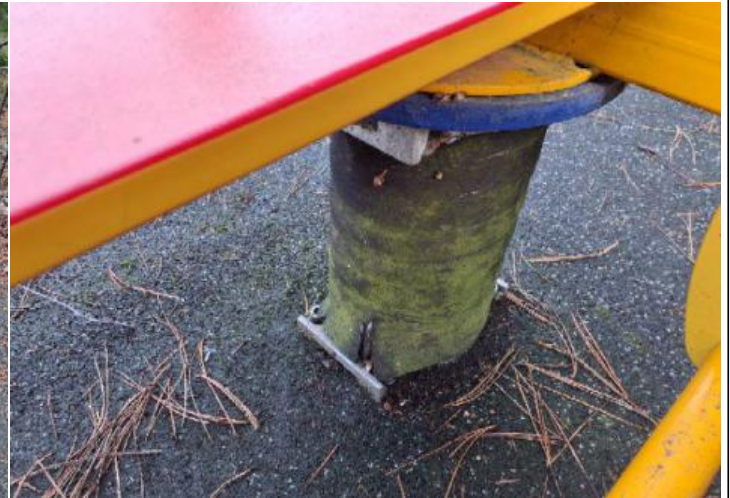
Finding: The spring cover is damaged, split or missing

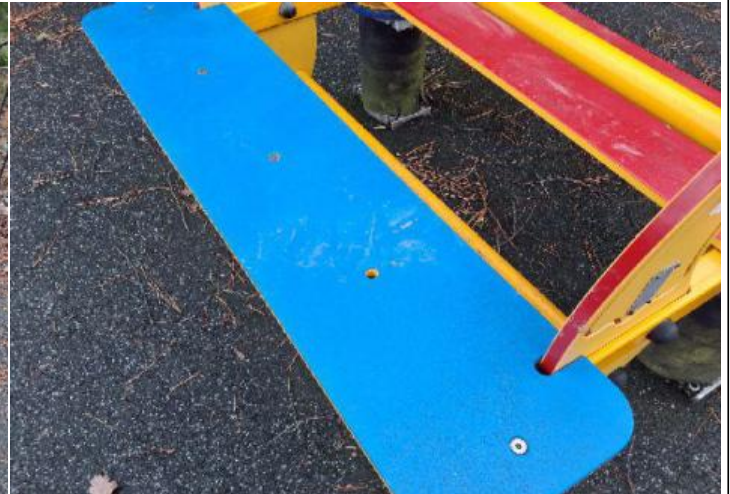
Finding: There is or are fixings missing on the item

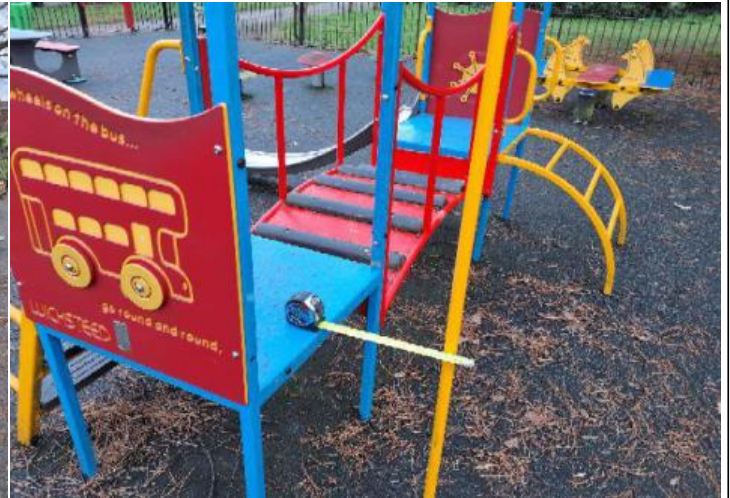
Finding: The free space between the fireman's pole and the platform is less than the minimum recommended dimension of 350mm in BS EN 1176 Part 1; this is however an intended design feature by the manufacturer to assist younger users in accessing the pole and is a very low risk finding - no remedial action is recommended

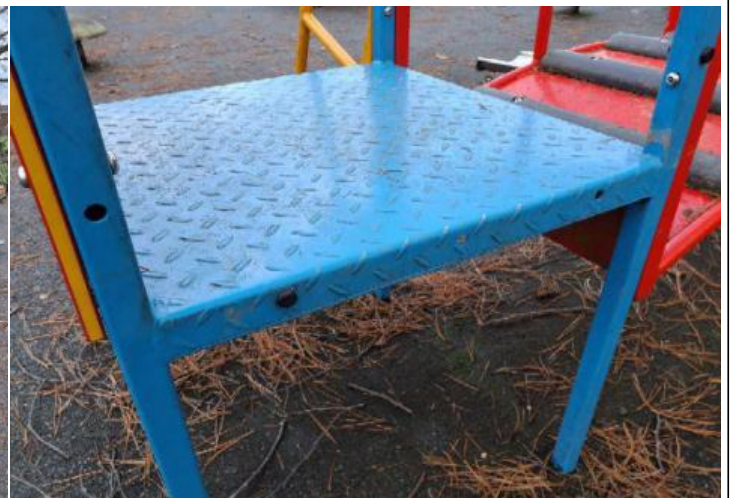
Finding: There is/are inserts missing

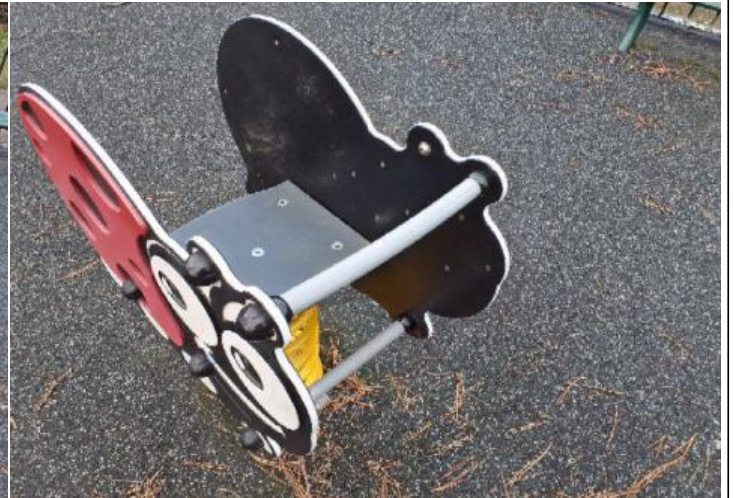
Finding: The Handgrips/Footrests rotate and may cause an unexpected movement for the user
Action: Secure Handgrips/Footrests to prevent rotation.

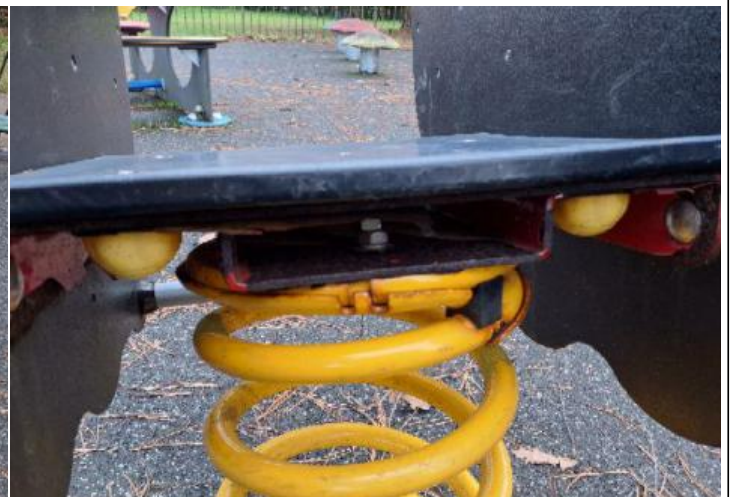
Finding: The paintwork on this item has been damaged or worn exposing the metal underneath which is rusting / corroding
Action: Treat affected areas and repaint

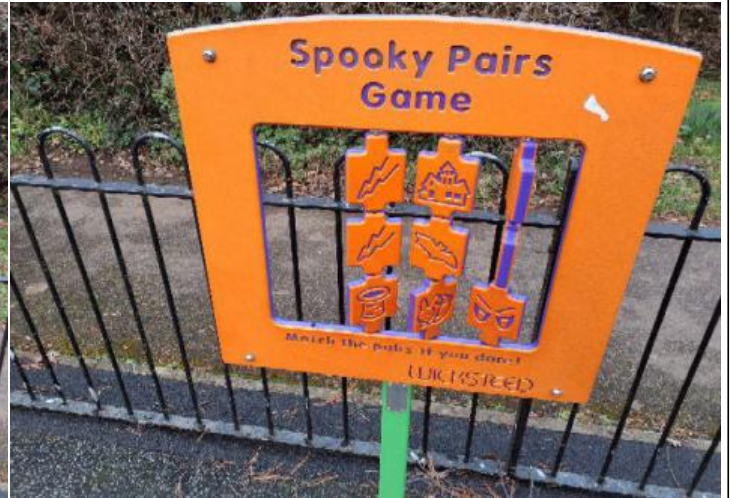
Finding: The item has missing component(s)

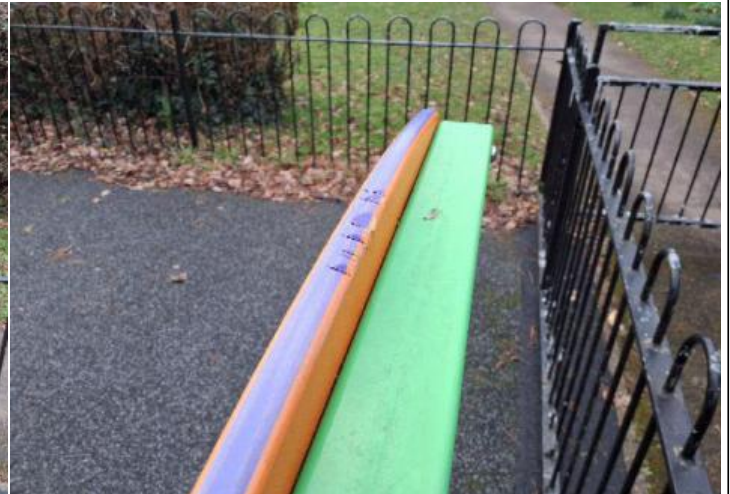
Finding: The item has been damaged

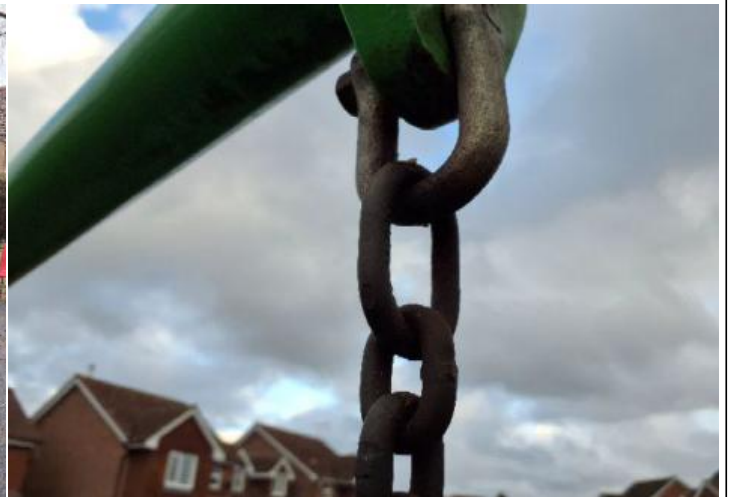
Finding: There is some notable evidence of chain wear

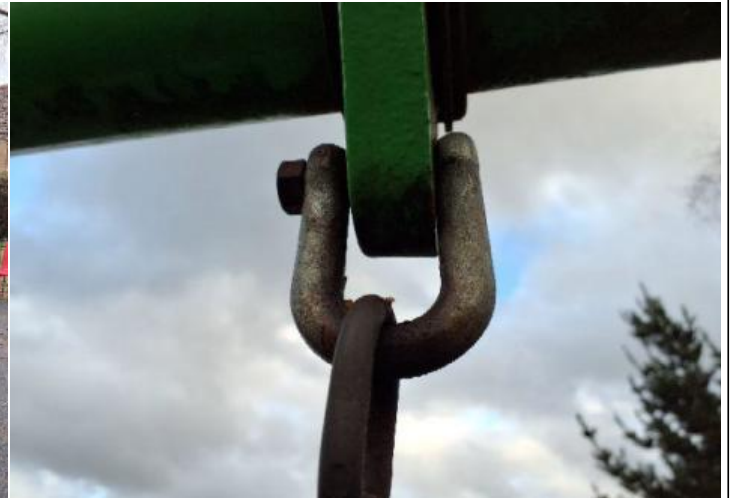
Finding: There is some wear to the shackles.

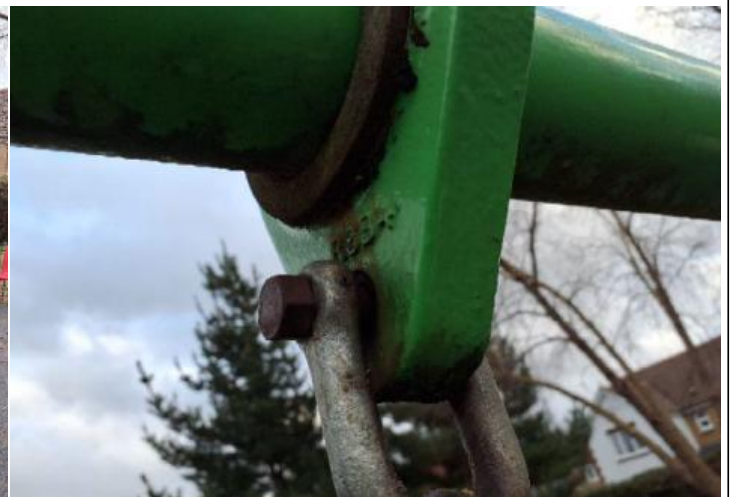
Finding: The bush / bushes is / are showing signs of wear
