Deputy Clerk's Report

the **play inspection** company

Annual Inspection

Marden Playing Field

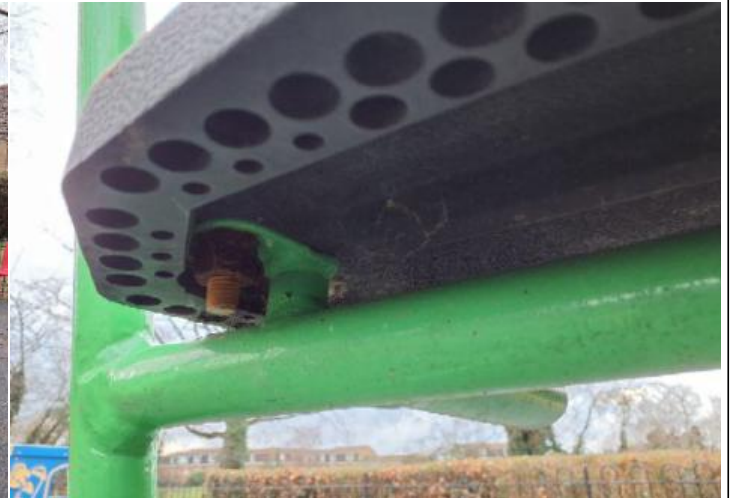
Finding: The fixings have corroded excessively

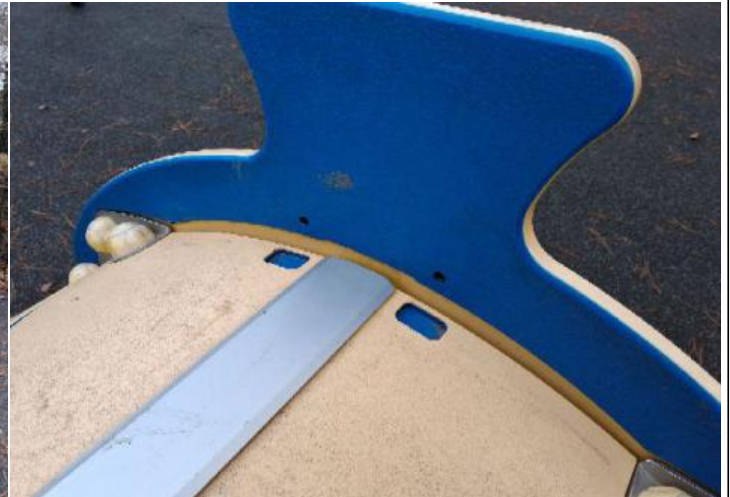
Finding: There is or are fixings missing on the item

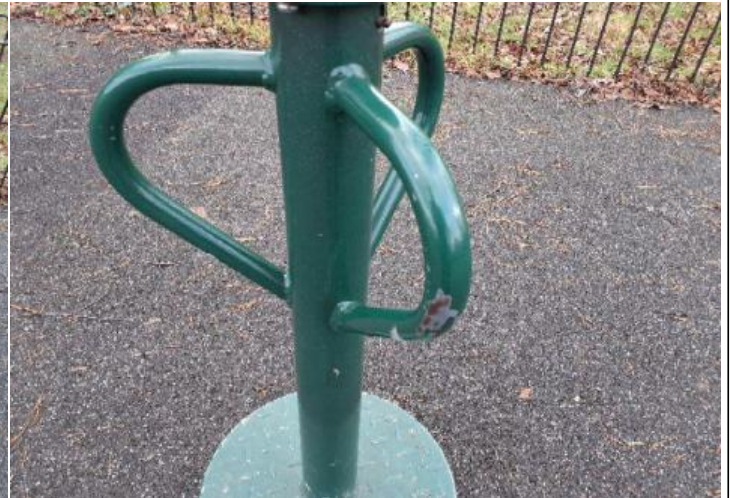
Finding: The paintwork on this item has been damaged or worn exposing the metal underneath which is rusting / corroding

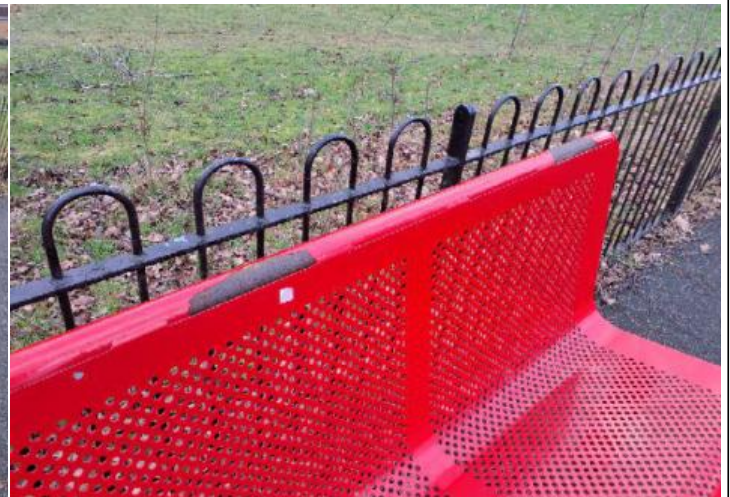
Finding: The paintwork on this item has been damaged or worn exposing the metal underneath which is rusting / corroding

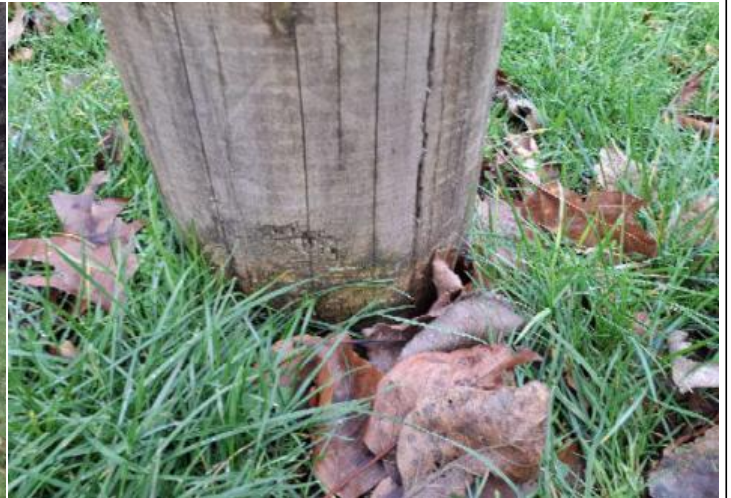
Finding: There is some strimmer / machinery damage apparent on the posts, this can penetrate the preservative applied to the timber and accelerate the rotting process

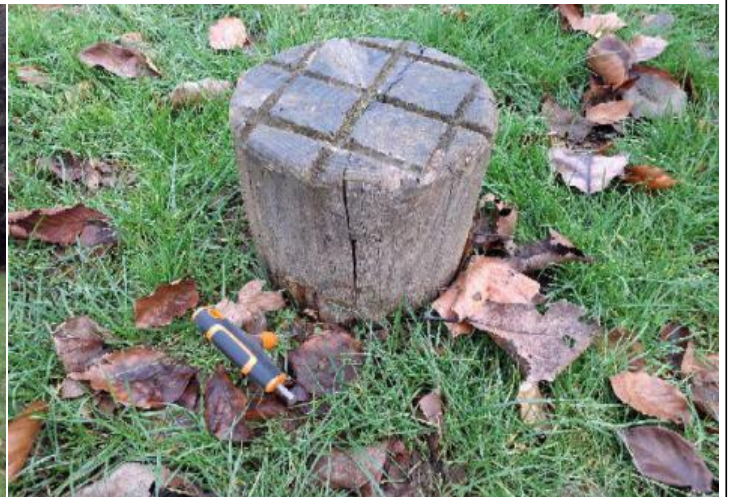
Finding: There is some evidence of rot in the timber

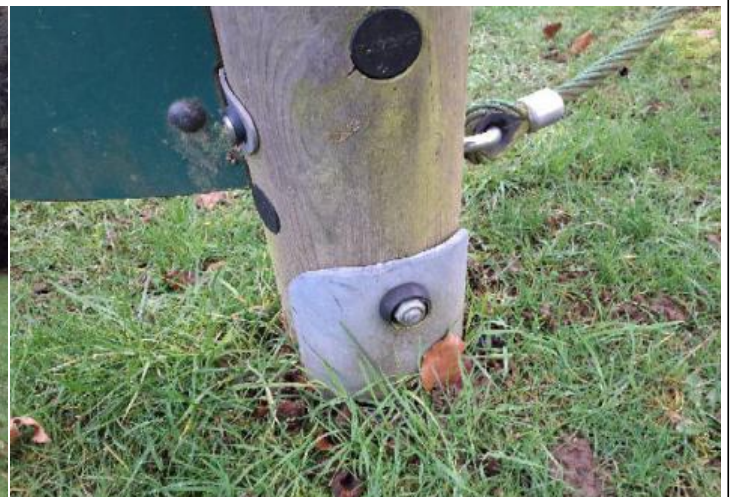
Finding: There is/are bolt cap covers missing or damaged on the item

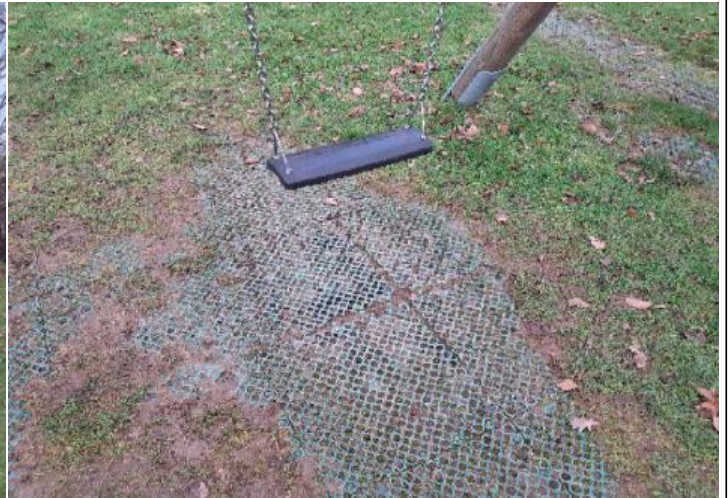
Finding: There is moderate damage to the surface

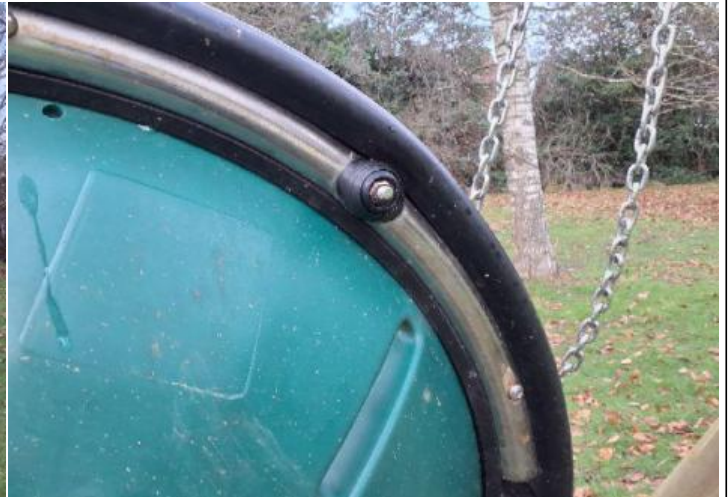
Finding: There are caps missing from the underside of the seats

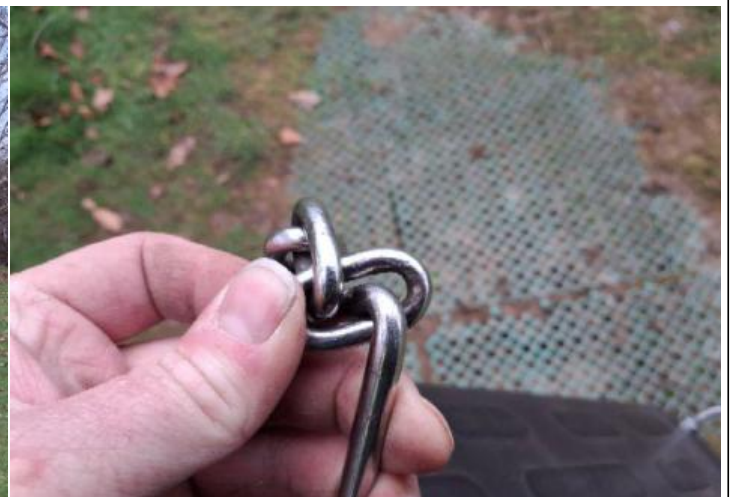
Finding: There is some notable evidence of chain wear

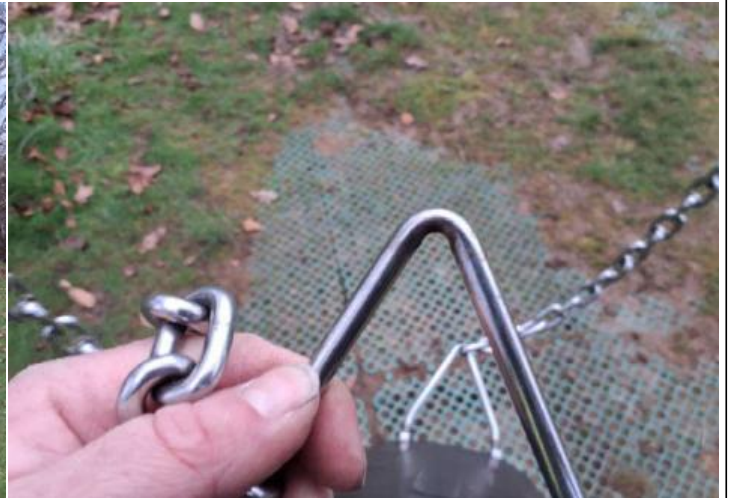
Finding: The swing seat connectors have some wear present

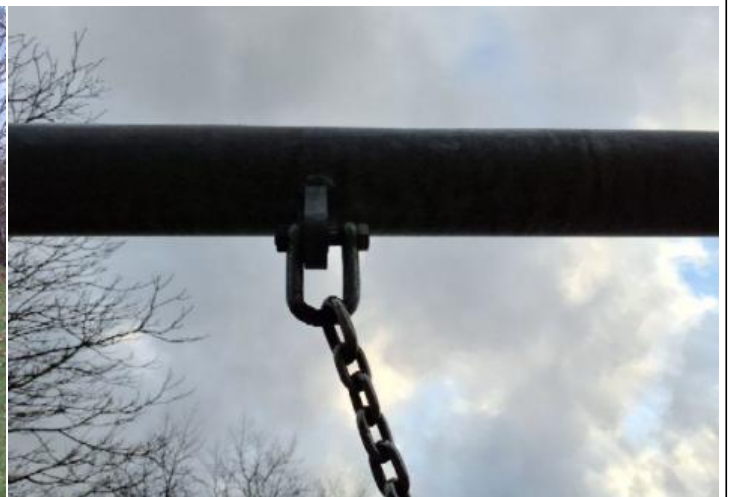
Finding: There is some wear to the shackles.

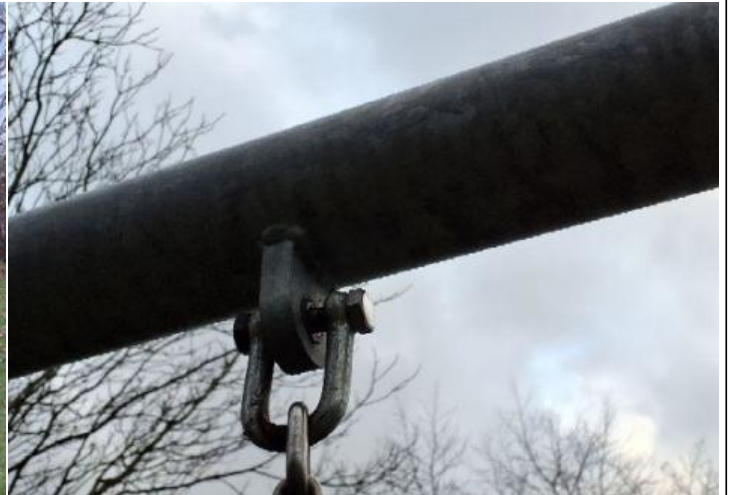
Finding: The bush / bushes is / are showing signs of wear
