Deputy Clerk's Report

the **play inspection** company

Annual Inspection

Marden Playing Field

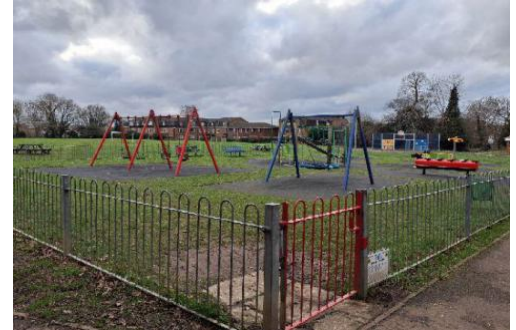
Item: Site General
Manufacturer: Owner/Operator
Surface Type: N/A
Item Quantity: 1
Equipment Compliance: N/A
Surface Area Compliance: N/A

There is weed / vegetation growth within the surface - Remove weed / vegetation growth

There are trip hazards at the edges of the surface - Remove trip hazard

There are gaps opening between the surfacing and the edging surround or between the joints in the surfacing - Monitor for any further deterioration and repair as required

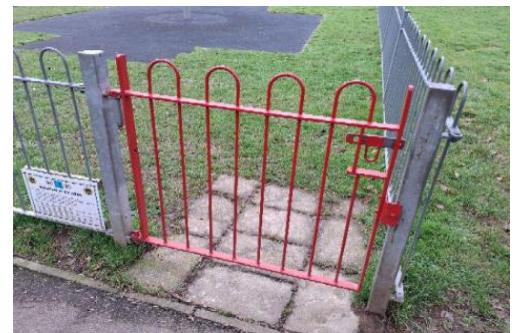
Item: Gate - Self Closing
Manufacturer: Not Identified
Surface Type: Mixed Surface
Item Quantity: 2
Equipment Compliance: N/A
Surface Area Compliance: N/A

The gate is not operating correctly - Take effective action to ensure the gate closes between 4 and 8 seconds

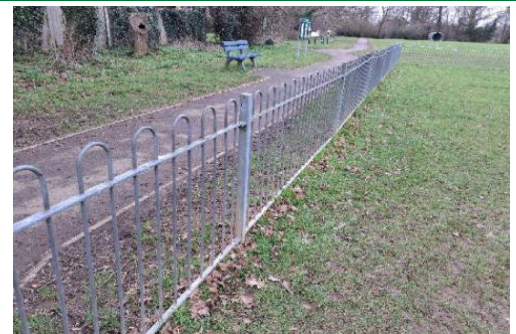
Item: Fence - Bow Top
Manufacturer: Not Identified
Surface Type: Grass
Item Quantity: 1
Equipment Compliance: N/A
Surface Area Compliance: N/A

There is some damage to the fence sections - Monitor for any further deterioration and repair as required

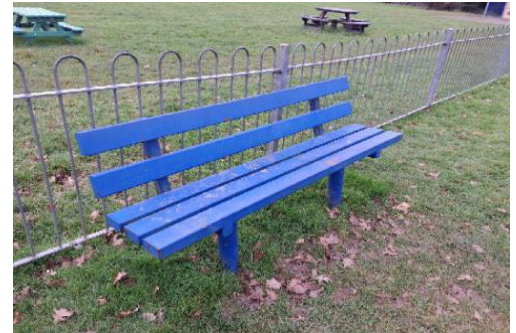
Item: Bench
Manufacturer: Not Identified
Surface Type: Concrete
Item Quantity: 3
Equipment Compliance: N/A
Surface Area Compliance: N/A

The paintwork on this item has been damaged or worn exposing the metal underneath which is rusting / corroding - Treat affected areas and repaint

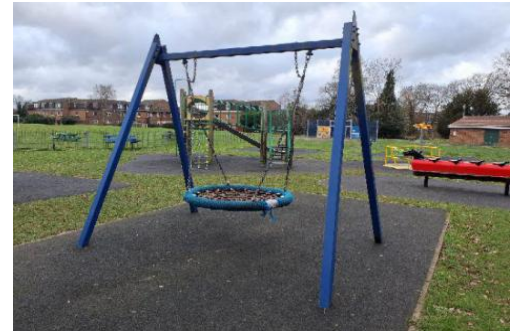
Item: Basket Swing - Type 1
Manufacturer: Park Leisure Ltd
Surface Type: Wet Pour
Item Quantity: 1
Equipment Compliance: No
Surface Area Compliance: Yes
Life Expectancy: >10 Years
Total Findings: 7

The seat is severely damaged and requires replacing -
 Replace damaged seat

There is some notable evidence of chain wear - Monitor for any further deterioration and replace when 40% worn

There is some wear to the shackles. - Monitor for any further deterioration and replace when 40% worn

The swing seat connectors have some wear present - Monitor for further deterioration and replace when 40% worn

The bush / bushes is / are showing signs of wear - Monitor for any further deterioration and replace as required

The split pins are missing from the shackles - Insert split pins to secure the shackles

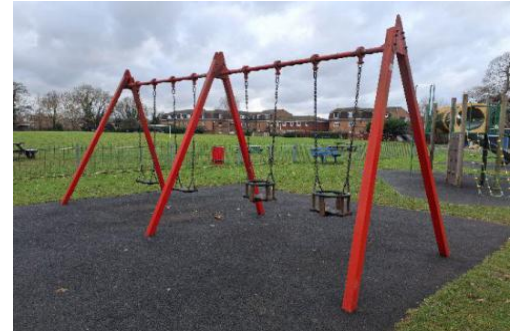
Item: 2 Bay 2 Flat 2 Cradle
Manufacturer: Park Leisure Ltd
Surface Type: Wet Pour
Item Quantity: 1
Equipment Compliance: No
Surface Area Compliance: Yes
Life Expectancy: >10 Years
Total Findings: 10

The chain openings are in excess of the 8.6mm as recommended by BS EN 1176 - Monitor - No action given the risk assessment

There is some notable evidence of chain wear - Monitor for any further deterioration and replace when 40% worn

There is some wear to the shackles. - Monitor for any further deterioration and replace when 40% worn

The bush / bushes is / are showing signs of wear - Monitor for any further deterioration and replace as required

The seat has minor damage or wear - Monitor for any further deterioration and replace as required

The swing seat connectors are loose - Tighten to secure

The fixings have corroded excessively - Replace all corroded fixings

The paintwork on this item has been damaged or worn exposing the metal underneath which is rusting / corroding - Treat affected areas and repaint

There is some minor damage to the surface - Monitor for any further deterioration and repair as required

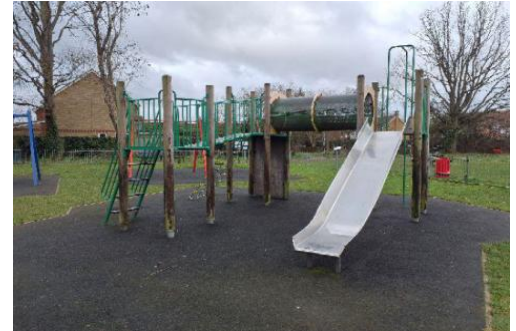
Item: Multi Play (Junior)
Manufacturer: Park Leisure Ltd
Surface Type: Wet Pour
Item Quantity: 1
Equipment Compliance: No
Surface Area Compliance: No
Life Expectancy: 5 -10 Years
Total Findings: 11

The surfacing dimensions are short and do not meet with the requirements of the current applicable standard - Monitor - No action given the risk assessment

There are a number of dents in the slide surface - Monitor for any further deterioration and repair as required

There is/are bolt cap covers missing or damaged on the item - Replace missing or damaged bolt cap covers

There is/are inserts missing - Replace missing inserts

There is/are finger entrapment/s in the top of the climbing wall and the item fails to meet the requirements of BS EN 1176 Part 1 4.2.7.6 Entrapment of fingers - Adjust to remove the entrapment

The bushes are worn or missing causing the fixing lugs to wear - Replace worn or missing bushes

There is some evidence of rot in the timber - Monitor for any further deterioration and replace as required

The paintwork on this item has been damaged or worn exposing the metal underneath which is rusting / corroding - Treat affected areas and repaint

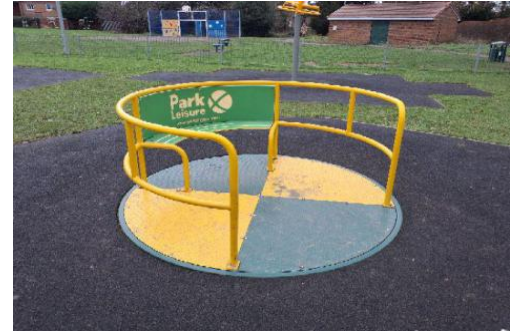
Item: Inclusive Roundabout
Manufacturer: Park Leisure Ltd
Surface Type: Wet Pour
Item Quantity: 1
Equipment Compliance: Yes
Surface Area Compliance: No
Life Expectancy: 5 -10 Years
Total Findings: 2

The surfacing dimensions are short and do not meet with the requirements of the current applicable standard - Monitor - No action given the risk assessment

There are gaps opening between the surfacing and the edging surround or between the joints in the surfacing - Monitor for any further deterioration and repair as required

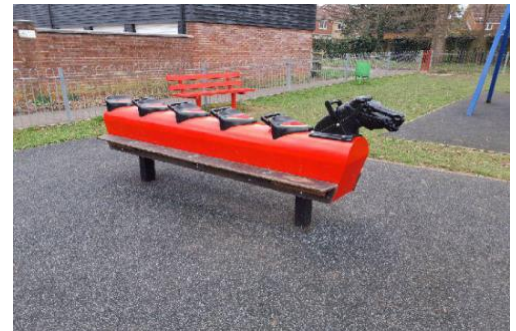
Item: Rocking Horse
Manufacturer: Wicksteed Playgrounds
Surface Type: Grass
Item Quantity: 1
Equipment Compliance: No
Surface Area Compliance: Yes
Life Expectancy: 5 -10 Years
Total Findings: 2

There is no gaiter protection for accessible moving parts (possible shear trap) as recommended in BS EN 1176 Part 1; 4.2.6 Moving Parts - Monitor - No action given the risk assessment

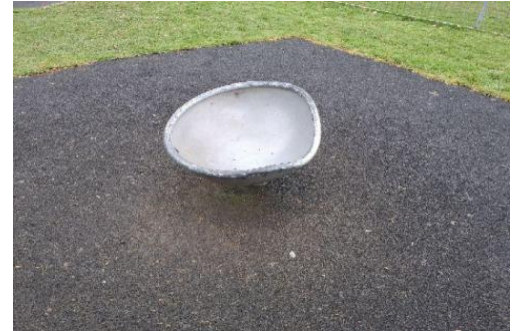
Item: Spinner Bowl
Manufacturer: Not Identified
Surface Type: Wet Pour
Item Quantity: 1
Equipment Compliance: Yes
Surface Area Compliance: Yes
Life Expectancy: 5 -10 Years
Total Findings: 2

The paint is flaking off the metalwork - Rub down and re-paint

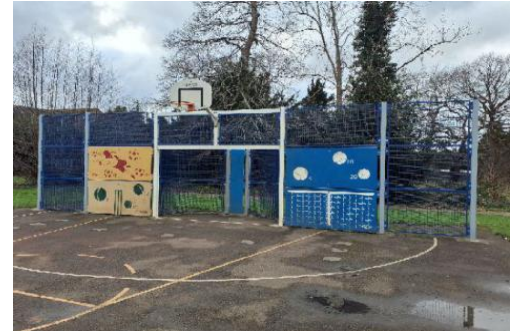
Item: Goal End
Manufacturer: Wicksteed Playgrounds
Surface Type: Bitmac
Item Quantity: 1
Equipment Compliance: No
Surface Area Compliance: N/A
Life Expectancy: >10 Years
Total Findings: 4

A clearly visible facility sign should be provided in a prominent position with the wording as detailed BS EN 15312- the equipment is not intended for children less than 3 years old- the warning - Do not climb on the framework or nets- the warning - Do not hang on the ring (if provided)- the warning - Do not wear rings or other jewellery- name and telephone number of the administrator- number to call in case of accident - Provide signage to BS EN 15312

There is/are finger entrapments in the framework and the item fails to meet the requirements of BS EN 15312 Clause 4.4.2.2 Entrapment of fingers - Monitor - No action given the risk assessment

There is algae, silt or moss growth on the surface resulting in slippery conditions - Clean and treat appropriately

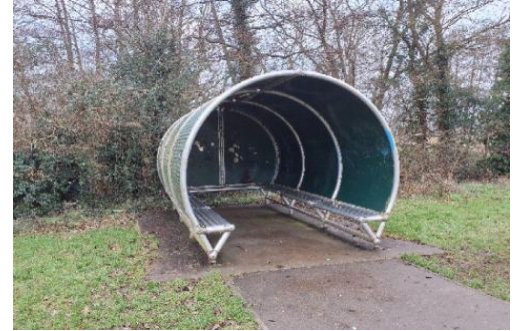
Item: Shelter
Manufacturer: Not Identified
Surface Type: Concrete
Item Quantity: 1
Equipment Compliance: N/A
Surface Area Compliance: N/A

The item has been damaged - Monitor for any further deterioration and replace as required

There is some evidence of fire damage to the item - Monitor for any further deterioration and repair as required

There is or are fixings missing on the item - Replace all missing fixings

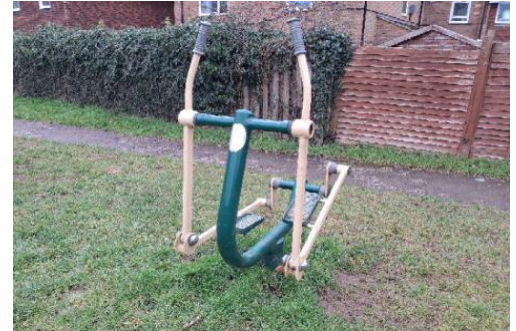
Item: Cross Trainer
Manufacturer: Wicksteed Playgrounds
Surface Type: Grass Matrix Tiles
Item Quantity: 1
Equipment Compliance: Yes
Surface Area Compliance: Yes
Life Expectancy: 5 -10 Years
Total Findings: 4

The instruction label provided has faded; an instruction label should be provided with each item of equipment in accordance with the requirements of BS EN 16630 - Provide appropriate instruction label/s

There is or are fixings missing on the item - Replace all missing fixings

There is/are inserts missing - Replace missing inserts

The bearing is showing signs of wear - Monitor for any further deterioration and replace as required

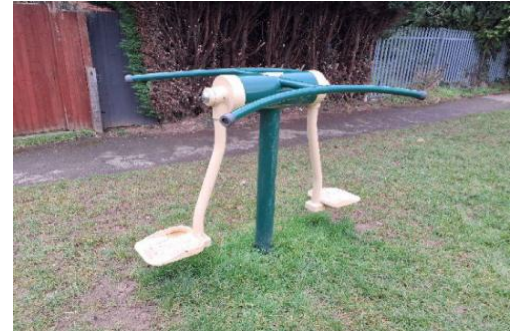
Item: Skier
Manufacturer: Wicksteed Playgrounds
Surface Type: Grass Matrix Tiles
Item Quantity: 1
Equipment Compliance: Yes
Surface Area Compliance: Yes
Life Expectancy: 5 -10 Years
Total Findings: 1

There is/are bolt cap covers missing or damaged on the item - Replace missing or damaged bolt cap covers

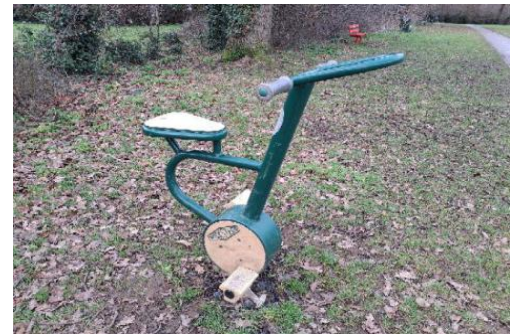
Item: Cycle
Manufacturer: Wicksteed Playgrounds
Surface Type: Grass Matrix Tiles
Item Quantity: 1
Equipment Compliance: Yes
Surface Area Compliance: Yes
Life Expectancy: 5 -10 Years
Total Findings: 1

The instruction label provided has faded; an instruction label should be provided with each item of equipment in accordance with the requirements of BS EN 16630 - Provide appropriate instruction label/s

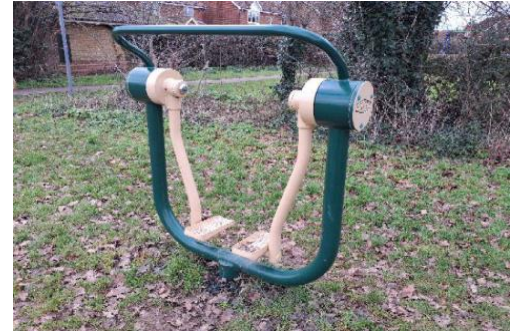
Item: Air Walker
Manufacturer: Wicksteed Playgrounds
Surface Type: Grass Matrix Tiles
Item Quantity: 1
Equipment Compliance: Yes
Surface Area Compliance: Yes
Life Expectancy: 5 -10 Years
Total Findings: 1

There is no instruction label provided; an instruction label should be provided with each item of equipment in accordance with the requirements of BS EN 16630 - Provide appropriate instruction label/s

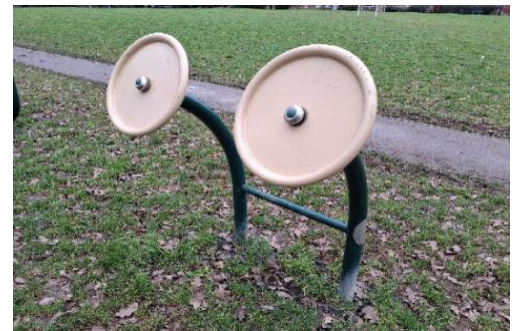
Item: Tai Chi Wheels
Manufacturer: Wicksteed Playgrounds
Surface Type: Grass Matrix Tiles
Item Quantity: 1
Equipment Compliance: Yes
Surface Area Compliance: Yes
Life Expectancy: 5 -10 Years
Total Findings: 1

The instruction label provided has faded; an instruction label should be provided with each item of equipment in accordance with the requirements of BS EN 16630 - Provide appropriate instruction label/s

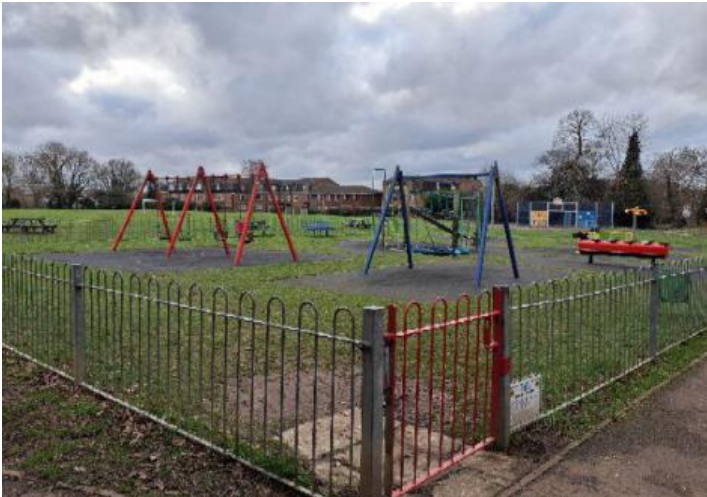
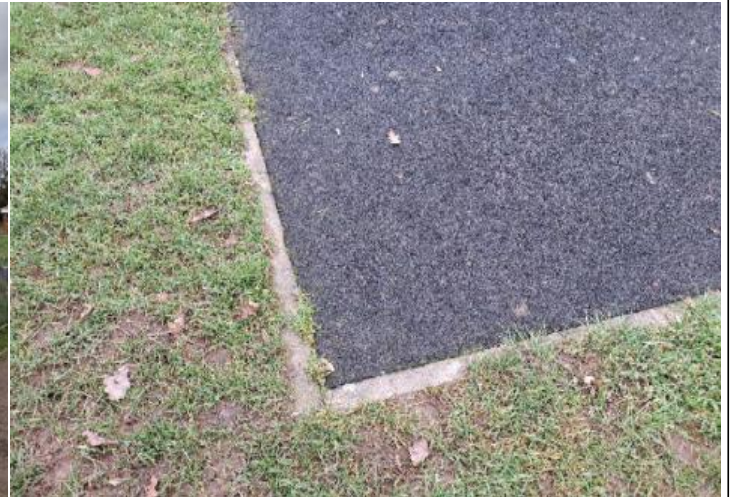
Finding: There is weed / vegetation growth within the surface

Action: Remove weed / vegetation growth

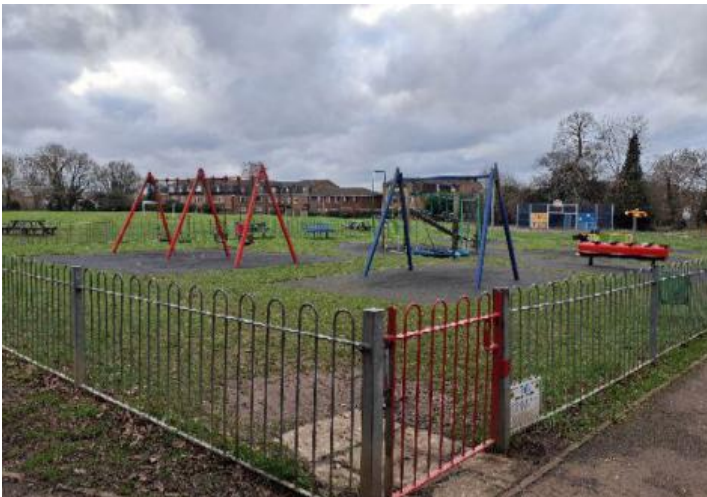
Finding: There are trip hazards at the edges of the surface

Action: Remove trip hazard

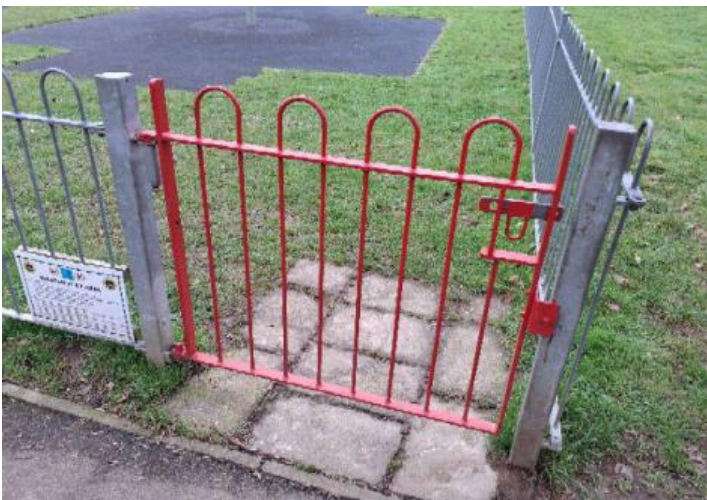
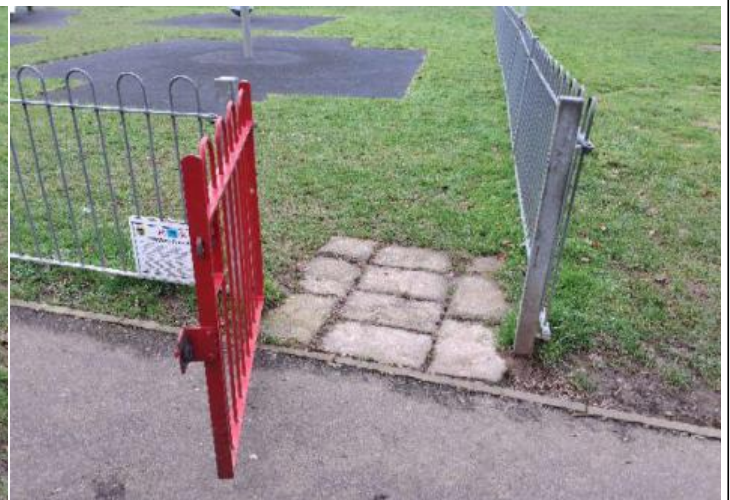
Finding: The gate is not operating correctly
Action: Take effective action to ensure the gate closes between 4 and 8 seconds

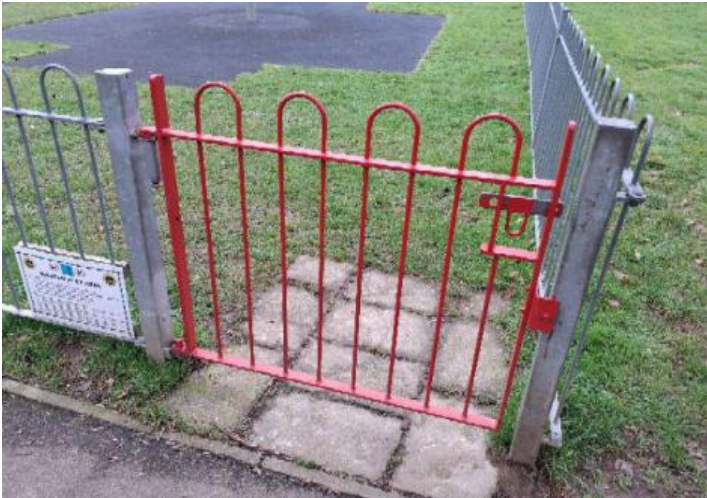
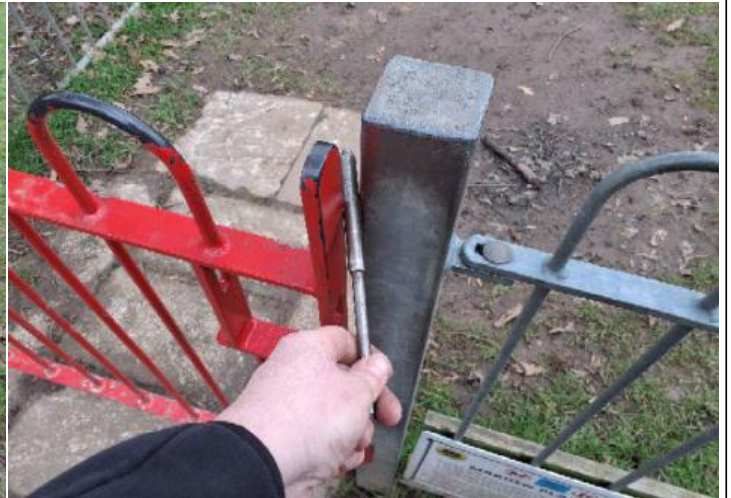
Finding: There are openings that are less than 12mm that could trap or crush fingers

Action: Provide a 12mm gap throughout full range of motion at both sides of gate

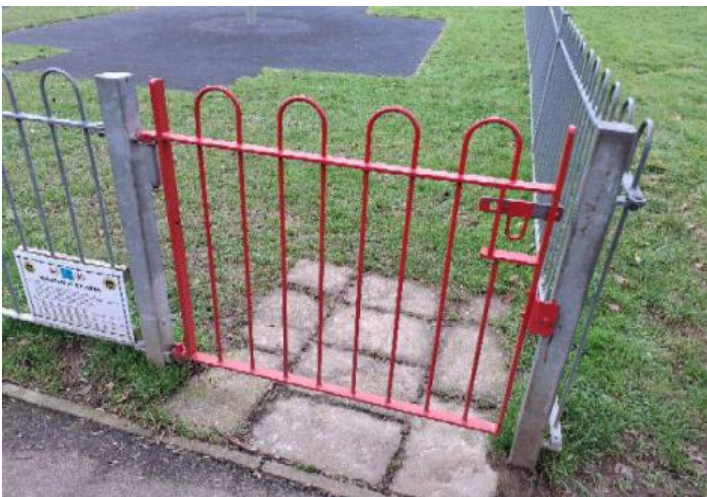
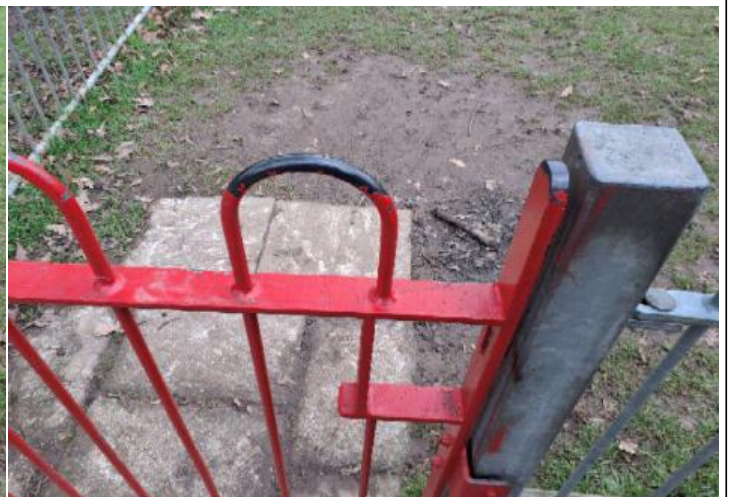
Finding: The paint is flaking off the metalwork

Action: Rub down and re-paint

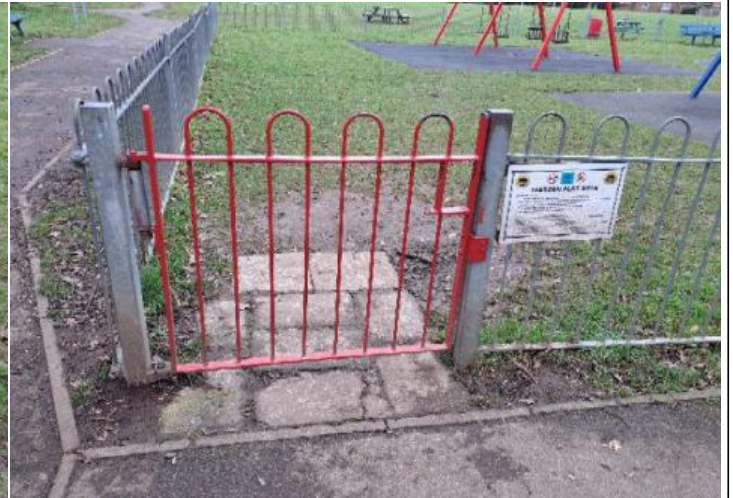
Finding: The gate is closing too quickly (less than 4 seconds)

Action: Take corrective action to ensure that the gate closes in 4-8 seconds from 90 degrees

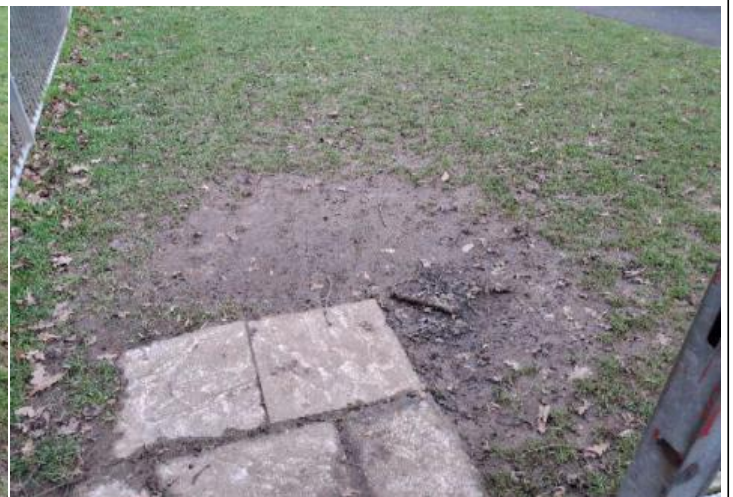
Finding: The area around the item has eroded and may become slippery

Action: Reinstate eroded area

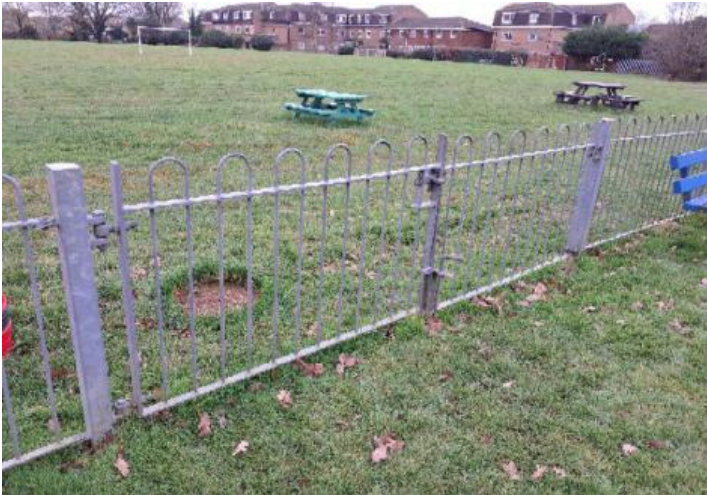
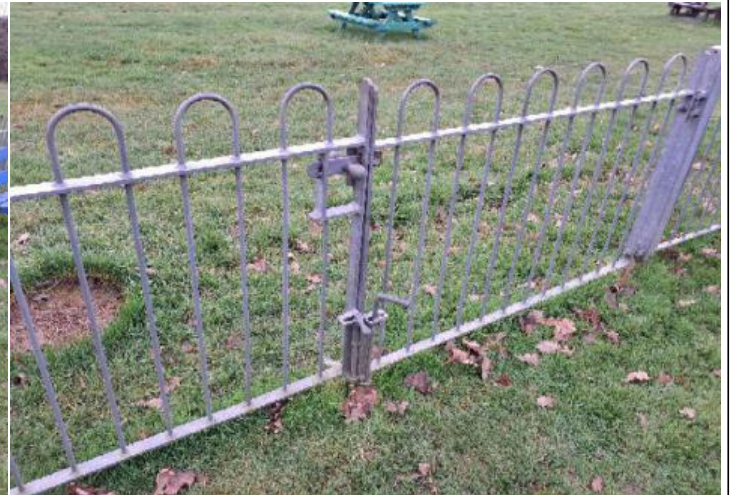
Finding: The maintenance gate was correctly padlocked at the time of inspection, however this means that the inspector was unable to fully assess the gate

Action: Ensure that there are 12mm gaps throughout the full range of motion on gate/s and between leaves where relevant

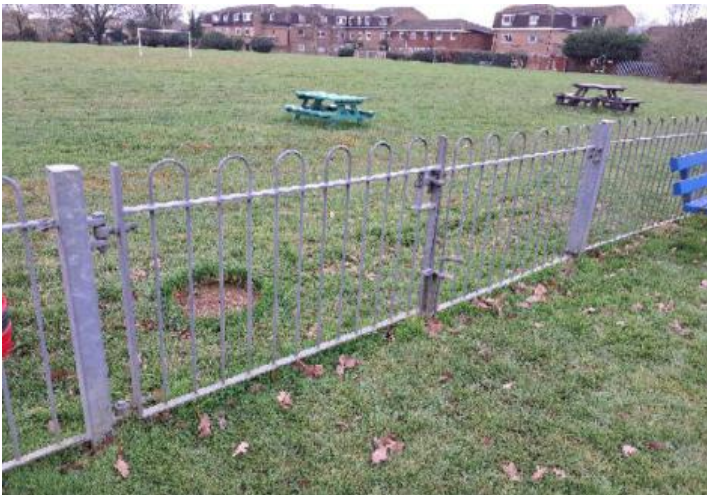
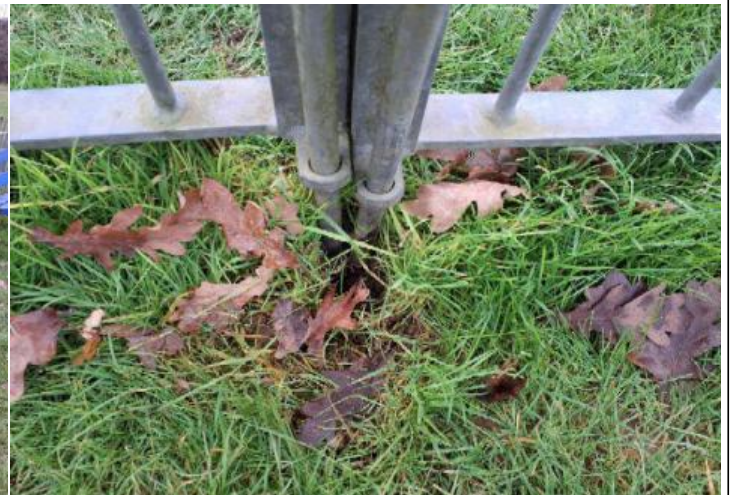
Finding: The gate has no drop bolt sleeves and/or drop bolts fitted

Action: Provide drop bolt sleeves and/or drop bolts

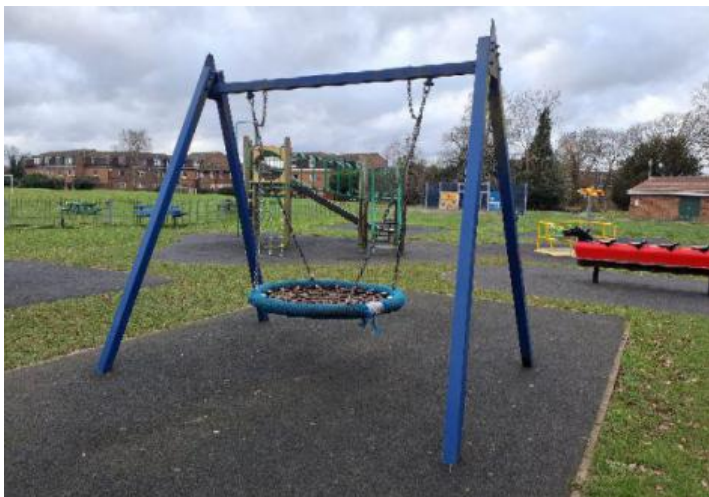
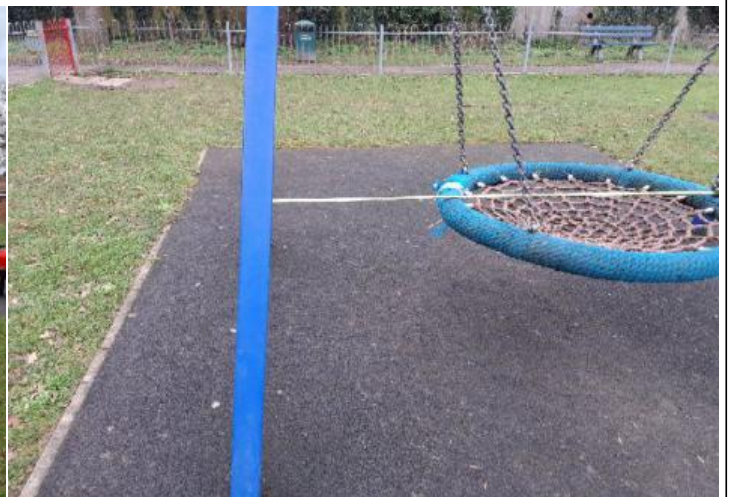
Item: Swings - Basket Swing - Type 1
Manufacturer: Park Leisure Ltd

Risk Level: L - Low Risk
Surface: Wet Pour

Finding: The seat/s is / are too close to the frame as defined in BS EN 1176 Part 2

Action: Monitor - No action given the risk assessment

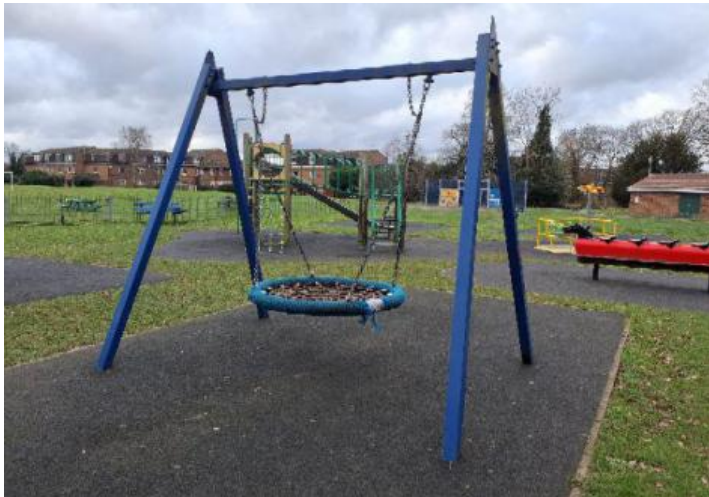
Item: Swings - Basket Swing - Type 1
Manufacturer: Park Leisure Ltd

Risk Level: L - Low Risk
Surface: Wet Pour

Finding: There is some wear to the shackles.

Action: Monitor for any further deterioration and replace when 40% worn

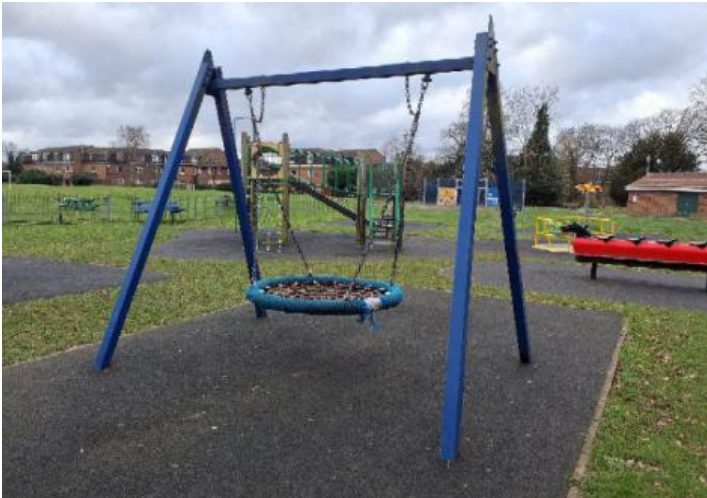
Item: Swings - Basket Swing - Type 1
Manufacturer: Park Leisure Ltd

Risk Level: L - Low Risk
Surface: Wet Pour

Finding: The swing seat connectors have some wear present

Action: Monitor for further deterioration and replace when 40% worn

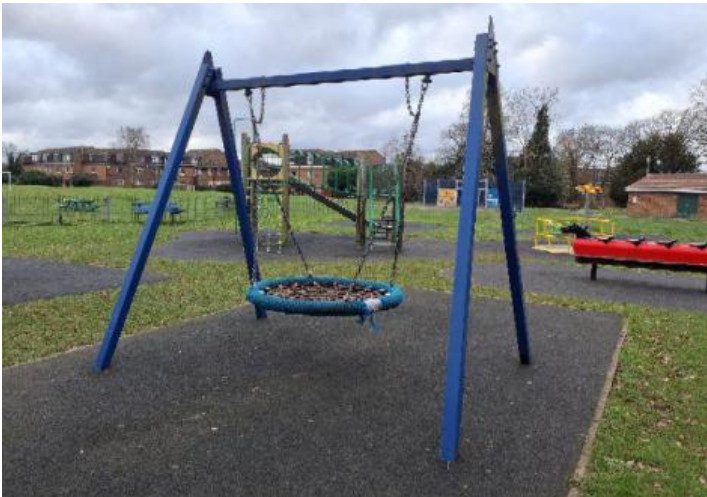
Item: Swings - Basket Swing - Type 1
Manufacturer: Park Leisure Ltd

Risk Level: V - Very Low Risk
Surface: Wet Pour

Finding: The bush / bushes is / are showing signs of wear

Action: Monitor for any further deterioration and replace as required

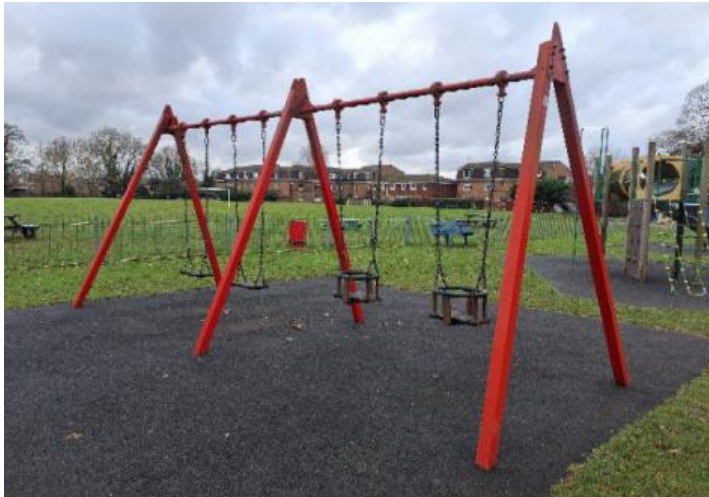
Item: Swings - 2 Bay 2 Flat 2 Cradle
Manufacturer: Park Leisure Ltd

Risk Level: V - Very Low Risk
Surface: Wet Pour

Finding: The chain openings are in excess of the 8.6mm as recommended by BS EN 1176

Action: Monitor - No action given the risk assessment

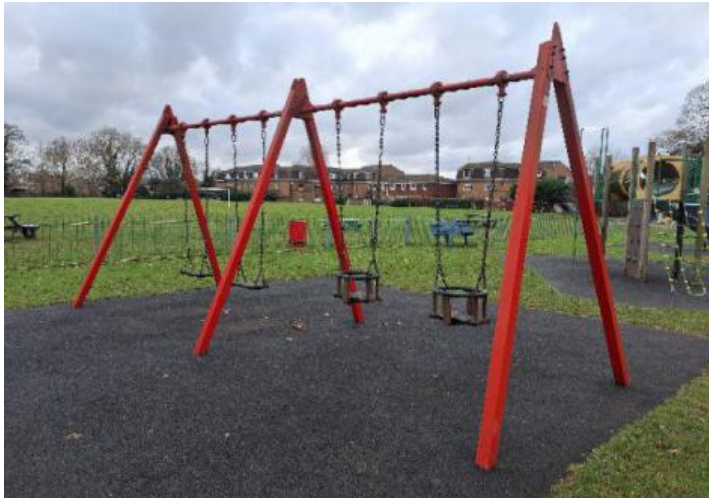
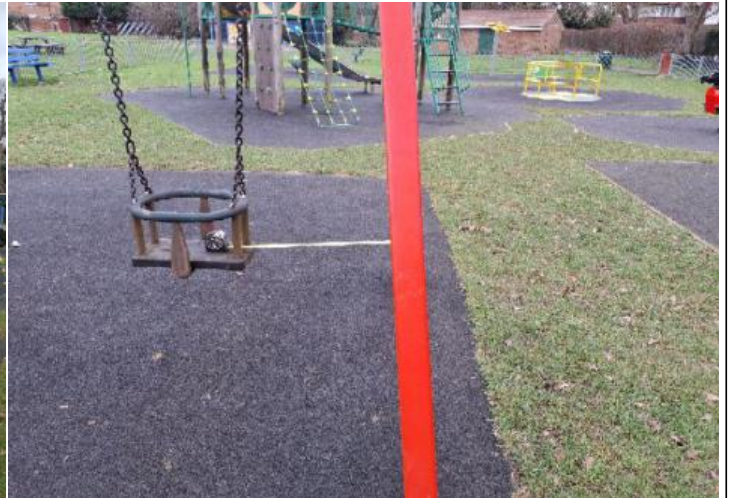
Item: Swings - 2 Bay 2 Flat 2 Cradle
Manufacturer: Park Leisure Ltd

Risk Level: L - Low Risk
Surface: Wet Pour

Finding: The seat/s is / are too close to the frame as defined in BS EN 1176 Part 2

Action: Monitor - No action given the risk assessment

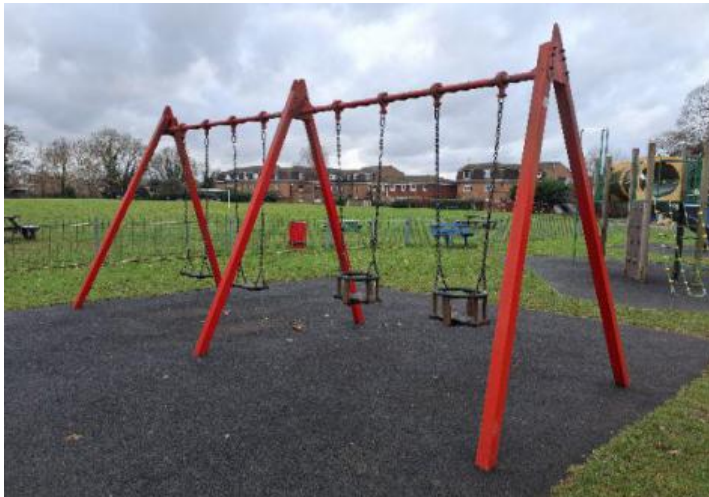
Item: Swings - 2 Bay 2 Flat 2 Cradle
Manufacturer: Park Leisure Ltd

Risk Level: L - Low Risk
Surface: Wet Pour

Finding: There is some notable evidence of chain wear

Action: Monitor for any further deterioration and replace when 40% worn

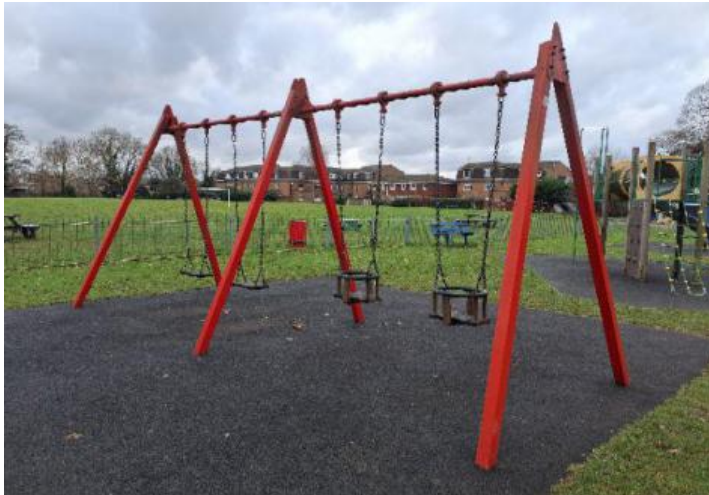
Item: Swings - 2 Bay 2 Flat 2 Cradle
Manufacturer: Park Leisure Ltd

Risk Level: L - Low Risk
Surface: Wet Pour

Finding: There is some wear to the shackles.

Action: Monitor for any further deterioration and replace when 40% worn

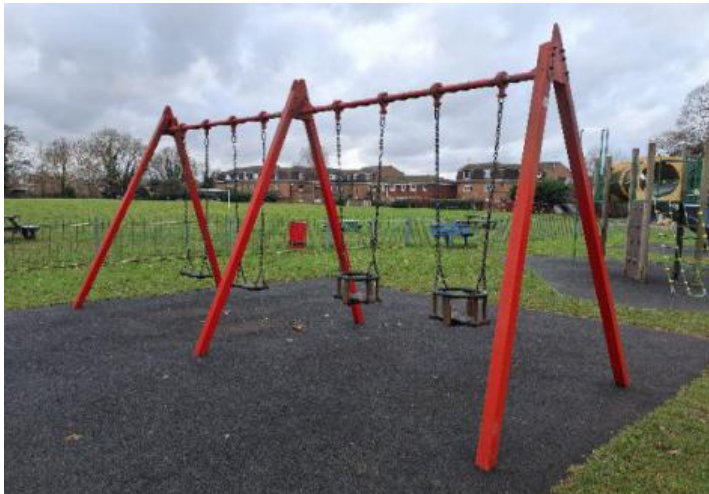
Item: Swings - 2 Bay 2 Flat 2 Cradle
Manufacturer: Park Leisure Ltd

Risk Level: V - Very Low Risk
Surface: Wet Pour

Finding: The bush / bushes is / are showing signs of wear

Action: Monitor for any further deterioration and replace as required

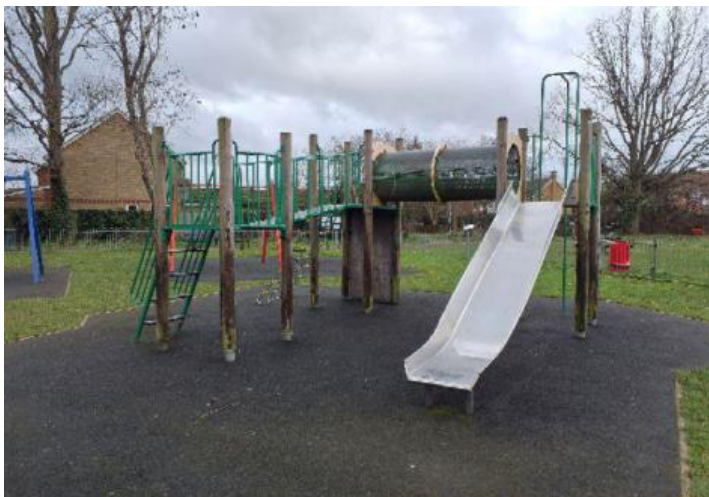
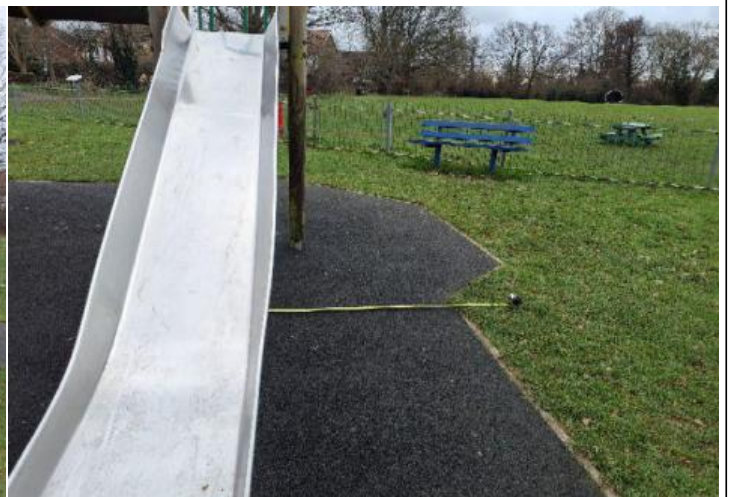
Item: Activity Equipment - Multi Play (Junior)
Manufacturer: Park Leisure Ltd

Risk Level: V - Very Low Risk
Surface: Wet Pour

Finding: The surfacing dimensions are short and do not meet with the requirements of the current applicable standard

Action: Monitor - No action given the risk assessment

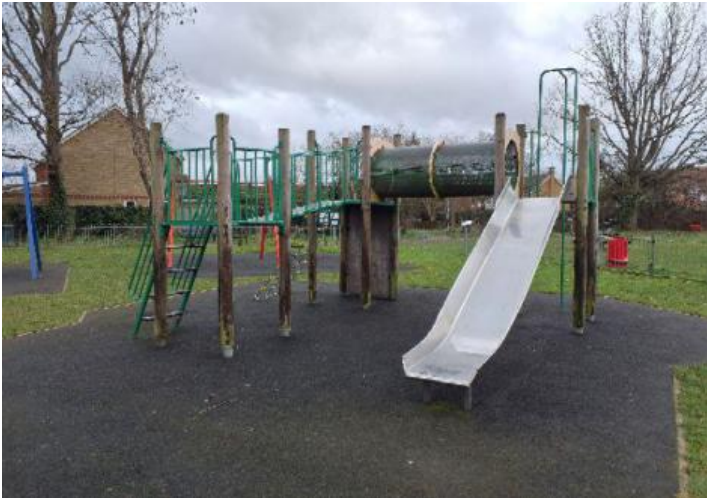
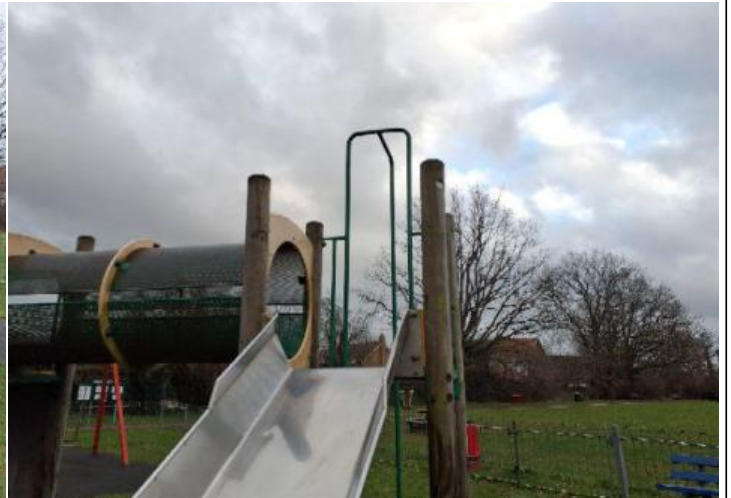
Item: Activity Equipment - Multi Play (Junior)
Manufacturer: Park Leisure Ltd

Risk Level: L - Low Risk
Surface: Wet Pour

Finding: This item has no slide bar fitted as required by BS EN 1176 Part 3

Action: Monitor use and consider the provision of a slide bar

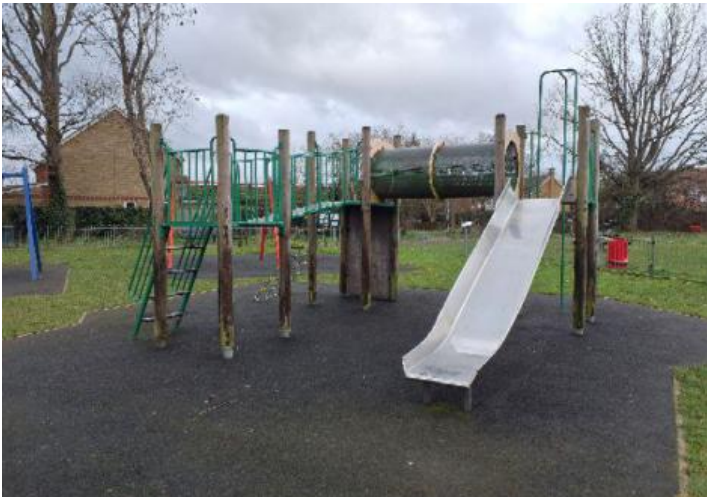
Item: Activity Equipment - Multi Play (Junior)
Manufacturer: Park Leisure Ltd

Risk Level: V - Very Low Risk
Surface: Wet Pour

Finding: There are a number of dents in the slide surface

Action: Monitor for any further deterioration and repair as required

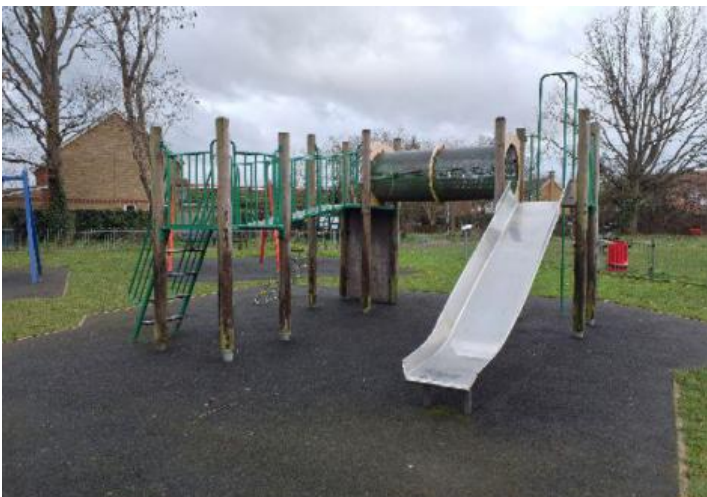
Item: Activity Equipment - Multi Play (Junior)
Manufacturer: Park Leisure Ltd

Risk Level: V - Very Low Risk
Surface: Wet Pour

Finding: There is/are inserts missing

Action: Replace missing inserts

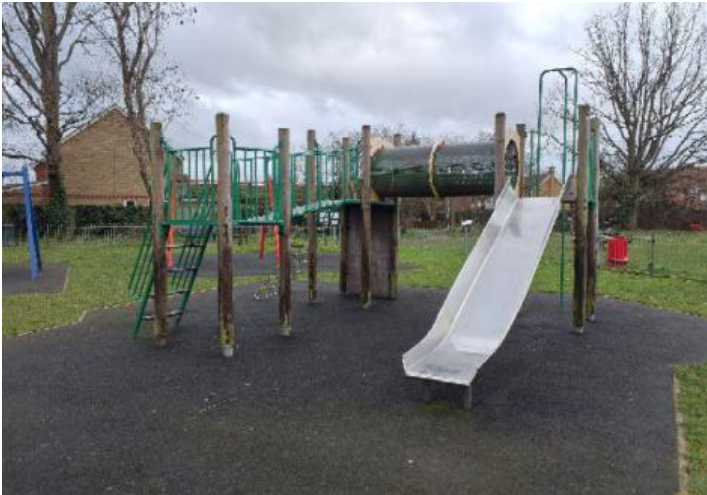
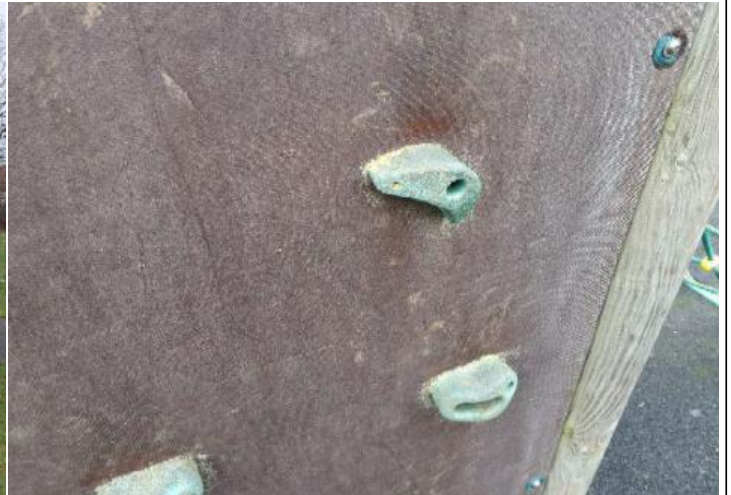
Item: Activity Equipment - Multi Play (Junior)
Manufacturer: Park Leisure Ltd

Risk Level: L - Low Risk
Surface: Wet Pour

Finding: There is algae or moss on the surface of the equipment

Action: Clean and treat appropriately

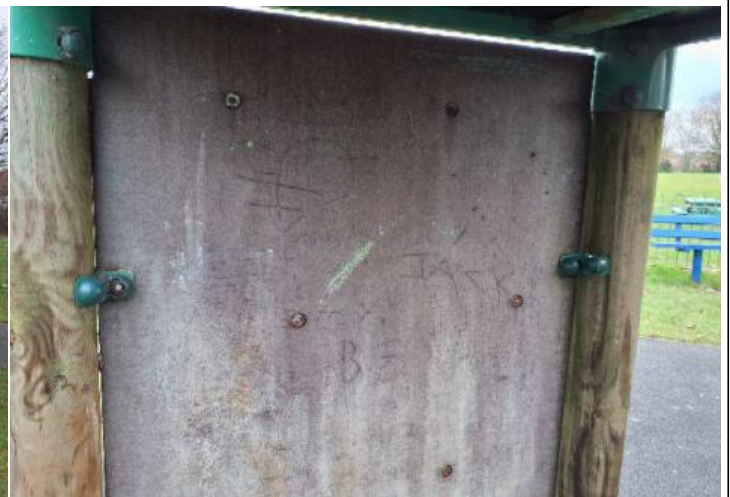
Item: Activity Equipment - Multi Play (Junior)
Manufacturer: Park Leisure Ltd

Risk Level: N - Risk Assessment not Undertaken
Surface: Wet Pour

Finding: There is some graffiti present
Action: Remove the graffiti

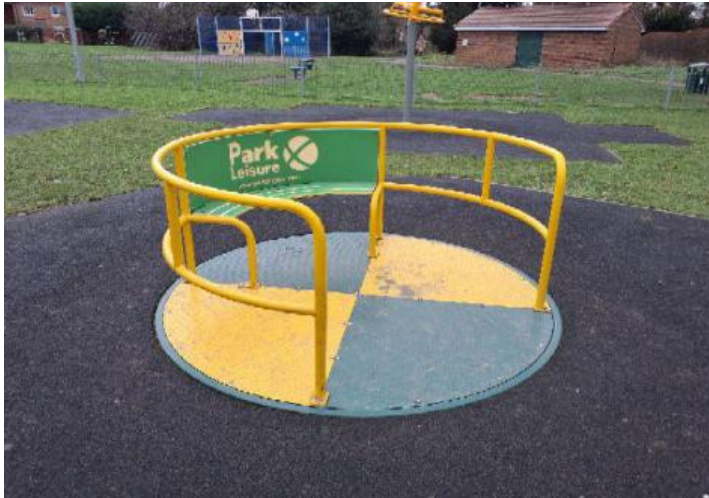
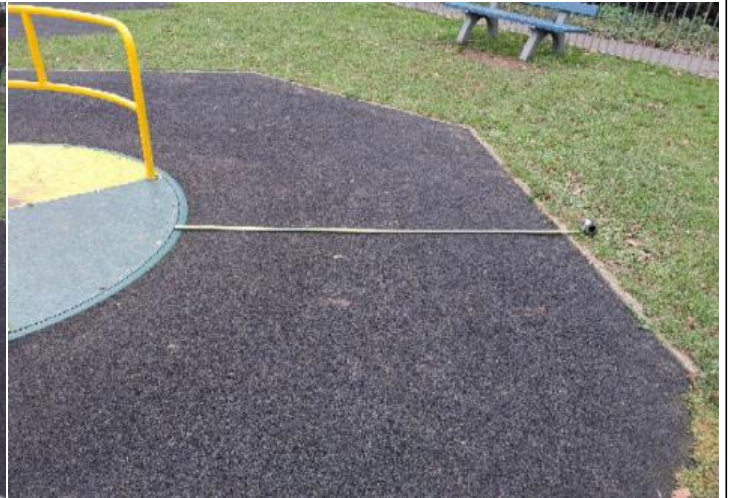
Item: Rotor Play - Inclusive Roundabout
Manufacturer: Park Leisure Ltd

Risk Level: V - Very Low Risk
Surface: Wet Pour

Finding: The surfacing dimensions are short and do not meet with the requirements of the current applicable standard

Action: Monitor - No action given the risk assessment

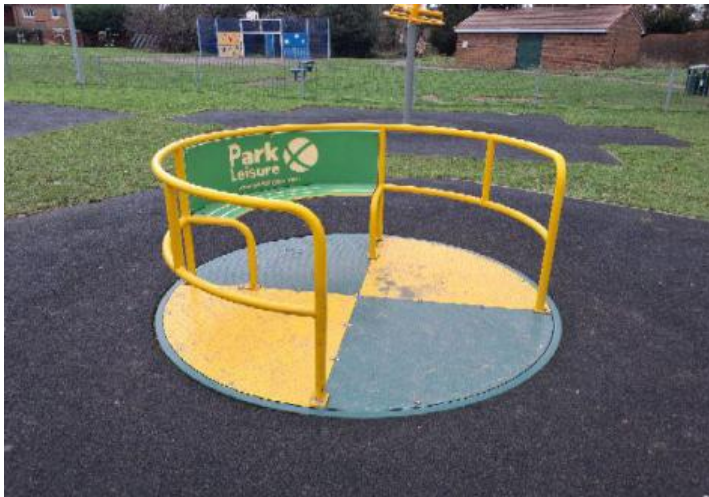
Item: Rotor Play - Inclusive Roundabout
Manufacturer: Park Leisure Ltd

Risk Level: L - Low Risk
Surface: Wet Pour

Finding: There are gaps opening between the surfacing and the edging surround or between the joints in the surfacing

Action: Monitor for any further deterioration and repair as required

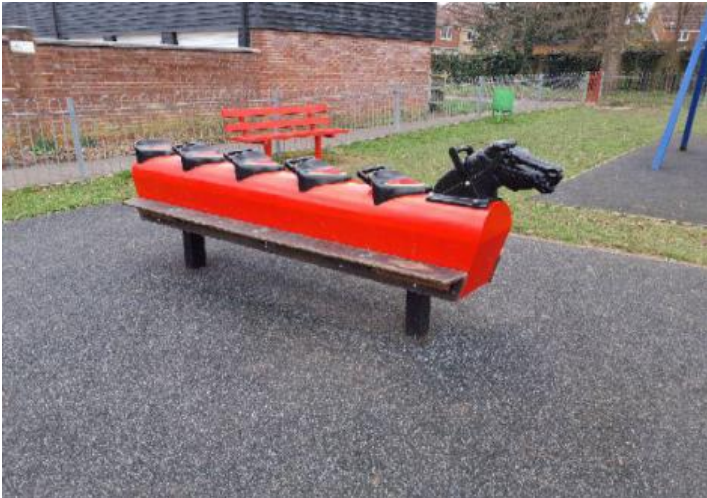
Item: Rocking Equipment - Rocking Horse
Manufacturer: Wicksteed Playgrounds

Risk Level: V - Very Low Risk
Surface: Grass

Finding: There is no gaiter protection for accessible moving parts (possible shear trap) as recommended in BS EN 1176 Part 1; 4.2.6 Moving Parts

Action: Monitor - No action given the risk assessment

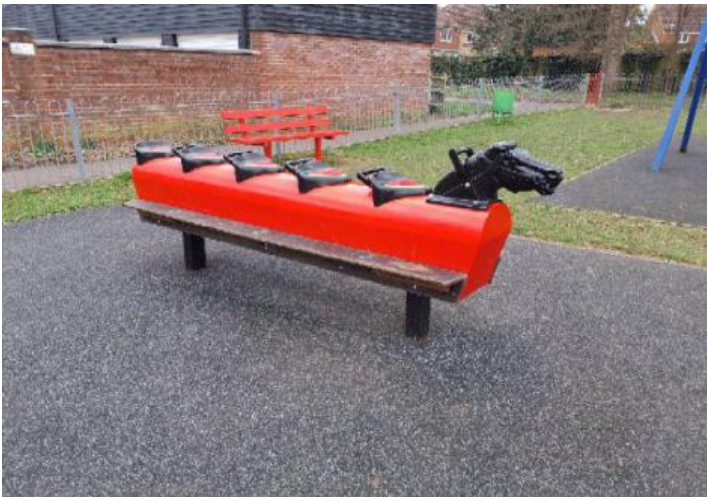
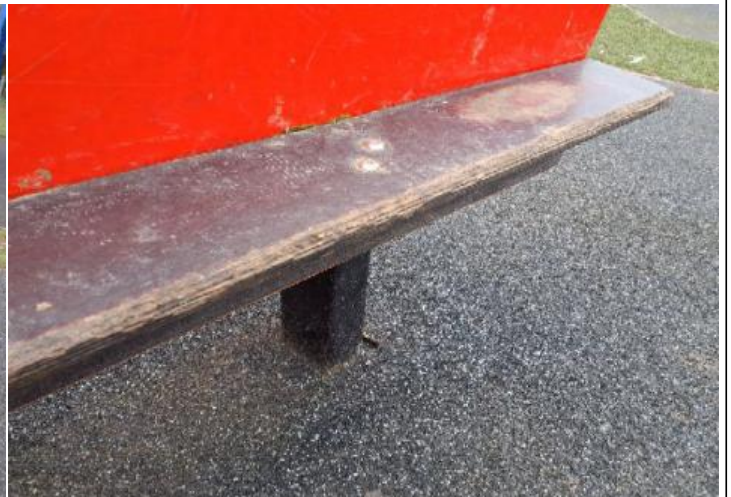
Item: Rocking Equipment - Rocking Horse
Manufacturer: Wicksteed Playgrounds

Risk Level: L - Low Risk
Surface: Grass

Finding: Parts of the timber are rough or splintered

Action: Remove all rough or sharp edges

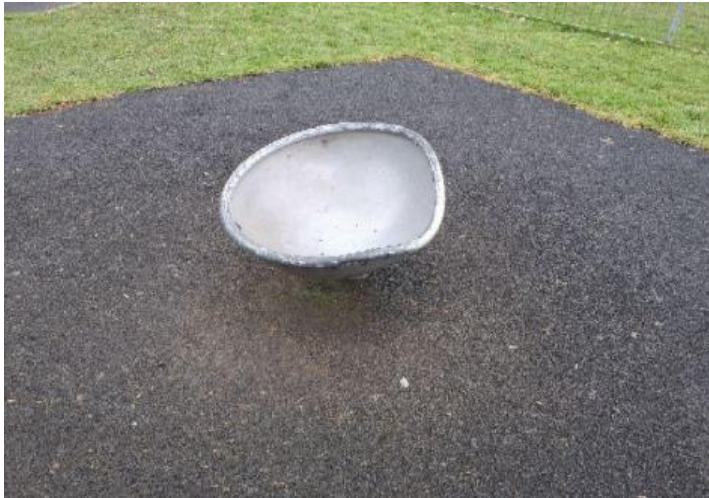
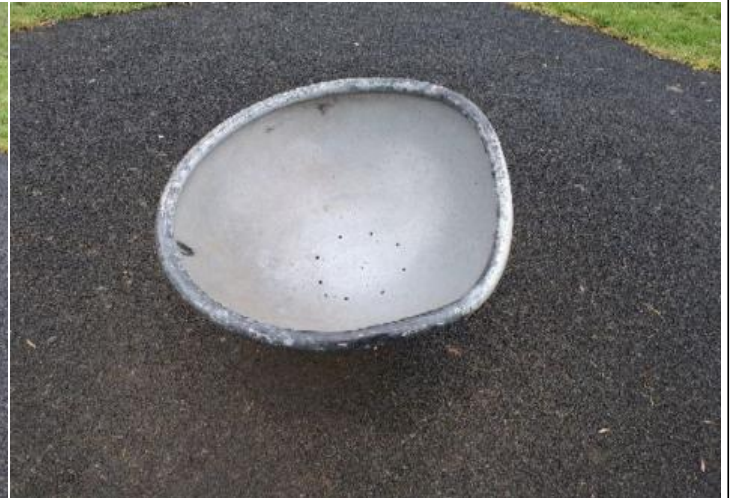
Item: Rotor Play - Spinner Bowl
Manufacturer: Not Identified

Risk Level: L - Low Risk
Surface: Wet Pour

Finding: The paint is flaking off the metalwork

Action: Rub down and re-paint
