Deputy Clerk's Report

the **play inspection** company

Annual Inspection

Marden Playing Field

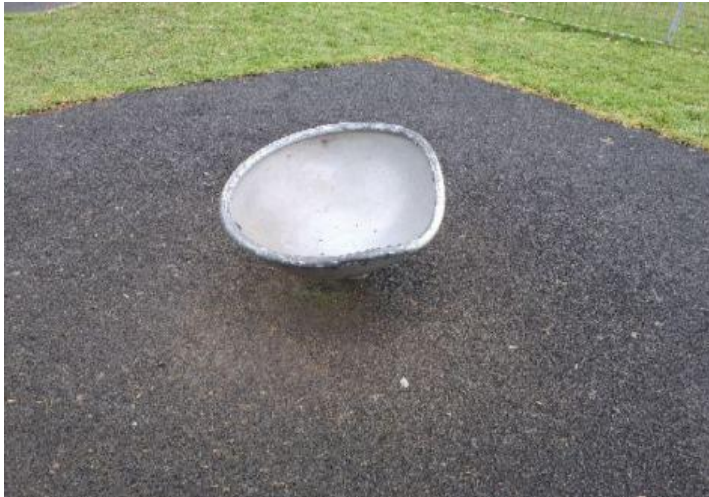
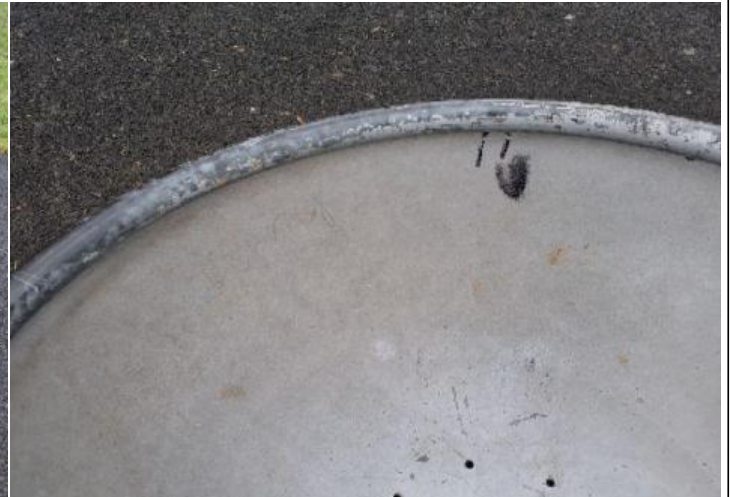
Item: Rotor Play - Spinner Bowl
Manufacturer: Not Identified

Risk Level: N - Risk Assessment not Undertaken
Surface: Wet Pour

Finding: There is some graffiti present

Action: Remove the graffiti

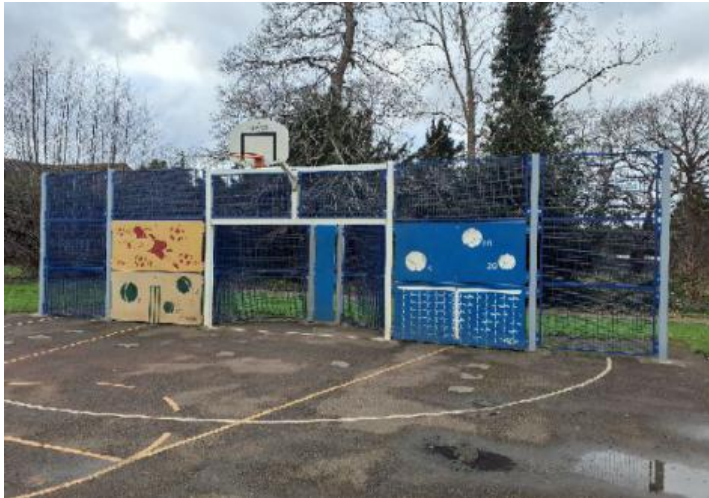
Item: Multi Use Games Area - Goal End
Manufacturer: Wicksteed Playgrounds

Risk Level: V - Very Low Risk
Surface: Bitmac

Finding: A clearly visible facility sign should be provided in a prominent position with the wording as detailed BS EN 15312- the equipment is not intended for children less than 3 years old- the warning - Do not climb on the framework or nets- the warning - Do not hang on the ring (if provided)- the warning - Do not wear rings or other jewellery- name and telephone number of the administrator- number to call in case of accident

Action: Provide signage to BS EN 15312

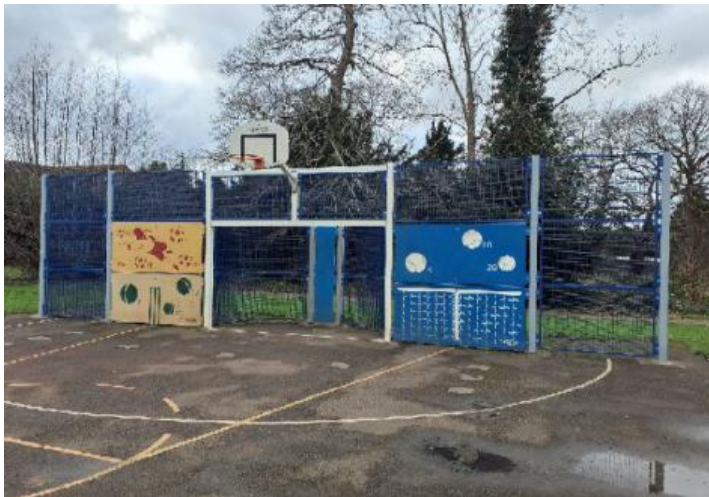
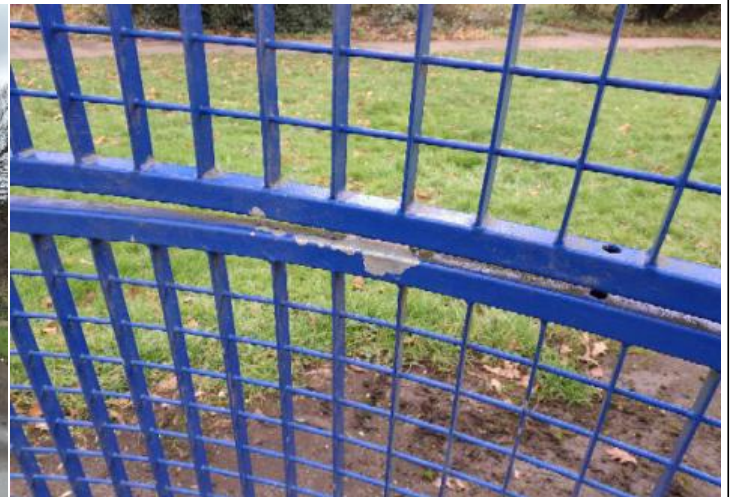
Item: Multi Use Games Area - Goal End
Manufacturer: Wicksteed Playgrounds

Risk Level: L - Low Risk
Surface: Bitmac

Finding: The paint is flaking off the metalwork

Action: Rub down and re-paint

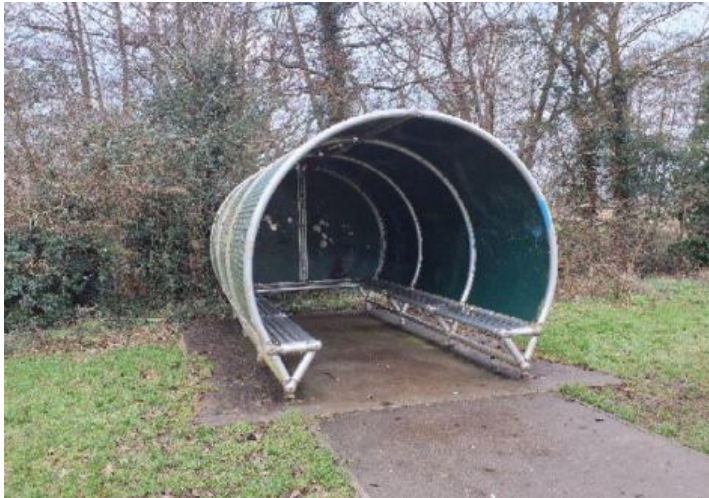
Item: Ancillary Items - Shelter
Manufacturer: Not Identified

Risk Level: L - Low Risk
Surface: Concrete

Finding: The item has been damaged

The item has been damaged - Monitor for any further deterioration and replace as required

Action: Monitor for any further deterioration and replace as required

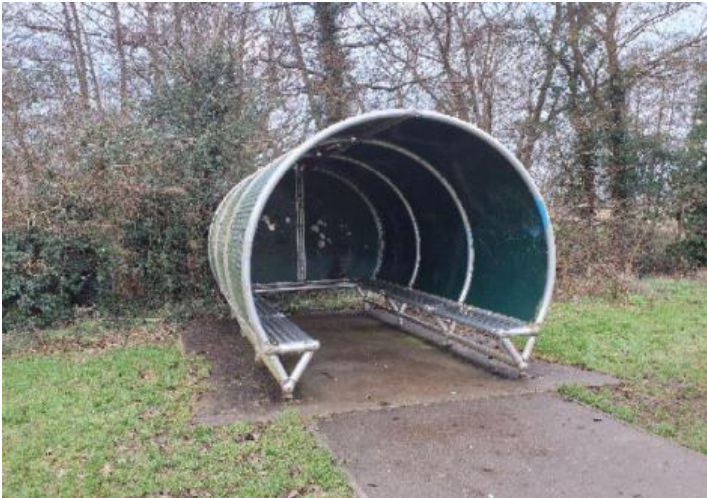
Item: Ancillary Items - Shelter
Manufacturer: Not Identified

Risk Level: L - Low Risk
Surface: Concrete

Finding: There is or are fixings missing on the item

Action: Replace all missing fixings

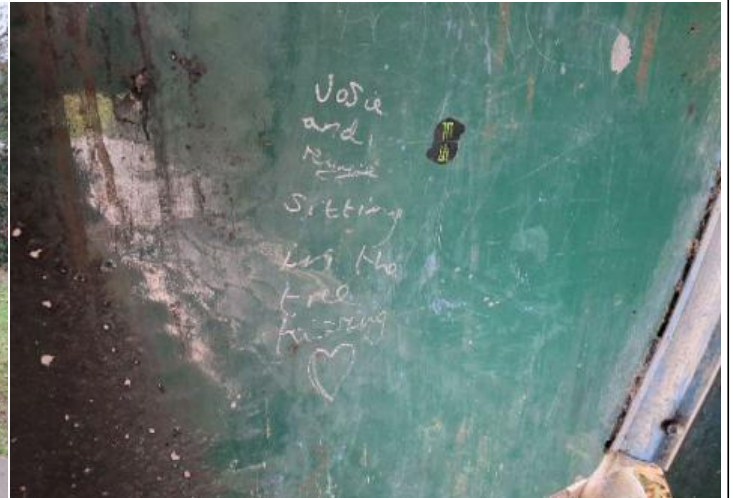
Item: Ancillary Items - Shelter
Manufacturer: Not Identified

Risk Level: N - Risk Assessment not Undertaken
Surface: Concrete

Finding: There is some graffiti present

Action: Remove the graffiti

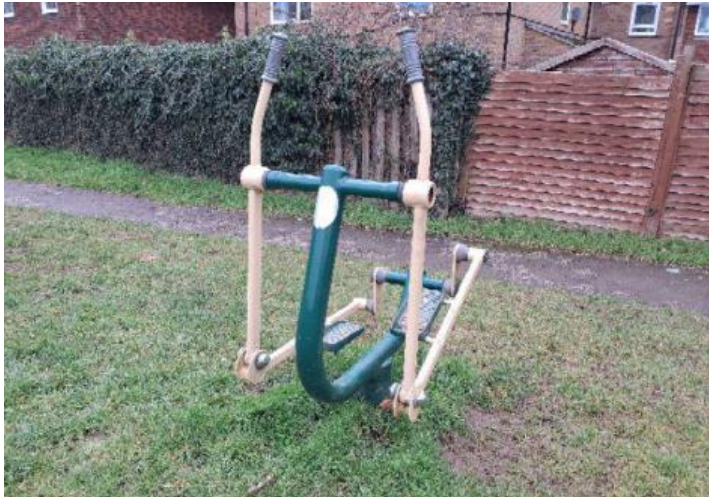
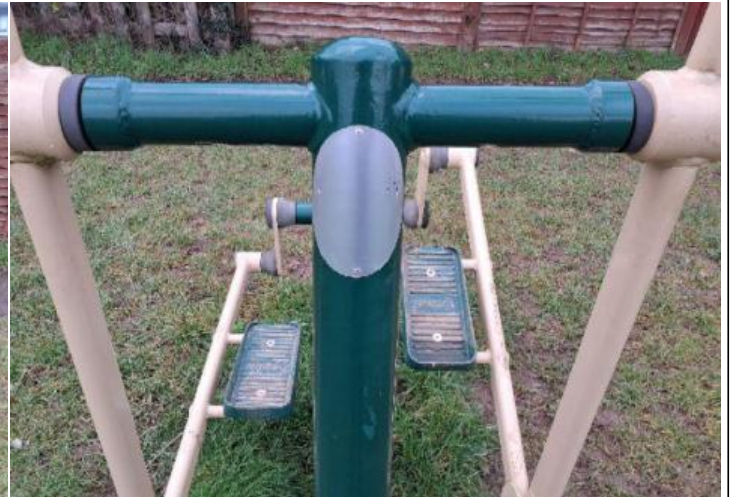
Item: Outdoor Fitness Equipment - Cross Trainer
Manufacturer: Wicksteed Playgrounds

Risk Level: V - Very Low Risk
Surface: Grass Matrix Tiles

Finding: The instruction label provided has faded; an instruction label should be provided with each item of equipment in accordance with the requirements of BS EN 16630

Action: Provide appropriate instruction label/s

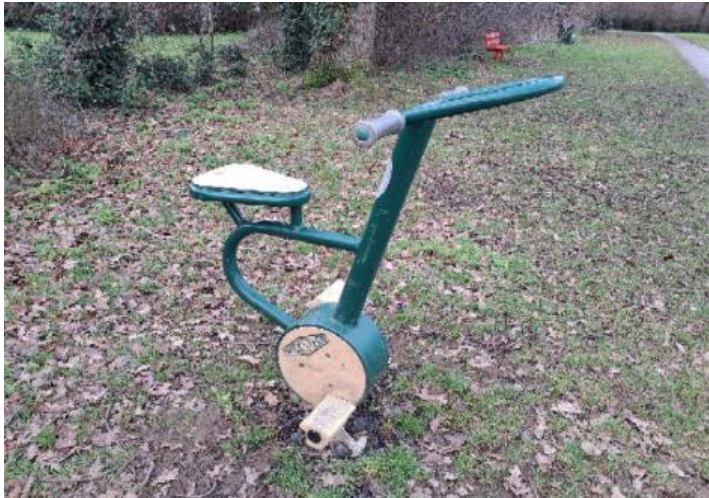
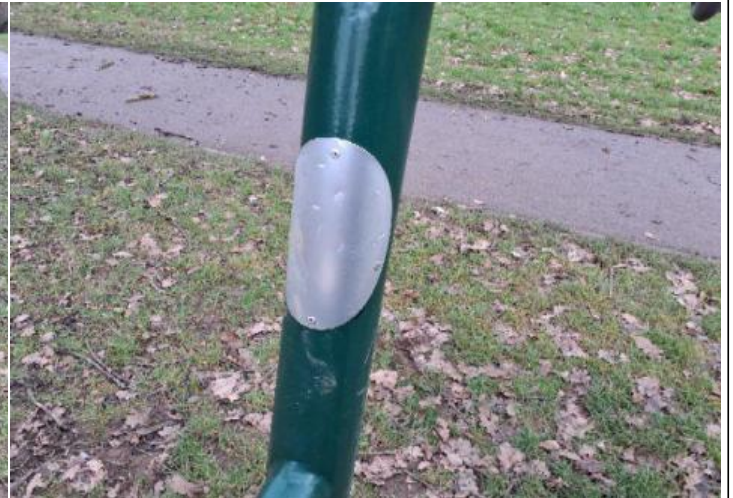
Finding: The instruction label provided has faded; an instruction label should be provided with each item of equipment in accordance with the requirements of BS EN 16630

Action: Provide appropriate instruction label/s

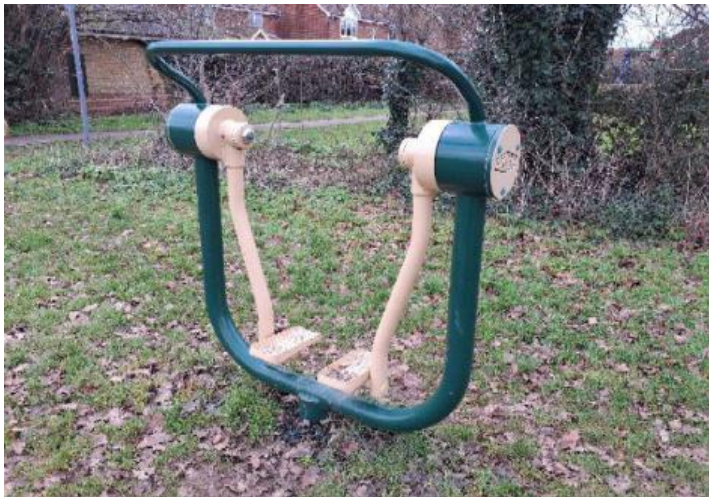
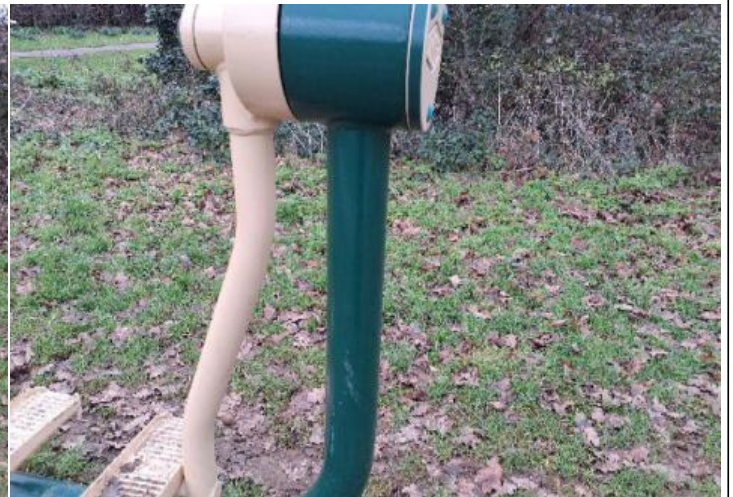
Finding: There is no instruction label provided; an instruction label should be provided with each item of equipment in accordance with the requirements of BS EN 16630

Action: Provide appropriate instruction label/s

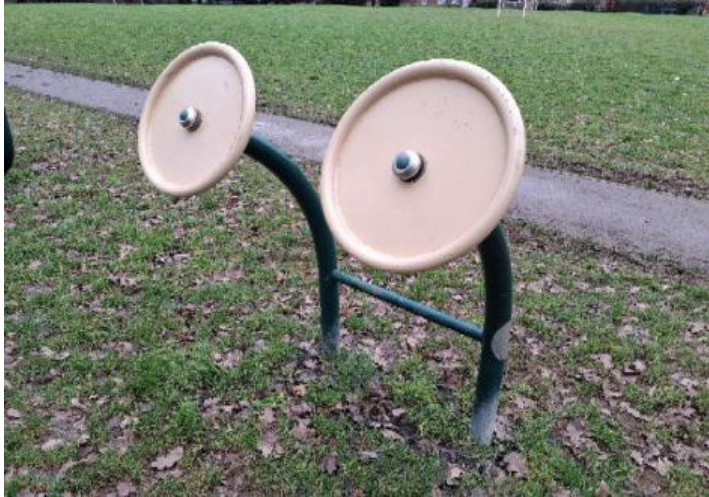
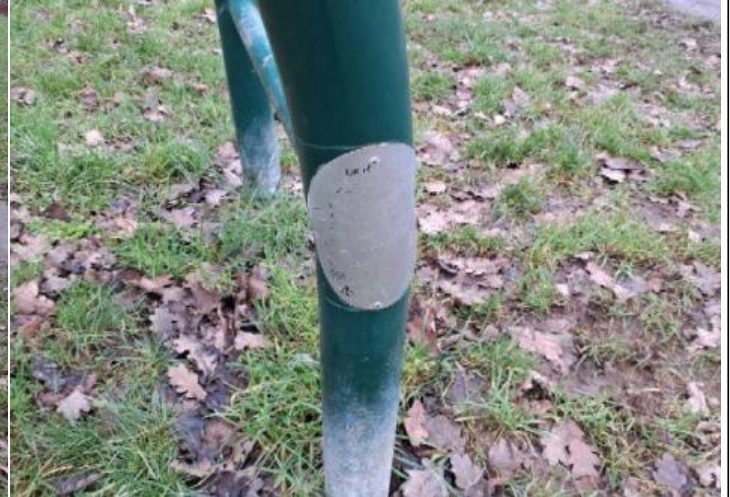
Finding: The instruction label provided has faded; an instruction label should be provided with each item of equipment in accordance with the requirements of BS EN 16630

Action: Provide appropriate instruction label/s

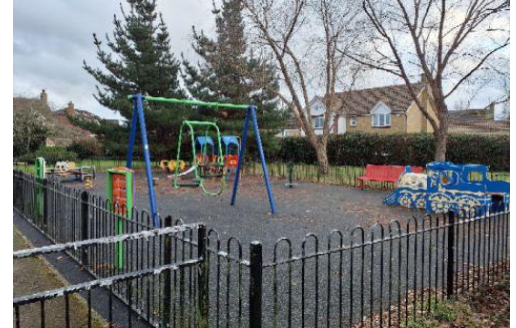
There is some tree debris on the surfacing - Remove and maintain

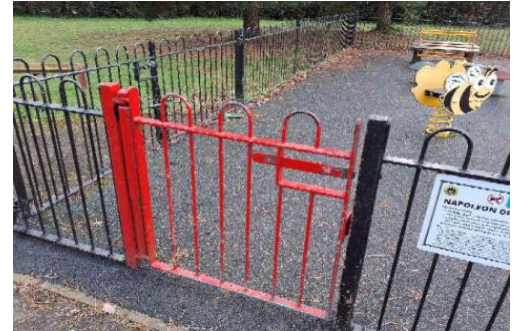
The paint is flaking off the metalwork - Rub down and re-paint

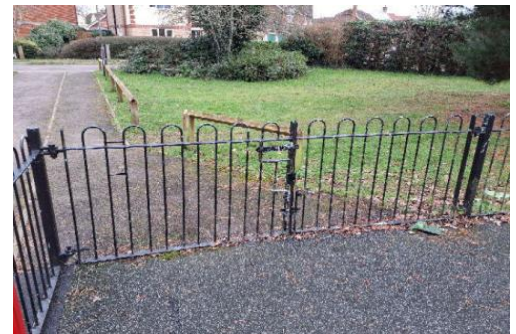
The maintenance gate was correctly padlocked at the time of inspection, however this means that the inspector was unable to fully assess the gate - Ensure that there are 12mm gaps throughout the full range of motion on gate/s and between leaves where relevant

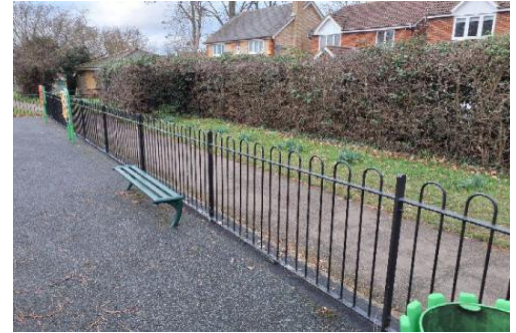
There is some damage to the fence sections - Monitor for any further deterioration and repair as required

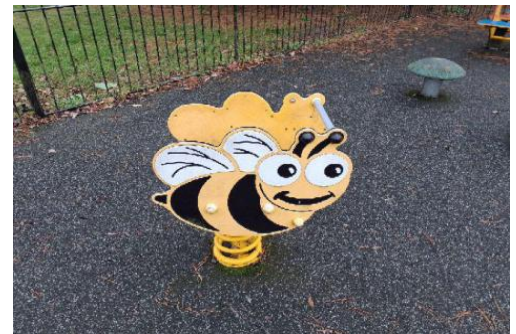
The Handgrips/Footrests rotate and may cause an unexpected movement for the user - Secure Handgrips/Footrests to prevent rotation.

A number of fixing(s) have worked loose - Secure all loose fixings

The paintwork on this item has been damaged or worn exposing the metal underneath which is rusting / corroding - Treat affected areas and repaint

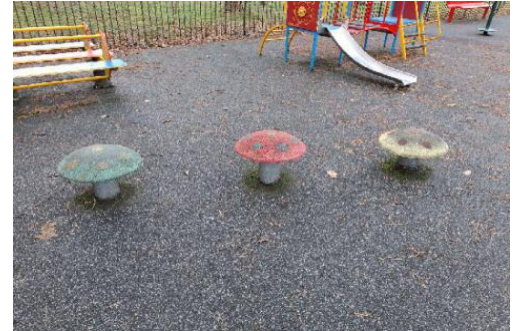
There is algae or moss on the surface of the equipment - Clean and treat appropriately

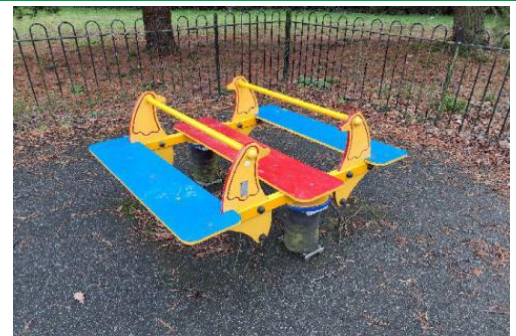
The spring cover is damaged, split or missing - Replace the cover

There is or are fixings missing on the item - Replace all missing fixings

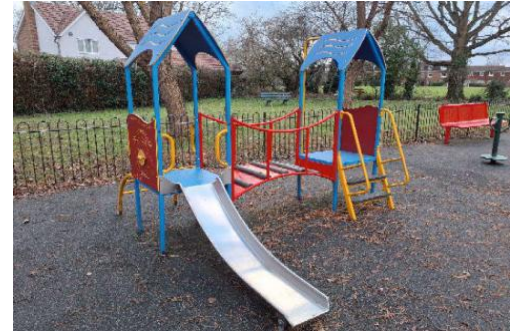
The free space between the fireman's pole and the platform is less than the minimum recommended dimension of 350mm in BS EN 1176 Part 1; this is however an intended design feature by the manufacturer to assist younger users in accessing the pole and is a very low risk finding - no remedial action is recommended - Monitor - No action given the risk assessment

There is/are inserts missing - Replace missing inserts

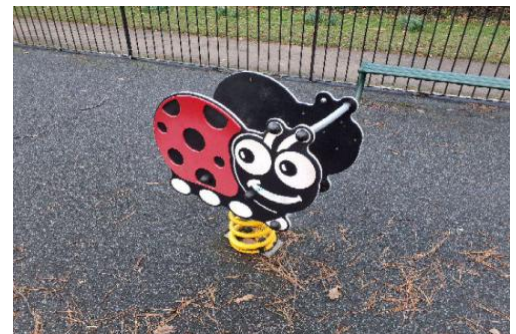
The Handgrips/Footrests rotate and may cause an unexpected movement for the user - Secure Handgrips/Footrests to prevent rotation.

The paintwork on this item has been damaged or worn exposing the metal underneath which is rusting / corroding - Treat affected areas and repaint

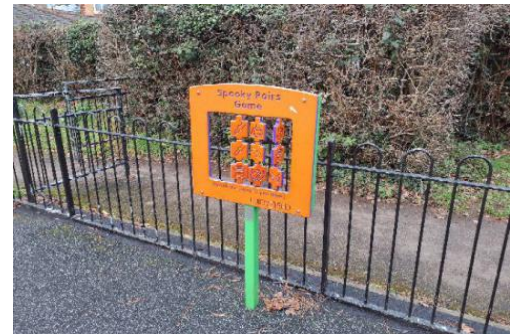
The item has missing component(s) - Consider replacing missing components

The item has been damaged - Monitor for any further deterioration and replace as required

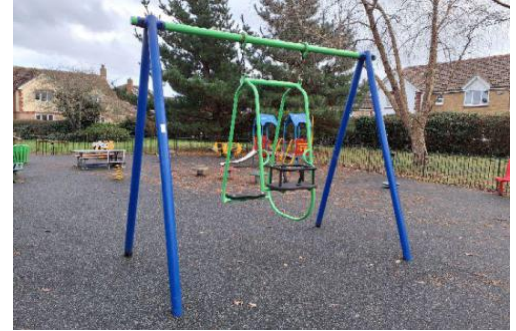
Finding 1
 Parts of the steel structure protrude beyond the protected elements of the seat and have no impact attenuating protection for users passing by or underneath - Refer to manufacturer for confirmation of design risk assessment

Finding 2
 There is some notable evidence of chain wear - Monitor for any further deterioration and replace when 40% worn

Finding 3
 There is some wear to the shackles. - Monitor for any further deterioration and replace when 40% worn

Finding 4
 The bush / bushes is / are showing signs of wear - Monitor for any further deterioration and replace as required

Finding 5
 The fixings have corroded excessively - Replace all corroded fixings

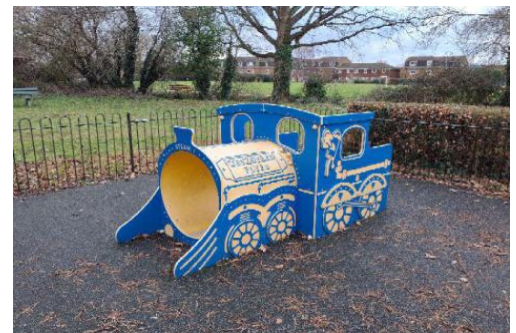
Finding 1
 There is or are fixings missing on the item - Replace all missing fixings

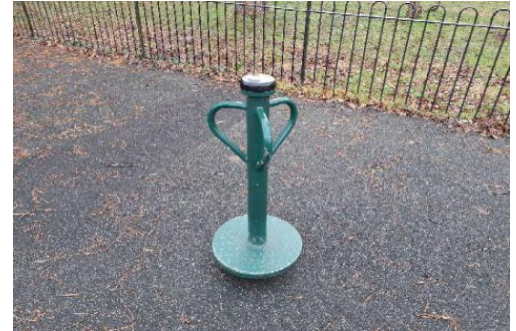
The paintwork on this item has been damaged or worn exposing the metal underneath which is rusting / corroding - Treat affected areas and repaint

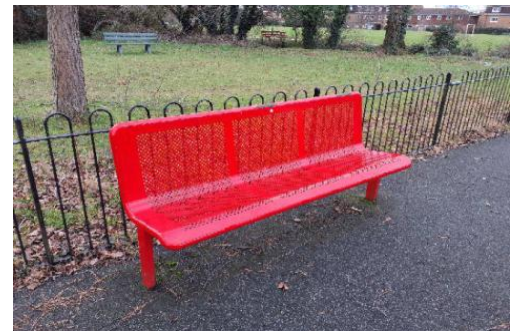
The paintwork on this item has been damaged or worn exposing the metal underneath which is rusting / corroding - Treat affected areas and repaint

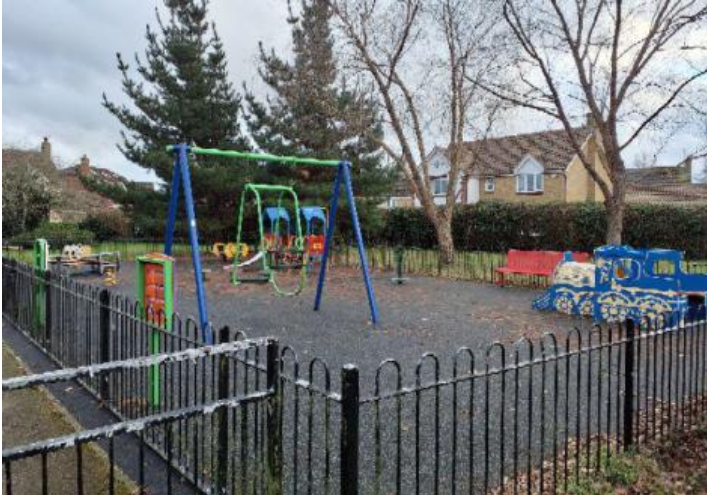
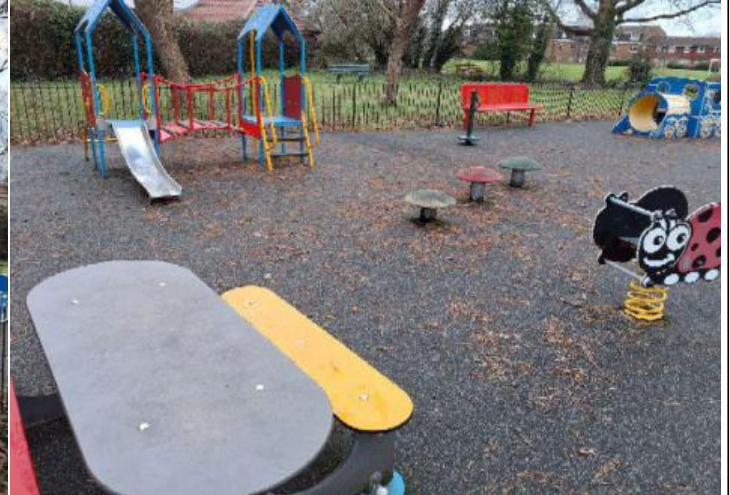
Finding: There is some tree debris on the surfacing

Action: Remove and maintain

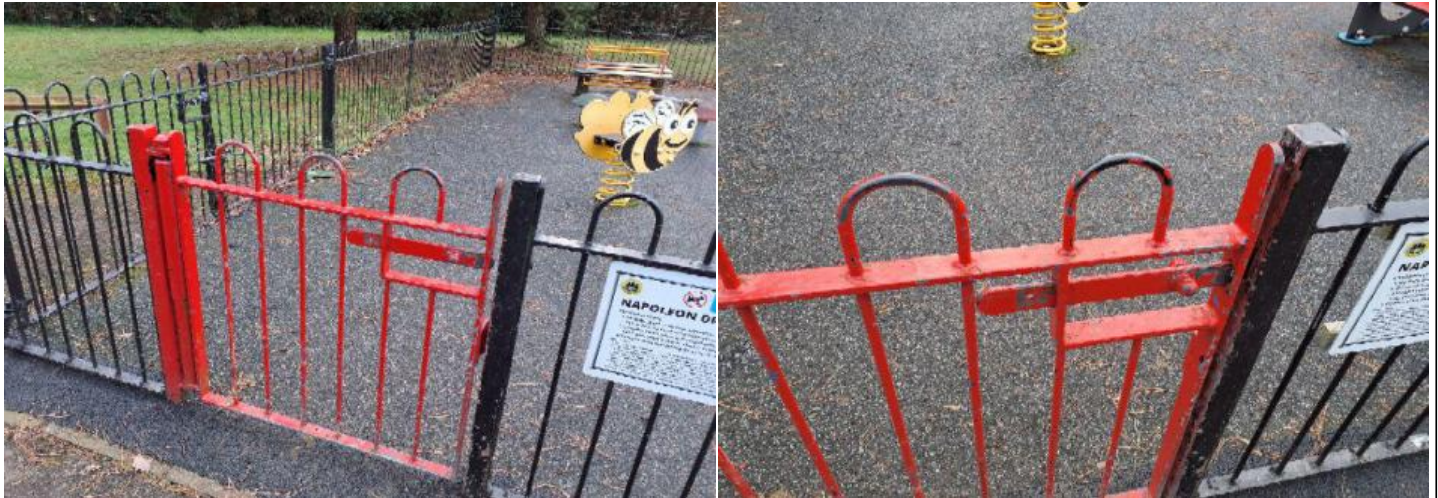
Finding: The paint is flaking off the metalwork

Action: Rub down and re-paint

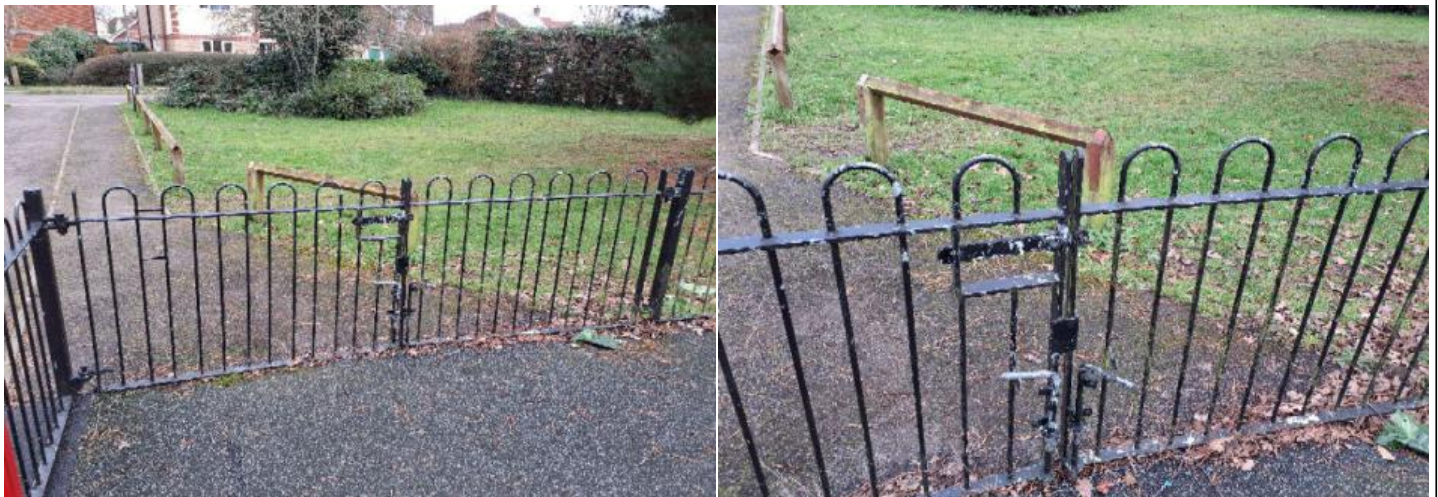
Finding: The maintenance gate was correctly padlocked at the time of inspection, however this means that the inspector was unable to fully assess the gate

Action: Ensure that there are 12mm gaps throughout the full range of motion on gate/s and between leaves where relevant

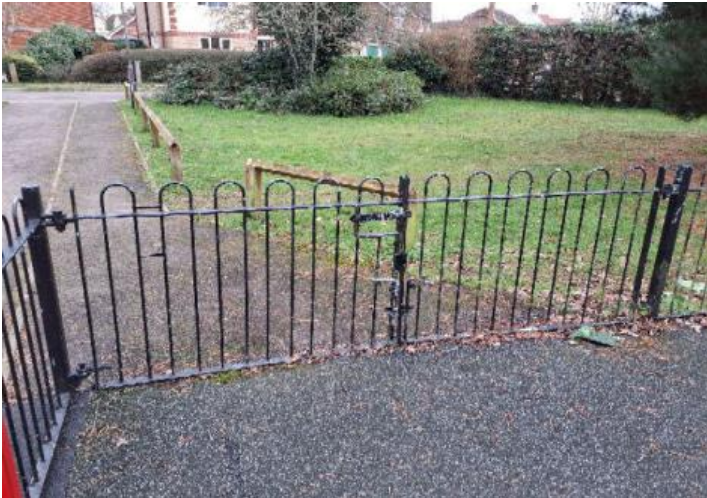
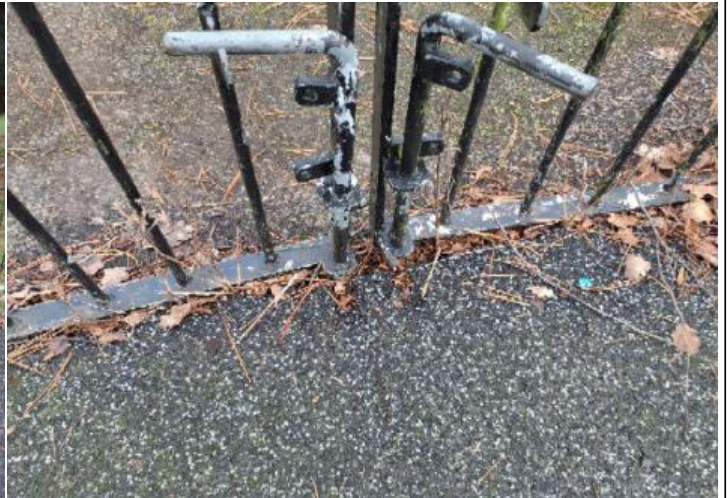
Finding: The gate has no drop bolt sleeves and/or drop bolts fitted

Action: Provide drop bolt sleeves and/or drop bolts

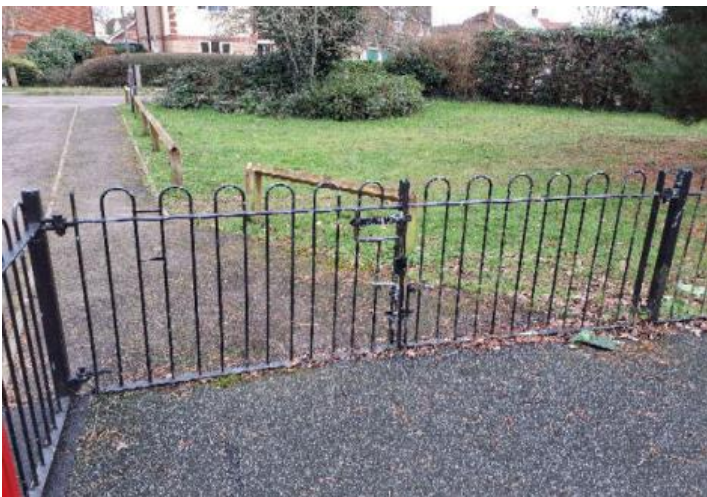
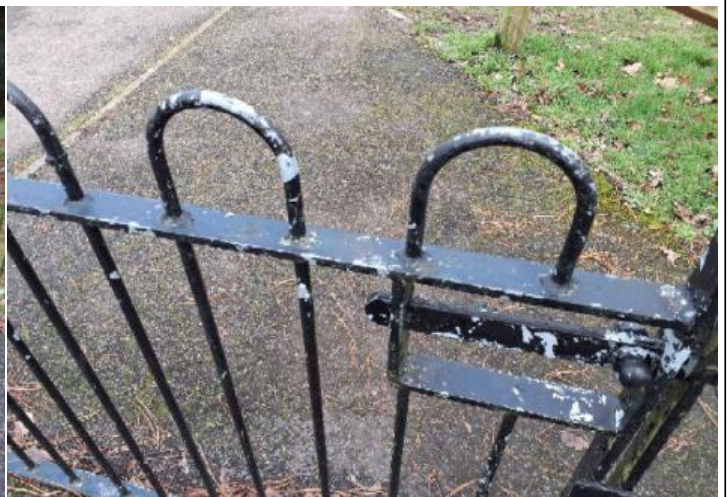
Finding: The paint is flaking off the metalwork

Action: Rub down and re-paint

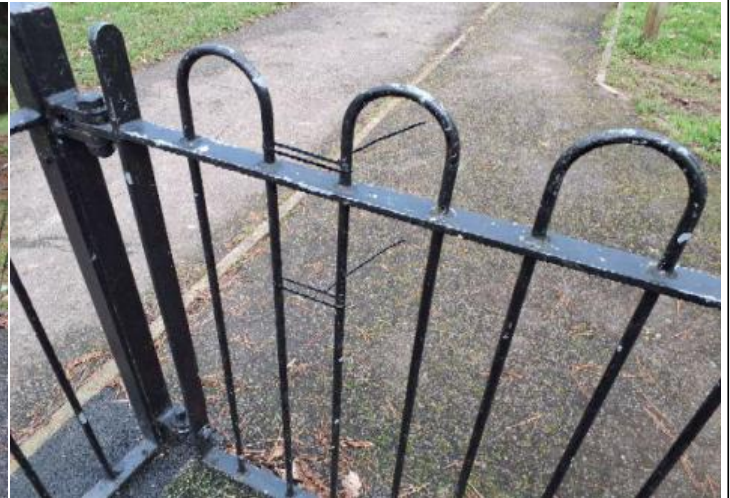
Finding: Cable ties are present and there are sharp projecting ends

Action: Remove redundant cable ties

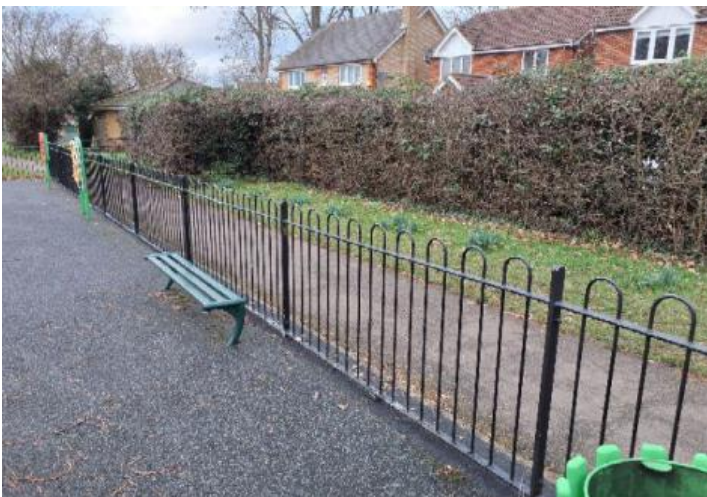
Finding: There is some damage to the fence sections

Action: Monitor for any further deterioration and repair as required

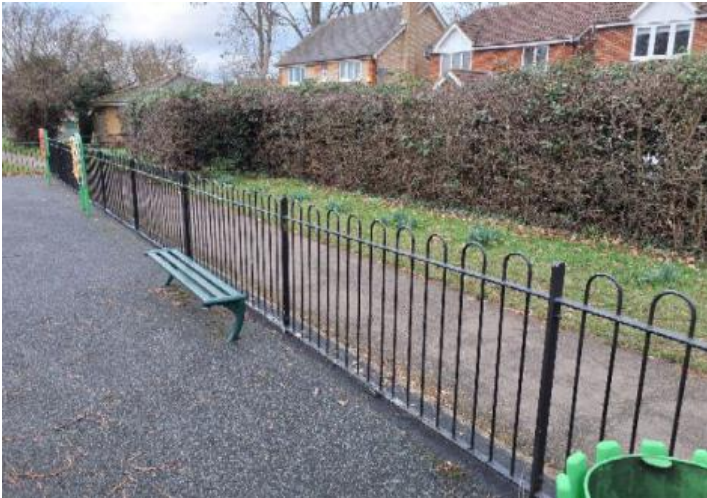
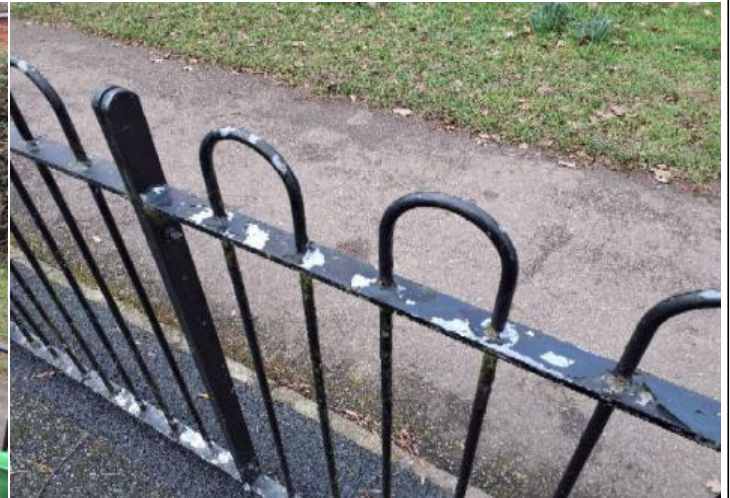
Finding: The paint is flaking off the metalwork

Action: Rub down and re-paint

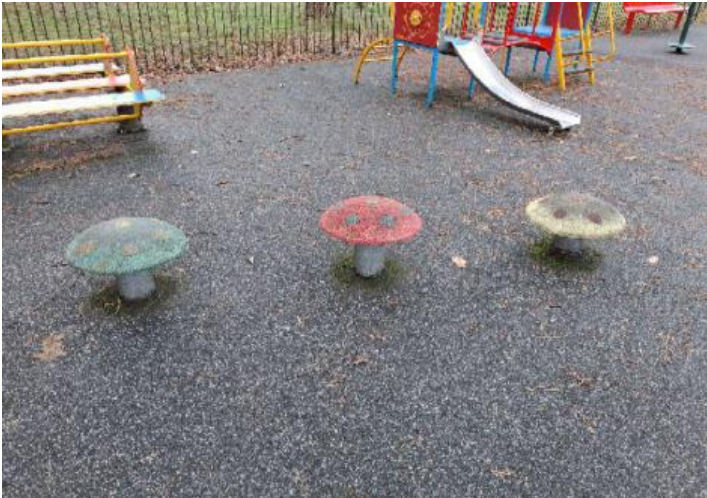
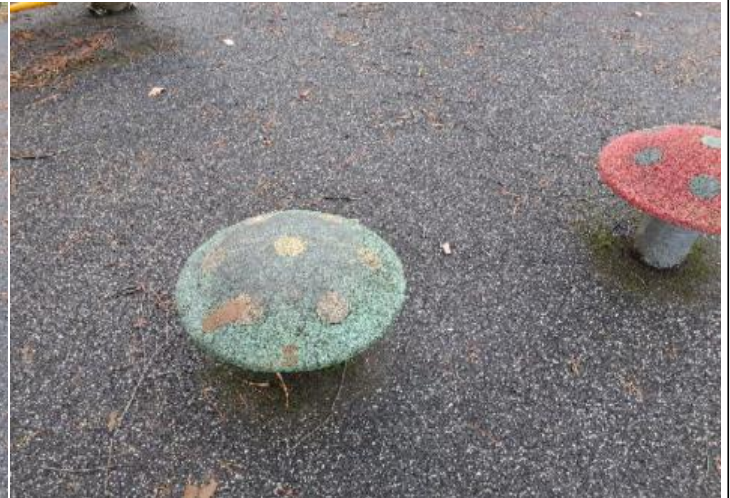
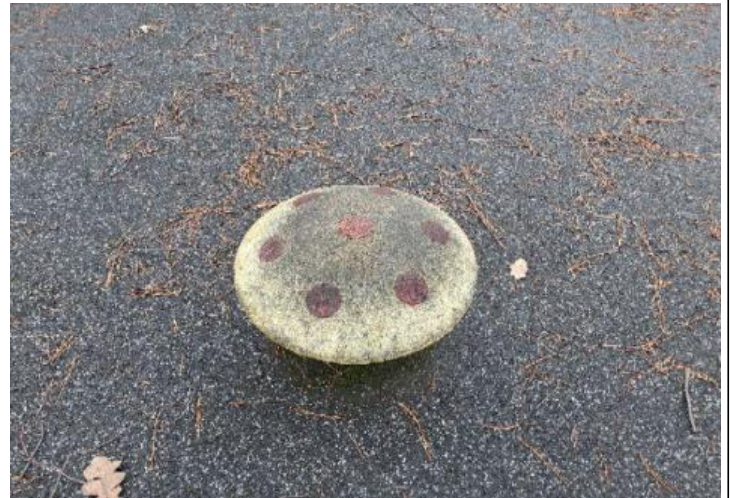
Item: Activity Equipment - Toadstools
Manufacturer: Wicksteed Playgrounds

Finding: There is algae or moss on the surface of the equipment

Action: Clean and treat appropriately

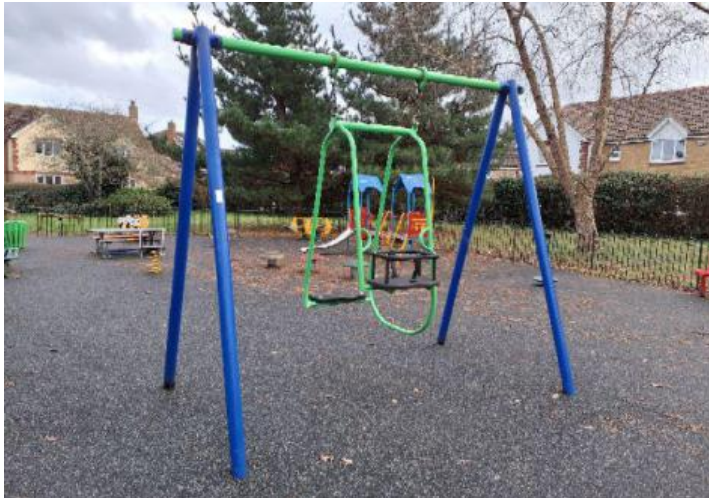
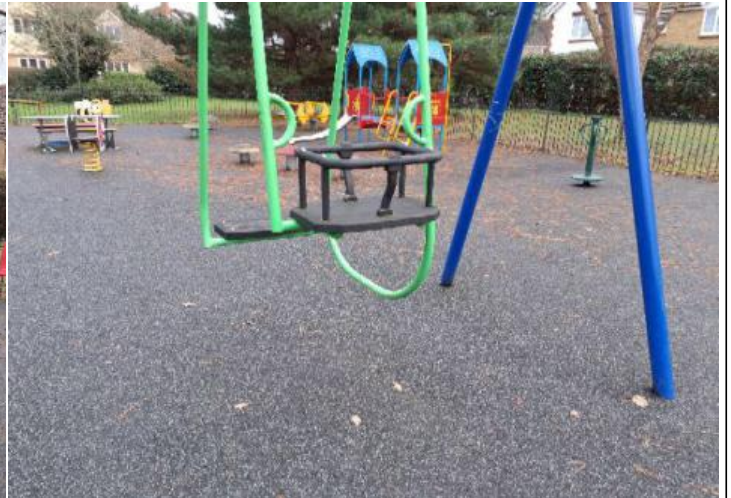
Item: Swings - 1 Bay Swing
Manufacturer: Wicksteed Playgrounds

Finding: Parts of the steel structure protrude beyond the protected elements of the seat and have no impact attenuating protection for users passing by or underneath

Action: Refer to manufacturer for confirmation of design risk assessment

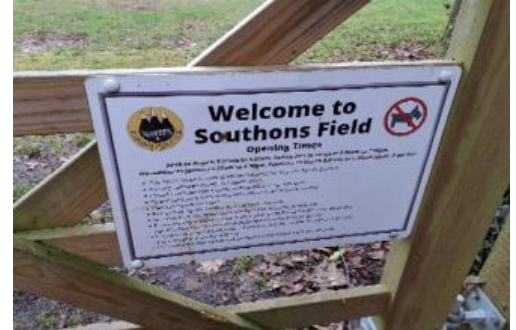
Item: Sign
Manufacturer: Not Identified
Surface Type: N/A
Item Quantity: 1
Equipment Compliance: N/A
Surface Area Compliance: N/A

This item is satisfactory - no work required -

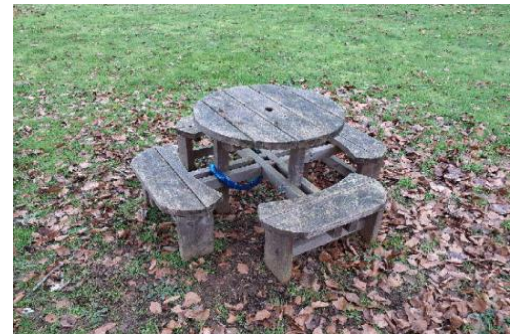
Item: Picnic Table
Manufacturer: Not Identified
Surface Type: Grass
Item Quantity: 9
Equipment Compliance: N/A
Surface Area Compliance: N/A

There is algae or moss on the surface of the bench - Clean and treat appropriately

i 4 - Very Low Risk

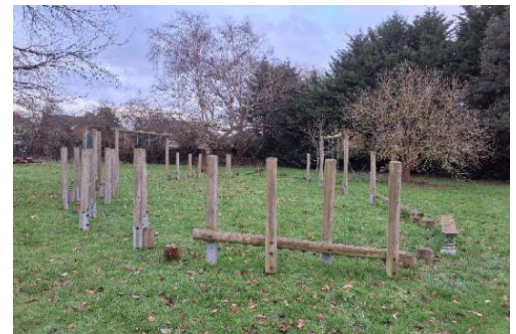
Item: Activity Trail
Manufacturer: Playdale Playgrounds Ltd
Surface Type: Grass
Item Quantity: 1
Equipment Compliance: Yes
Surface Area Compliance: Yes
Life Expectancy: 5 -10 Years
Total Findings: 6

There is some strimmer / machinery damage apparent on the posts, this can penetrate the preservative applied to the timber and accelerate the rotting process - Monitor for any deterioration (rot) and replace as required

There is some evidence of rot in the timber - Monitor for any further deterioration and replace as required

There is/are bolt cap covers missing or damaged on the item - Replace missing or damaged bolt cap covers

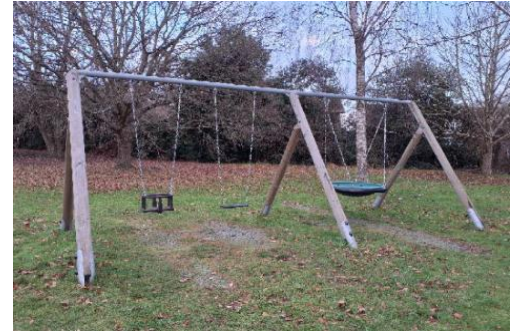
Item: 2 Bay Swing
Manufacturer: Playdale Playgrounds Ltd
Surface Type: Grass Matrix Tiles
Item Quantity: 1
Equipment Compliance: Yes
Surface Area Compliance: Yes
Life Expectancy: 5 -10 Years
Total Findings: 7

There is moderate damage to the surface - Repair the damaged areas of surfacing

The swing seat connectors have some wear present - Monitor for further deterioration and replace when 40% worn

The bush / bushes is / are showing signs of wear - Monitor for any further deterioration and replace as required

There are caps missing from the underside of the seats - Replace missing caps under the seats

There is some notable evidence of chain wear - Monitor for any further deterioration and replace when 40% worn

There is some wear to the shackles. - Monitor for any further deterioration and replace when 40% worn

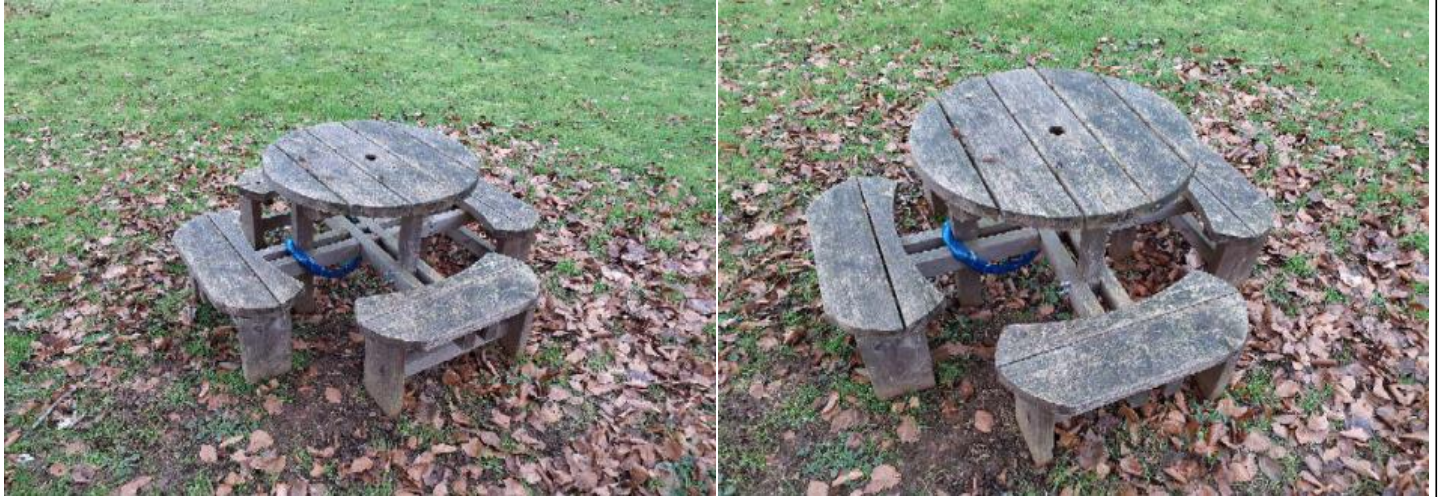
Item: Ancillary Items - Picnic Table
Manufacturer: Not Identified

Finding: There is algae or moss on the surface of the bench **Action:** Clean and treat appropriately

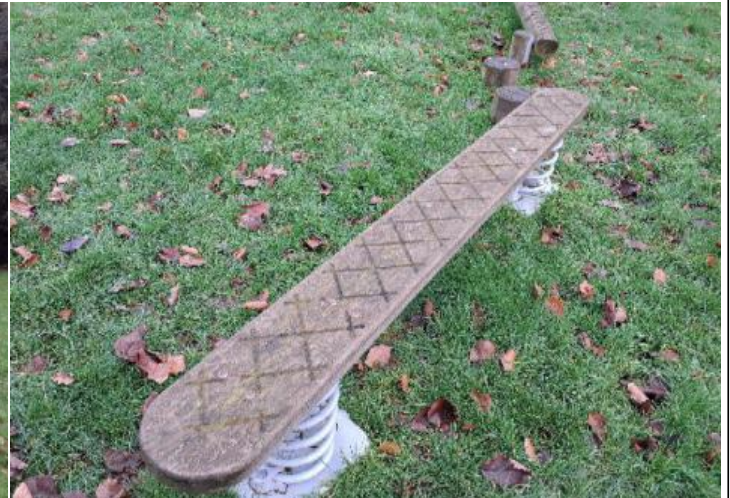
Item: Activity Equipment - Activity Trail
Manufacturer: Playdale Playgrounds Ltd

Finding: There is algae or moss on the surface of the equipment

Action: Clean and treat appropriately

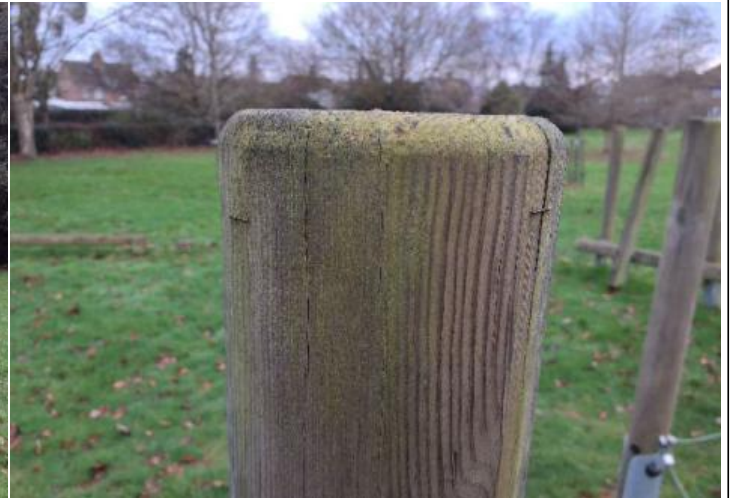
Item: Activity Equipment - Activity Trail
Manufacturer: Playdale Playgrounds Ltd

Finding: There are sharp protruding staples on the item

Action: Remove staples

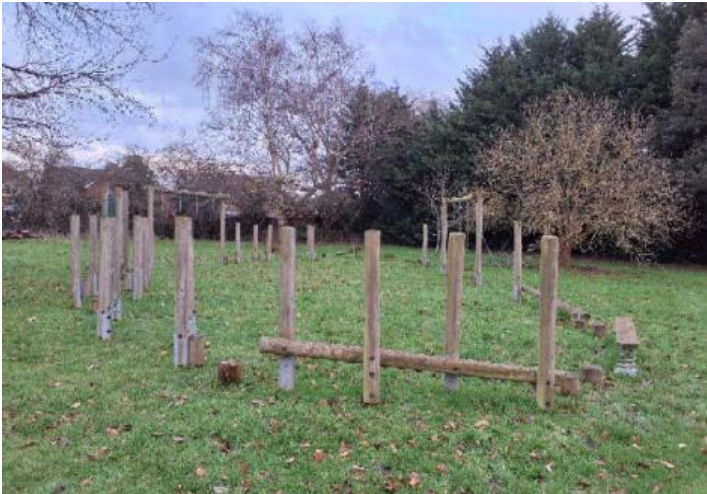
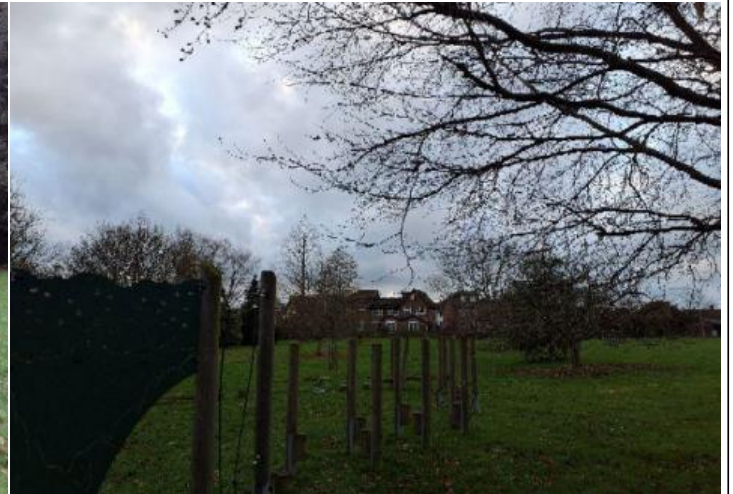
Item: Activity Equipment - Activity Trail
Manufacturer: Playdale Playgrounds Ltd

Finding: The tree canopy overhangs the equipment and is less than 2.0m away

Action: Lift tree canopy to ensure a minimum clearance of 2.0m from the equipment

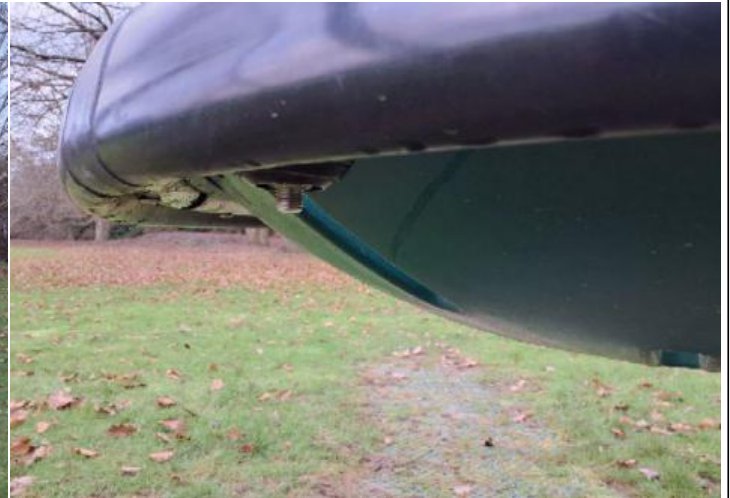
Item: Swings - 2 Bay Swing
Manufacturer: Playdale Playgrounds Ltd

Finding: There are projecting bolt thread(s) present

Action: Remove excess thread length and deburr or provide cap
